## SERVICE TECHNICAL INFORMATION

### ONE POINT REPAIR

UTSUNOMIYA, JULY 31, 1997  
REF. NO.: S1-97-026  
CUSTOMER RELATIONS & SERVICE DIV.

MODEL : HS-JS445

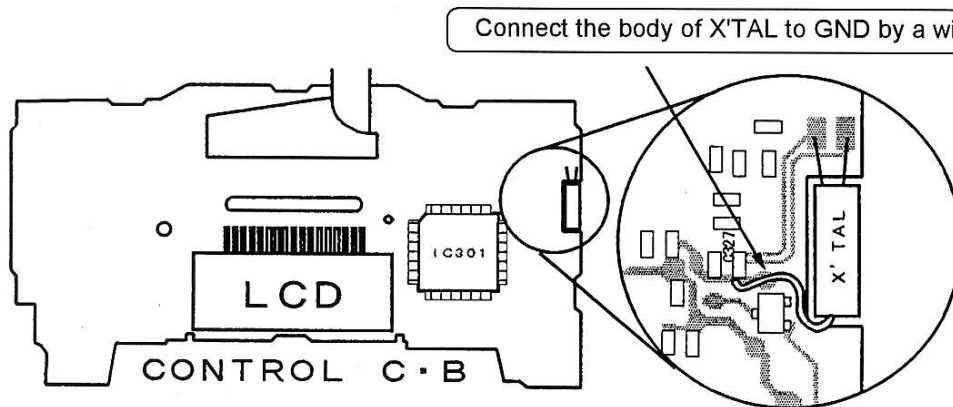
REMEDIES : ① For noise during FM reception

CONTENTS : When sound recording on radio mode is made with the above model, "peep" sound (REC BEAT) may be recorded. If such a symptom is indicated, perform the remedy below.

As shown in the figure below, solder the wire to the body of X'TAL (X301) of the CONTROL CB and connect the body to GND of C327.
