## SERVICE TECHNICAL INFORMATION

### ONE POINT REPAIR

REF. NO. : SI-94-041

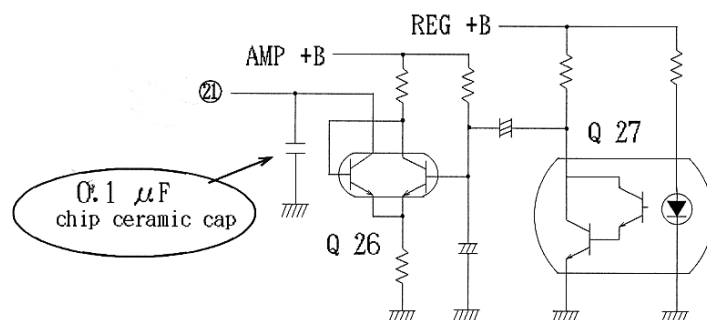
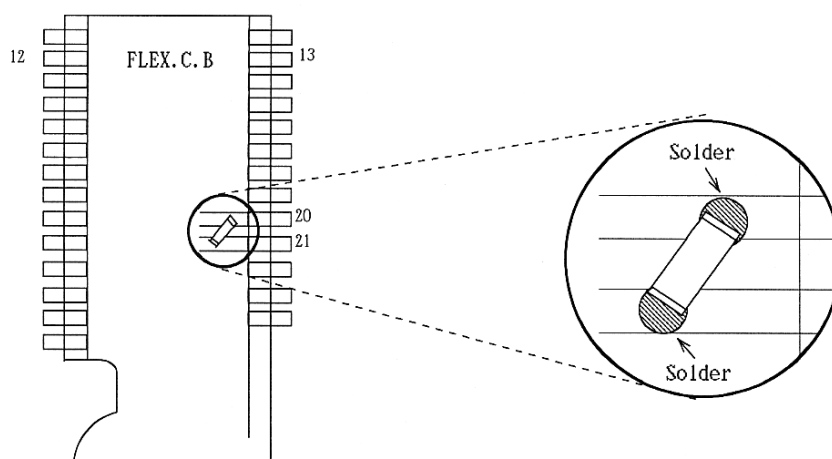
- MODEL : HS-JX838  
SUBJECT : Noise occurs during TV recording  
CONTENT : A noise caused by the photo sensor pulse signal occurs during TV recording. This noise can be detected by the REC monitor and a small amount of the noise is recorded. If this problem is indicated by the customer, follow the remedy below.
- REMEDY : Add a 0.1 $\mu$ F chip ceramic capacitor between the Q26 collector and earth.  
(Solder between the FLEX. C.B. 20 pin and 21 pin as shown in the diagram.)
