## SERVICE TECHNICAL INFORMATION

### ONE POINT REPAIR

REF. NO.: S1-97-025

MODEL : HS-JX819/-JX839/-JX859/-JX959

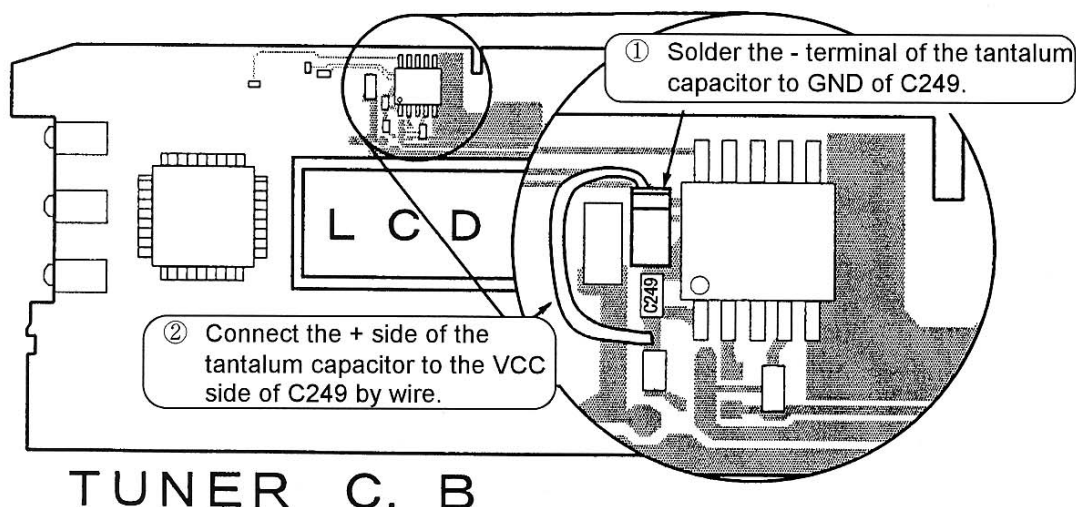
TUNER C. B

CONTENTS : In the above headphone stereos, "hoot" noise (oscillation sound at 500 Hz) may be heard from the headphones during FM stereo reception. In such a case, perform the remedy below.

REMEDY : Connect a tantalum capacitor of 10  $\mu$ F in parallel to the ceramic capacitor of 0.01  $\mu$ F which is connected to the power supply of the prescaler IC.

For the products of serial No. \*\*\*\*\*77A0001 and later, measures are taken by changing the resistor R246 of the power supply of the prescaler IC from 33 to 10  $\Omega$  in the production process.
