## SERVICE TECHNICAL INFORMATION

### ONE POINT REPAIR

UTSUNOMIYA, JAN. 20, 1998  
REF. NO.: SI-97-063  
CUSTOMER RELATIONS & SERVICE DIV.

- MODELS** : HS-JX869/879
- SUBJECT** : Previous recording remains undeleted after the operation of recording - stopping - recording again, at the interrupted point.

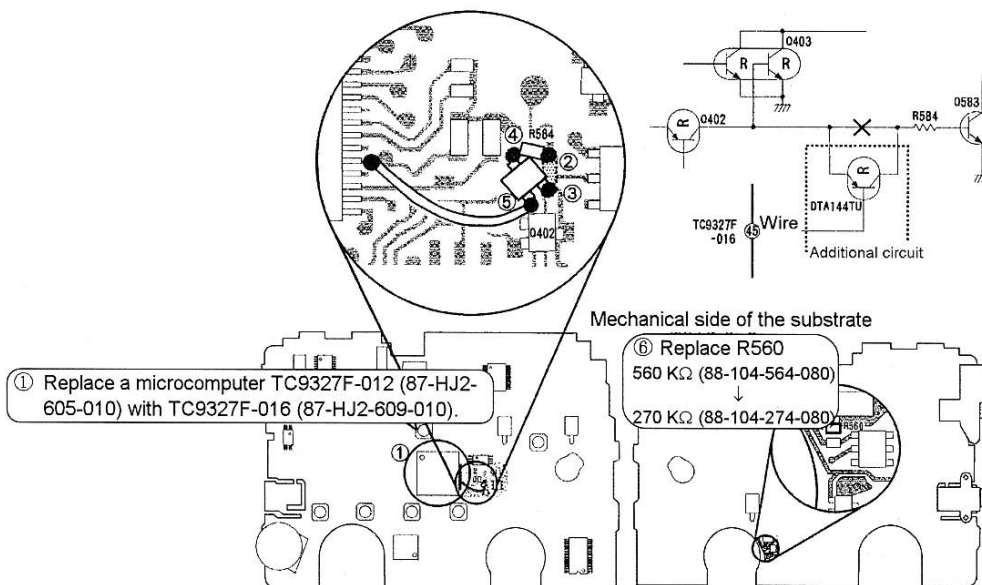
- CONTENTS** : During operation of overwriting on a previously-recorded tape, a device of the above model fails to delete previous recording for approximately 0.7 seconds at the point where recording has been interrupted. The fault occurs during the following operation:  
Recording is stopped, and then resumed from the same point.  
To solve the problem, take the following actions

- REMEDIES** :
- 1) Replace the microcomputer TC9327F-012 with TC9327F-016 on the main substrate.  
(The old and new microcomputers are incompatible with each other.)

- 2) Remove R584 chip resistor on the substrate.
  - 3) Solder the emitter of an externally mounted transistor DTA144TU onto Q402-side land to where R584 was connected before.

- 4) Solder the collector of the externally mounted transistor DTA144TU onto R584. Solder the other side of R584 lead onto the originally connected land. Here, R584 has been turned in 90 degrees.

- 5) Connect the base of the externally mounted transistor DTA144TU to the pin 45 of microcomputer TC9327F using a lead wire.
  - 6) Replace the chip resistor R560 (560K-ohm) on the substrate bottom (mechanical side of the substrate) with a 270K-ohm resistor.
