SERVICE TECHNICAL INFORMATION

ONE POINT REPAIR

UTSUNOMIYA, November 30, 1994
 REF. NO. : SI-94-029
 TECHNICAL SUPPORT DIV.

MODEL : NSX-800, NS-T160
 SUBJECT : Discoloration around the IC601 (LA6515) of the CD board.
 SYMPTOM : There may be CD players that have a blackened area around the IC601 of the CD C.B. Despite discoloration, the CD functions are usually normal, and in most cases, the ICs are not damaged. Also, the degree of change differs depending on how the CD players were used.

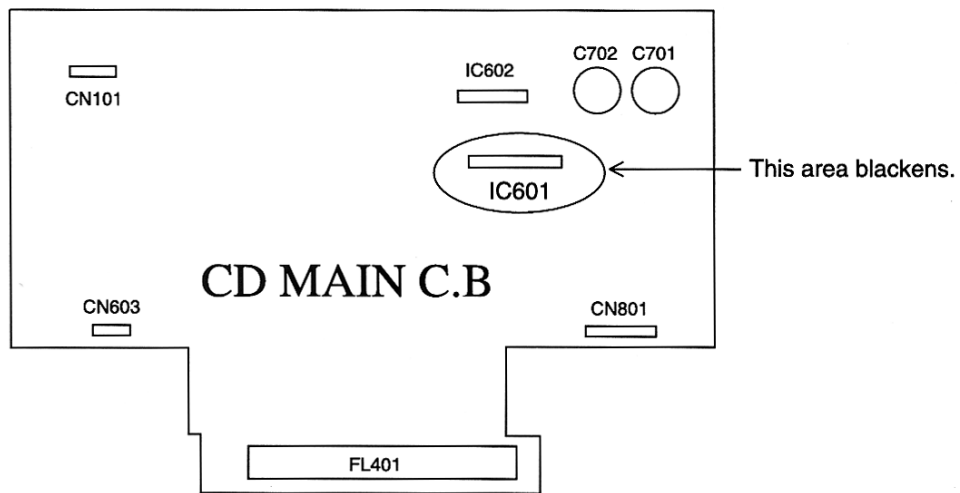
Be sure to perform a visual check even if malfunctions occurred in parts other than the CD unit.
 In such cases, take the following measures.

REMEDY : Replace the IC601 LA6515 with the IC601 LA6510 which emits less heat.
 Circuit changes are not necessary, because LA6515 pins and LA 6510 pins are compatible.

IC601 LA6515 87-001-872-010

change to ↓

IC601 LA6510 87-001-173-010
