SERVICE TECHNICAL INFORMATION

REF. NO.: SI-94-006

NSX-510G HE. HD. HR. E. K. Z. U.

Sound distortion when playing recorded sound from a particular CD.

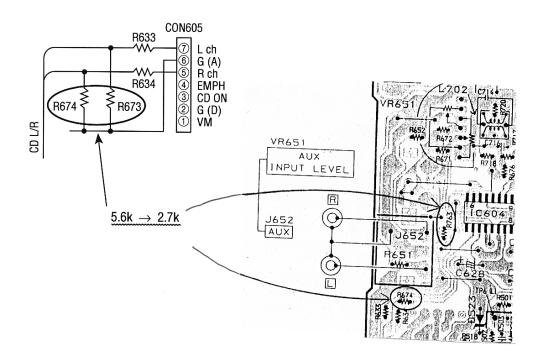
There may be cases in which sound becomes distorted when the unit plays a tape recorded from

a particular CD which has too high signal out put.

Note: "R763" in the wiring diagram is a misprint. Replace with "R673."

Change the following resistors on the CD signal lines of the MAIN C.B as indicated below.

R673, R674

$5.6K \rightarrow 2.7K$

This modification should lower the CD output signal level by approximately 3dB.
