## SERVICE TECHNICAL INFORMATION

## ONE POINT REPAIR

REF. NO.: SI-97-061

NSX-F9, F12, F15, NK950, S94, S95, R900, RK900, RK850, R800

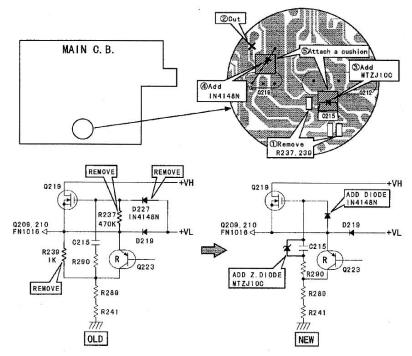
When the FET of the power amplifier fails, there is a case that the transistor on

the power stage also fails and a phenomenon of "No power" occurs.

Exchange the FET and transistor and take the following countermeasures at

the same time.

① Remove R237 (470 k $\Omega$ ) and R239 (1 k $\Omega$ ) on the MAIN C.B.

② Cut the pattern of D227 on the cathode side.

③ Solder the Zener diode MTZJ10C at both ends of C215.

④ Add the diode IN4148N between the Q219 gate and D219 cathode.

(5) Attach a cushion under the added Zener diode and diode.

\* The Darlington transistors on the power amplifier unit are complementarily connected. Even if only one transistor is faulty, when exchanging it, be sure to exchange a pair of transistors.
