## SERVICE TECHNICAL INFORMATION

UTSUNOMIYA, AUGUST 31, 1997  
 REF. NO.: SI-97-029  
 CUSTOMER RELATIONS & SERVICE DIV.

### ONE POINT REPAIR

- MODEL : NSX-V200, E7M (E, K, Z)  
 SUBJECT : No CD operation  
 SYMPTOMS : With respect to the aforementioned model, the ICP may be disconnected due to mechanical restrictions of the CD and the CD may not operate. When it is indicated, take the following countermeasure.  
 REMEDIES : Change ICP-N10 on the CD C.B. to ICP-N15.

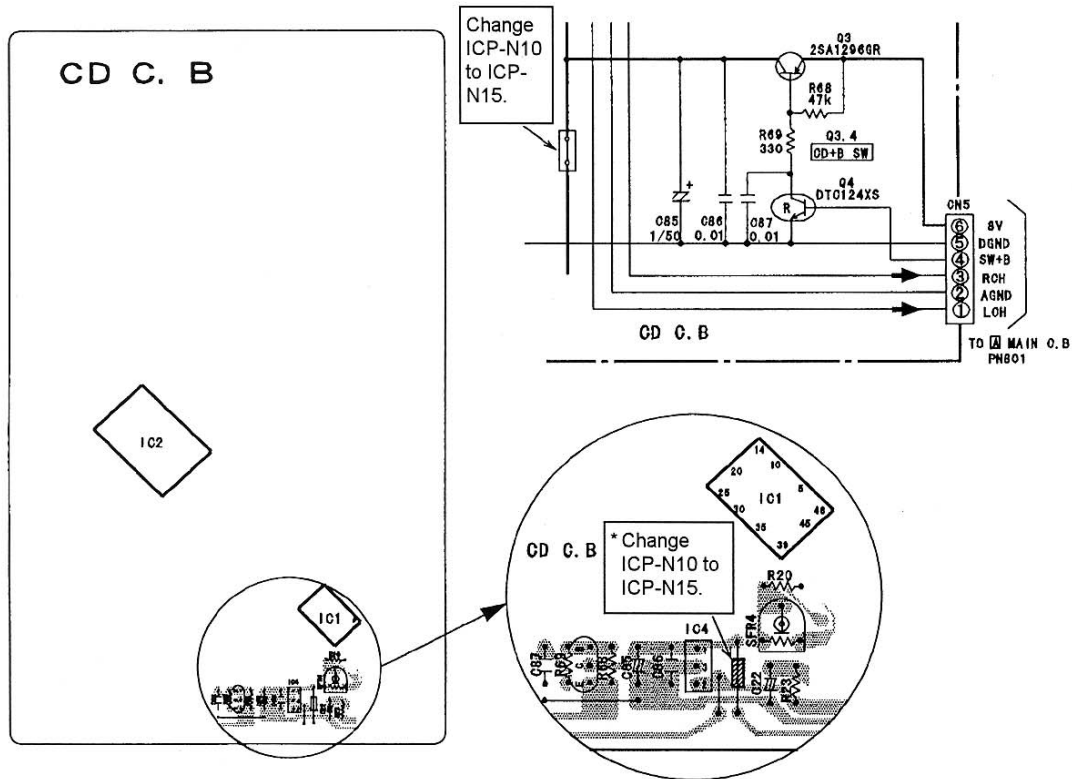
\* ICP-N10 is not described in the service manual. Instead it is described as jumper wire in the service manual.

Ref.	Part Name	Part No.
	ICP-N15	87-001-486-010
