SERVICE TECHNICAL INFORMATION

ONE POINT REPAIR

UTSUNOMIYA, APRIL 20, 1998
 REF. NO.: SI-98-004
 CUSTOMER RELATIONS & SERVICE DIV.

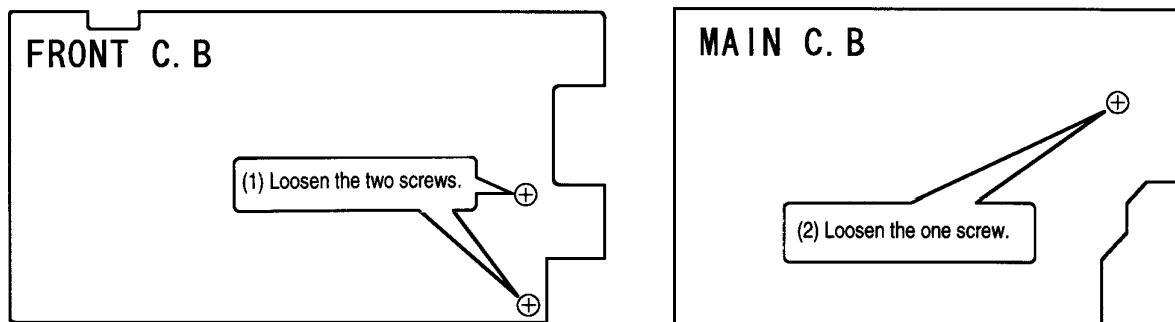
MODEL : NSX-V210
 SUBJECT : No power is turned on.
 DESCRIPTION : It may happen that CON101 of the front C. B and CON601 of the main C. B are disconnected due to a shock during transport and a failure such as "No power is turned on" is caused.
 For a device requested repair, take the following countermeasures regardless of existence of user's indication. This is applicable to devices produced since March 1997.

Countermeasure : (1) Loosen the two screws BVT2+3-10 on the front C. B.
 (2) Loosen the one screw BVT2+3-10 on the main C. B.
