SERVICE TECHNICAL INFORMATION

ONE POINT REPAIR

UTSUNOMIYA, NOVEMBER 15, 1995
 REF. NO. : SI-95-036
 CUSTOMER RELATIONS & SERVICE DIV.

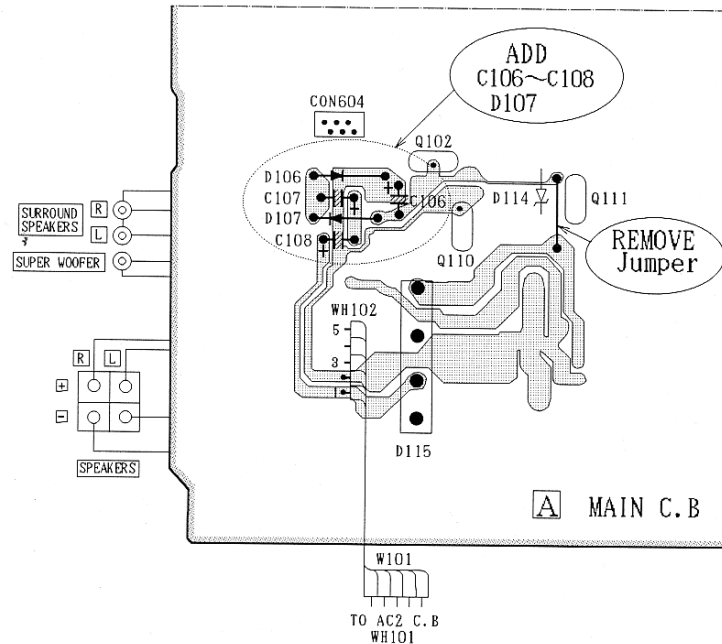
- MODEL : NSX-V30 / V31G / V33 / AP1MK2
 SUBJECT : Changing brightness of FL display
 SYMPTOM : The FL display flickers when T-BASS is ON and the volume is at or beyond the 10 o'clock position. If such a problem is indicated by the customer, perform the remedy described below.
 REMEDY : As shown in the diagram below, add 3 electrolytic condensers and 2 diodes to the MAIN C.B. and remove 1 jumper wire.

Before modification

After modification
