SERVICE TECHNICAL INFORMATION

ONE POINT REPAIR

REF. NO. : S1-95-019
CUSTOMER RELATION & SERVICE DIV.

- MODEL :** SC-A55/C55
SUBJECT : Power can not be turned ON
SYMPTOM : For the above models, there are cases in which the power can not be turned ON. If such a symptom is indicated by the customer, perform the following remedy.
REMEDY : Cut the MAIN CB GND pattern. Also, replace when D1 (RL201) of the controller board is burned, or when the AC adapter is disconnected.

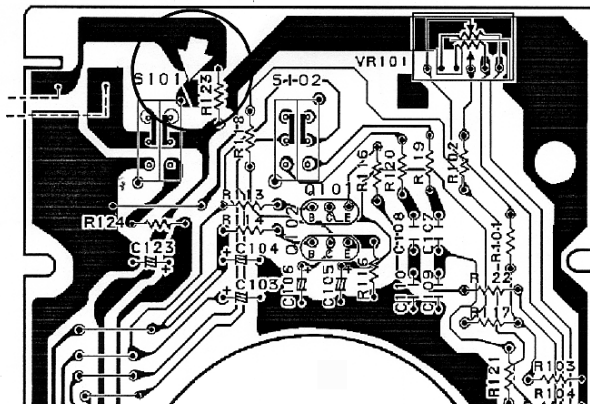
Cut the pattern indicated by the arrow.

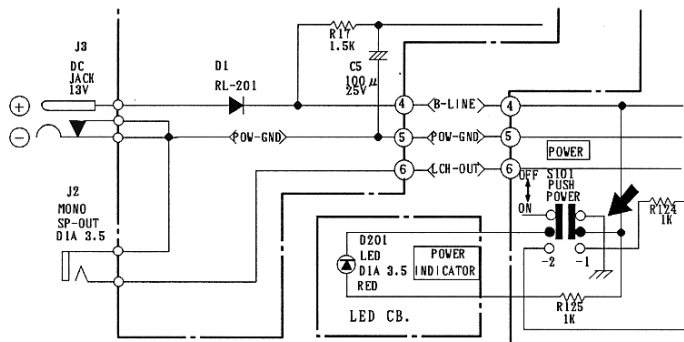
Solder flows into SW. When the power is OFF, +B flows into GND.
(Cut portion indicated by the arrow.)
