SERVICE TECHNICAL INFORMATION

ONE POINT REPAIR

UTSUNOMIYA, OCTOBER 15, 1996
 REF. NO. : SI-96-033
 CUSTOMER RELATIONS & SERVICE DIV.

MODEL : LCX-700M, XR-M7
 SUBJECT : Does not initialize after power is turned on.
 SYMPTOM : When the set fails to initialize after the power is turned on (Direct Key LED blinks), perform the remedy described below.

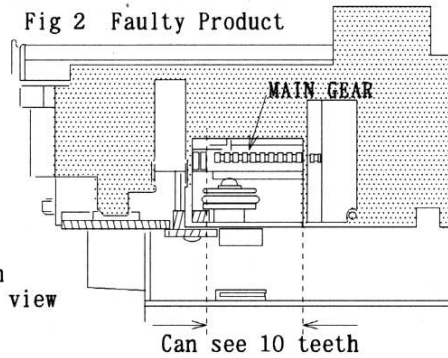
Fig 2 Faulty Product

REMEDY : Check the number of main gear teeth while a CD is being chucked (See Fig. 2). If 11 teeth are not seen, replace the CAM SL.

Replace the CAM SL.
