SERVICE TECHNICAL INFORMATION

ONE POINT REPAIR

UTSUNOMIYA, APR. 15, 1999
 REF. NO.: SI-98-050
 CUSTOMER RELATIONS & SERVICE DIV.

MODEL : XR-MD85

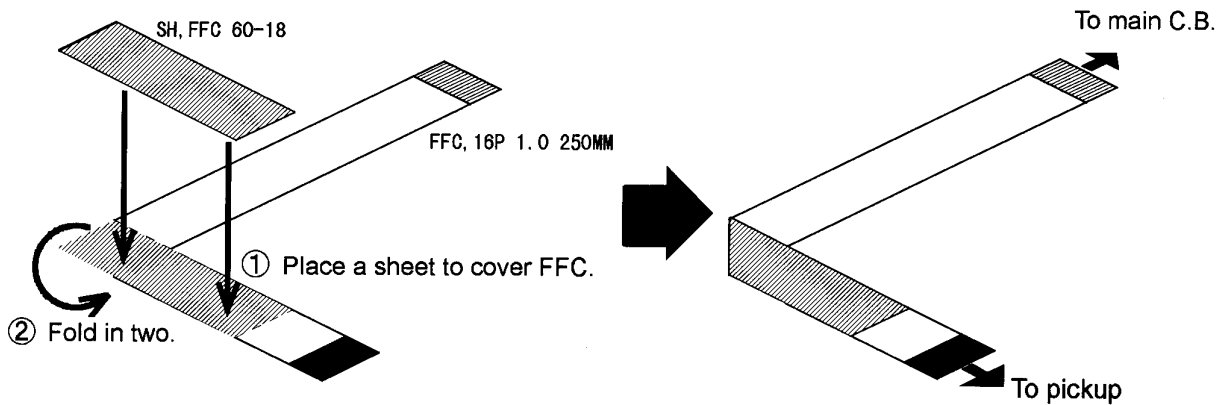
CONTENTS : Coating on the 16-P FFC between the pickup and the CD C.B. may come off, by rubbing against the cabinet bottom. Worn-out coating may cause a break in R70, which results in inability to play CD. Take the action described below, regardless of the troubles currently occurring.

ACTION : Place a sheet on 16-P FFC as shown in the figure.
