### **TECHNICAL BULLETIN**

Ref:TB96005	Issue No.1	Date:03/07/96	Page: 1	of: 1
Title: GL4 Stereo module modification			Authorisation: CD

### **GL4 Headphone Breakthrough**

#### **GL4 Mute Group Lock-Up**

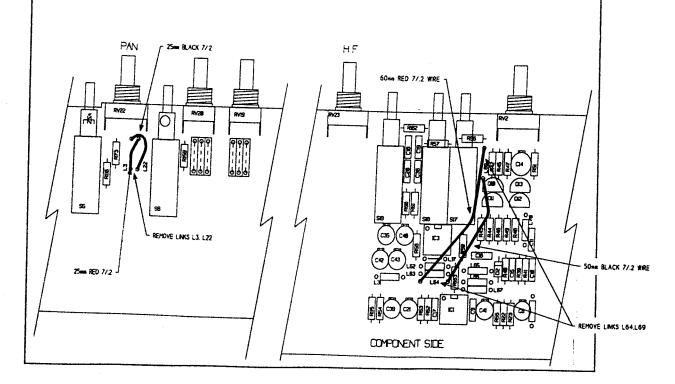
The operation of the Mono Summing switches is opposite to that denoted by the front panel graphics.

Ensure a clean, flat work surface on which to work. Remove all knobs and pot nuts from the stereo input channels. Invert the console and remove the base. Unplug and remove the stereo input PCB's and remove links L3, L22, L64 and L69 as shown below. Fit the four new wire links as shown below.

Check your work carefully. Check in particular for any solder splashes or dry joints. Return the boards to their original position, reconnect the PCB's and fit the pot nuts. Refit the base, flip the console onto its base and refit all knobs. Power up the console and check for correct operation.

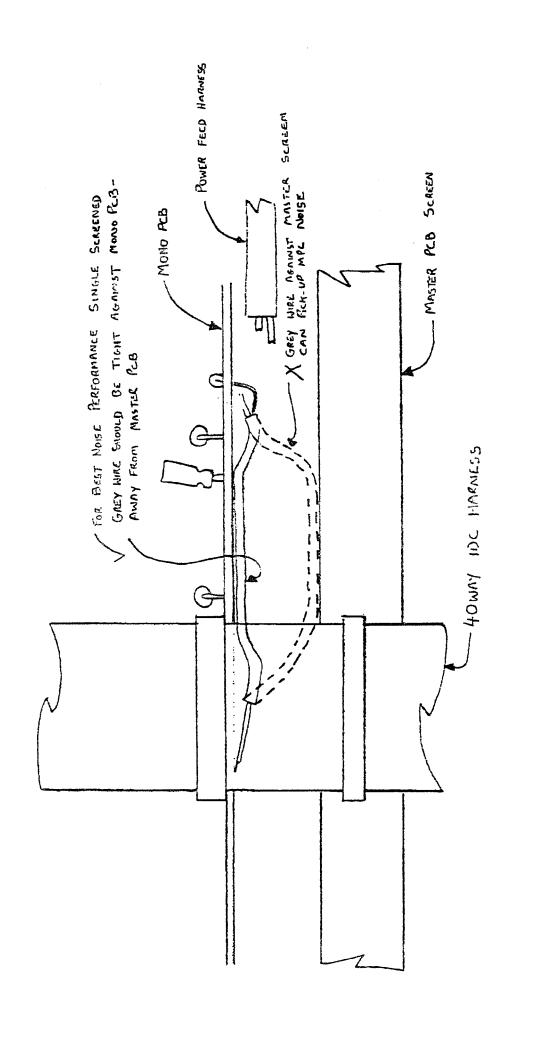
When using low impedance Headphones at high listening levels some breakthrough to left and right outputs may be detectable. This is due to modulation of the "clean" earth feeding the mix amps. To improve the level of breakthrough it is necessary to isolate the earths from both the headphone sockets, and the 47/25 headphone amp supply filter capacitors. To isolate the headphone socket earth, remove Link LK18 from the Master PCB, (see section B-24 of the service manual, LK18 is at the bottom left of Phones 2 socket SK2) then solder a length of 16/.2 wire from the Phones 1 earth point, to the earth Star point on the Power XLR input socket. Next locate capacitors C55, C56 on the Mono PCB, (section B-26 of the service manual, C55,56 are directly below the AB monitor switch S10). The negative terminal of C55, and the positive terminal of C56 need to be lifted from the PCB, then soldered together, (probably easier to remove the caps altogether, and fit new ones) and a second piece of 16/.2 wire soldered from this joint, back to the Power XLR earth Star point. Alternatively a single length of 16/.2 could be used, if a small piece of the insulation was removed to enable it to be soldered to the caps, before being taken on to the Phones 1 earth point.

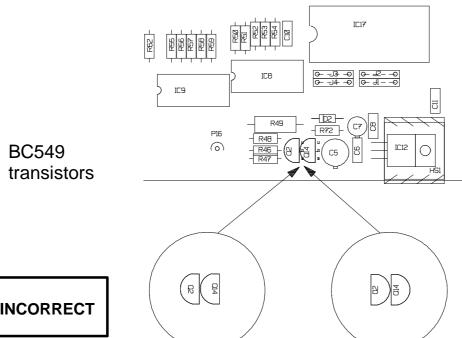
**X**INCORRECT

Due to a change in specification to the BC549 transistors, some production consoles will have these devices fitted reversed on the MONO PCB, AG2005A. These transistors, Q2 and Q14, are part of the power-on reset circuit for the mute processor, and although they will function in the incorrect position, they can cause the mute systems in certain consoles to lock up when first switched on from cold. Normally they will resume correct operation within a few minutes. This may be more noticeable if the DC supply voltage is lower than the +/- 16V specified.

**NOTE** The overlay in the service manual shows the *incorrect* orientation for the BC549 transistors. They should be positioned as the other transistors on the assembly.

If startup problems are encountered, then check these transistors for orientation, and reverse or replace them if necessary. With the console inverted on a suitably sized clean work surface, clear of parts and debris, and with a cloth to protect the console cosmetics, remove the base and locate the +5V regulator IC12, (identified by the black finned heatsink fitted to it) on the MONO PCB. The two transistors are to one end of the heatsink, next to a 330uF capacitor (C5). Check with the diagram and correct if needed.

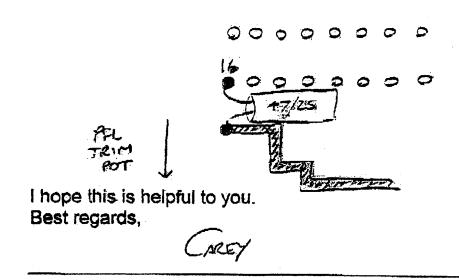
The PFL click problem occursion some consoles and is related to component tolerances. Not all consoles suffer this. However, a simple modification to the main MONC pcb will cure this:

This provides additional decoupling for the + supply to the 4053. This has been implemented in production from 5/No 621223 on.

Solder a 47uF/25V electrolytic capacitor from pin 16 (+ve leg) of IC37 (PFL IC 4053) to 0V ground (-ve leg). The nearest 0V is the thick track below this IC towards the front panel as shown below.
