# MULTIPLE PLAY MANUAL TURNTABLES

## SERVICE BULLETIN

SUBJECT: NEW CARTRIDGE MOUNTING SCREWS-ALL MODELS

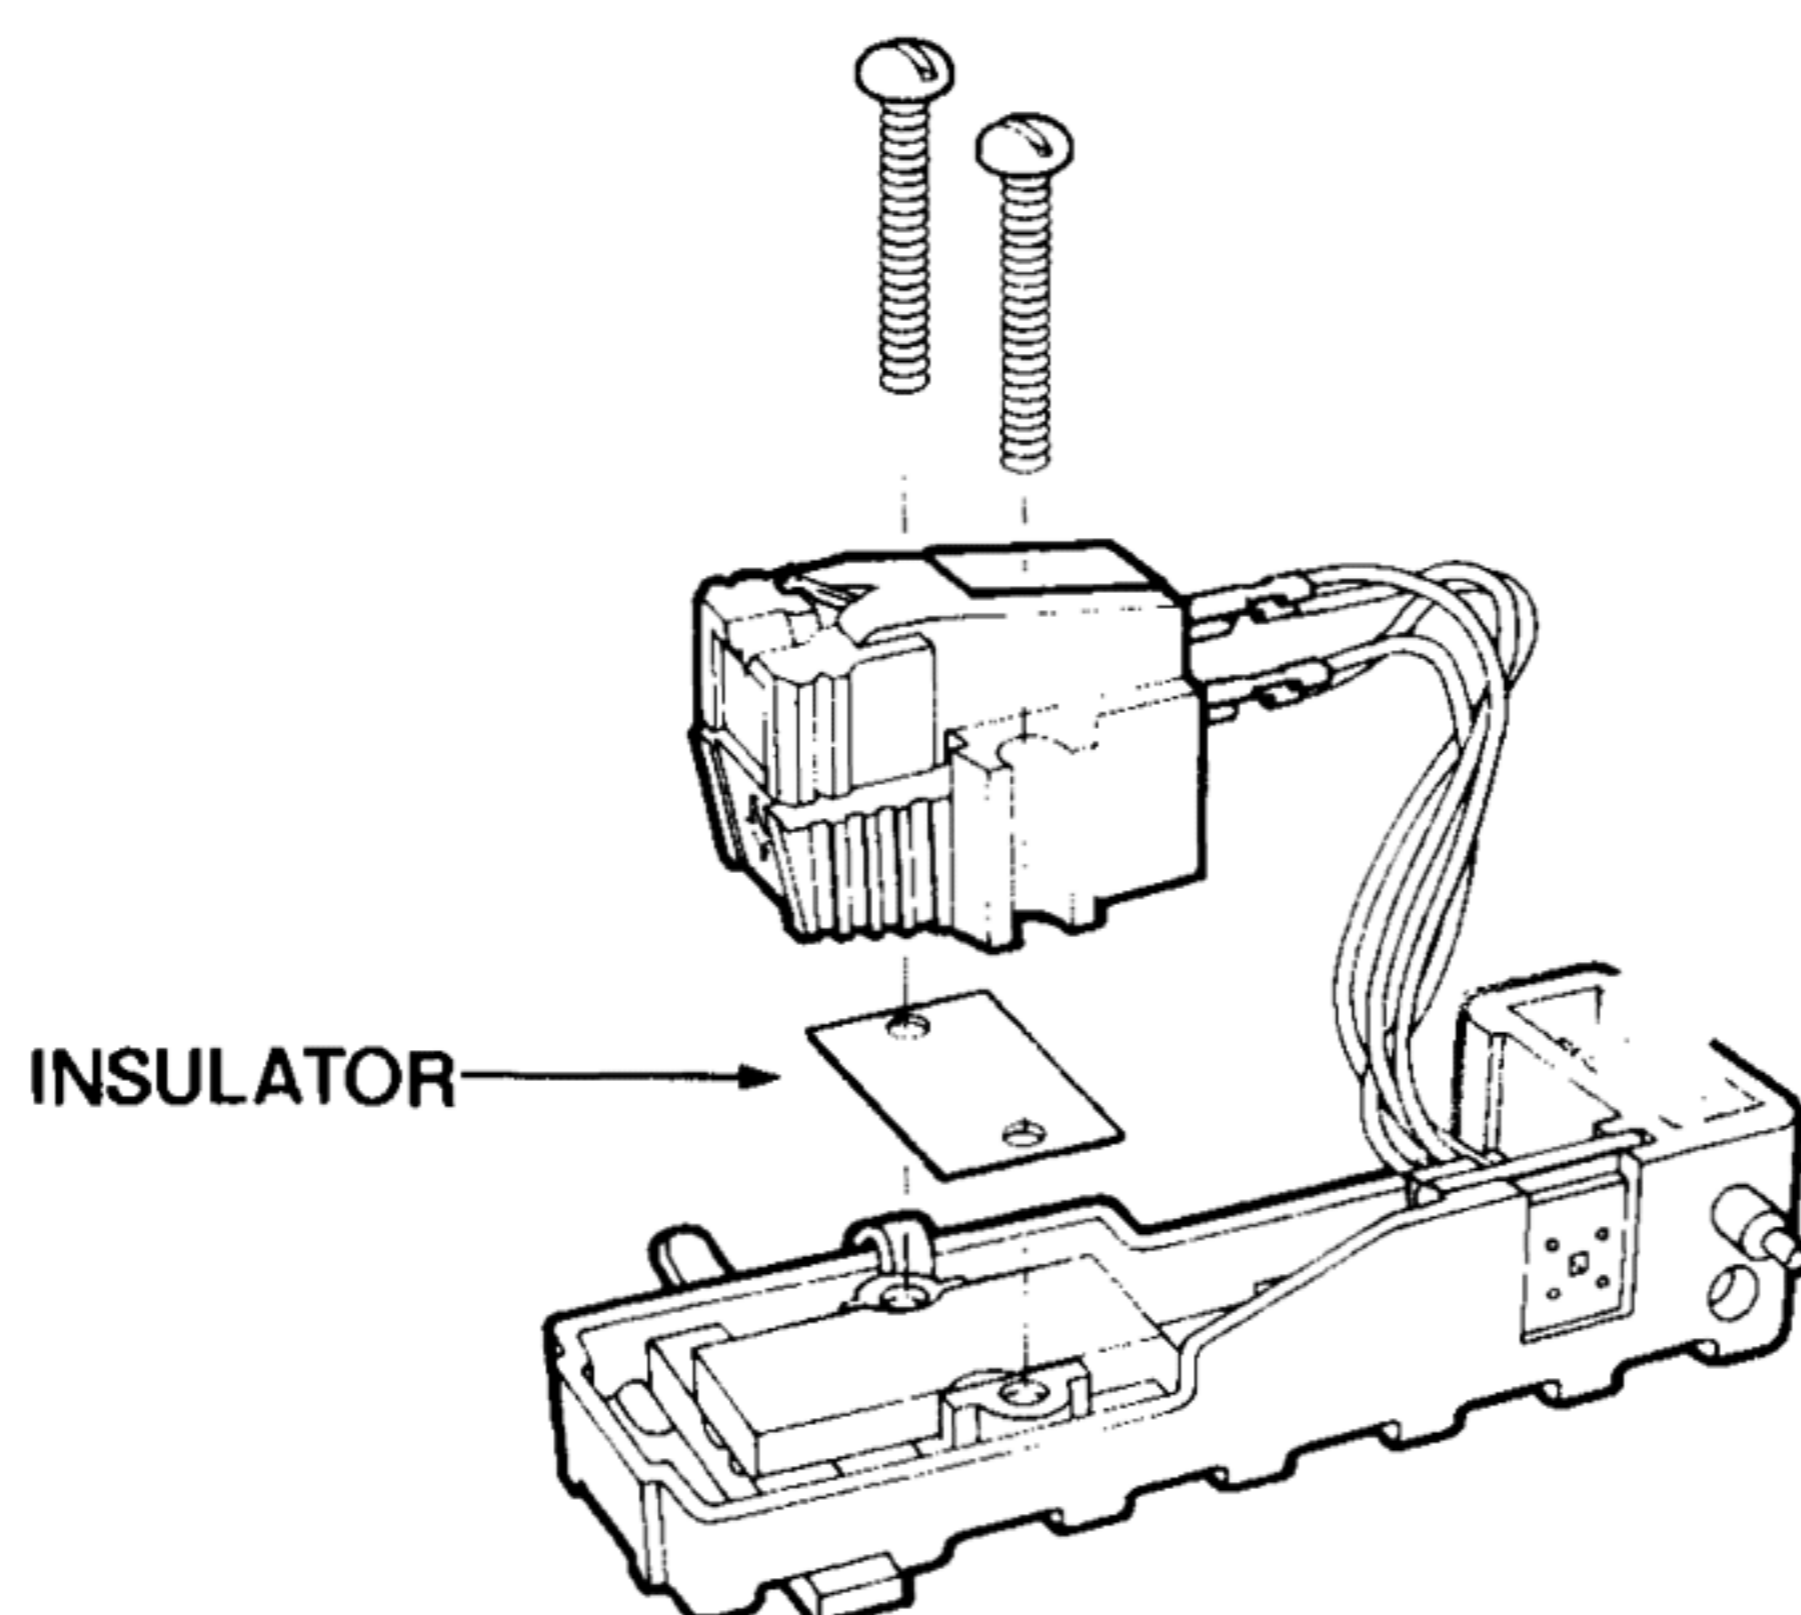
We have been receiving complaints from consumers and dealers about hum and in almost all instances, this has been attributed to the ground strap not being removed, as specified in our instructions. To further compound this problem, certain cartridges now have internal grounding and the ground strap is impossible to remove.

To eliminate this problem, and at the same time, retain the advantages of a shielded pickup head, we have changed our cartridge mounting hardware. Instead of metal screws, B·I·C units will shortly be supplied with nylon screws (non-conductive). Nylon screws are also lower in mass, thus further reducing the tonearm mass of B·I·C units.

We will also supply a non-conductive spacer which must be used between the cartridge and the cartridge mounting plate in order to isolate the cartridge from the mounting bracket (see diagram). If the cartridge is mounted, using the isolation strip and nylon screws, the possibility of ground loops will be completely eliminated.

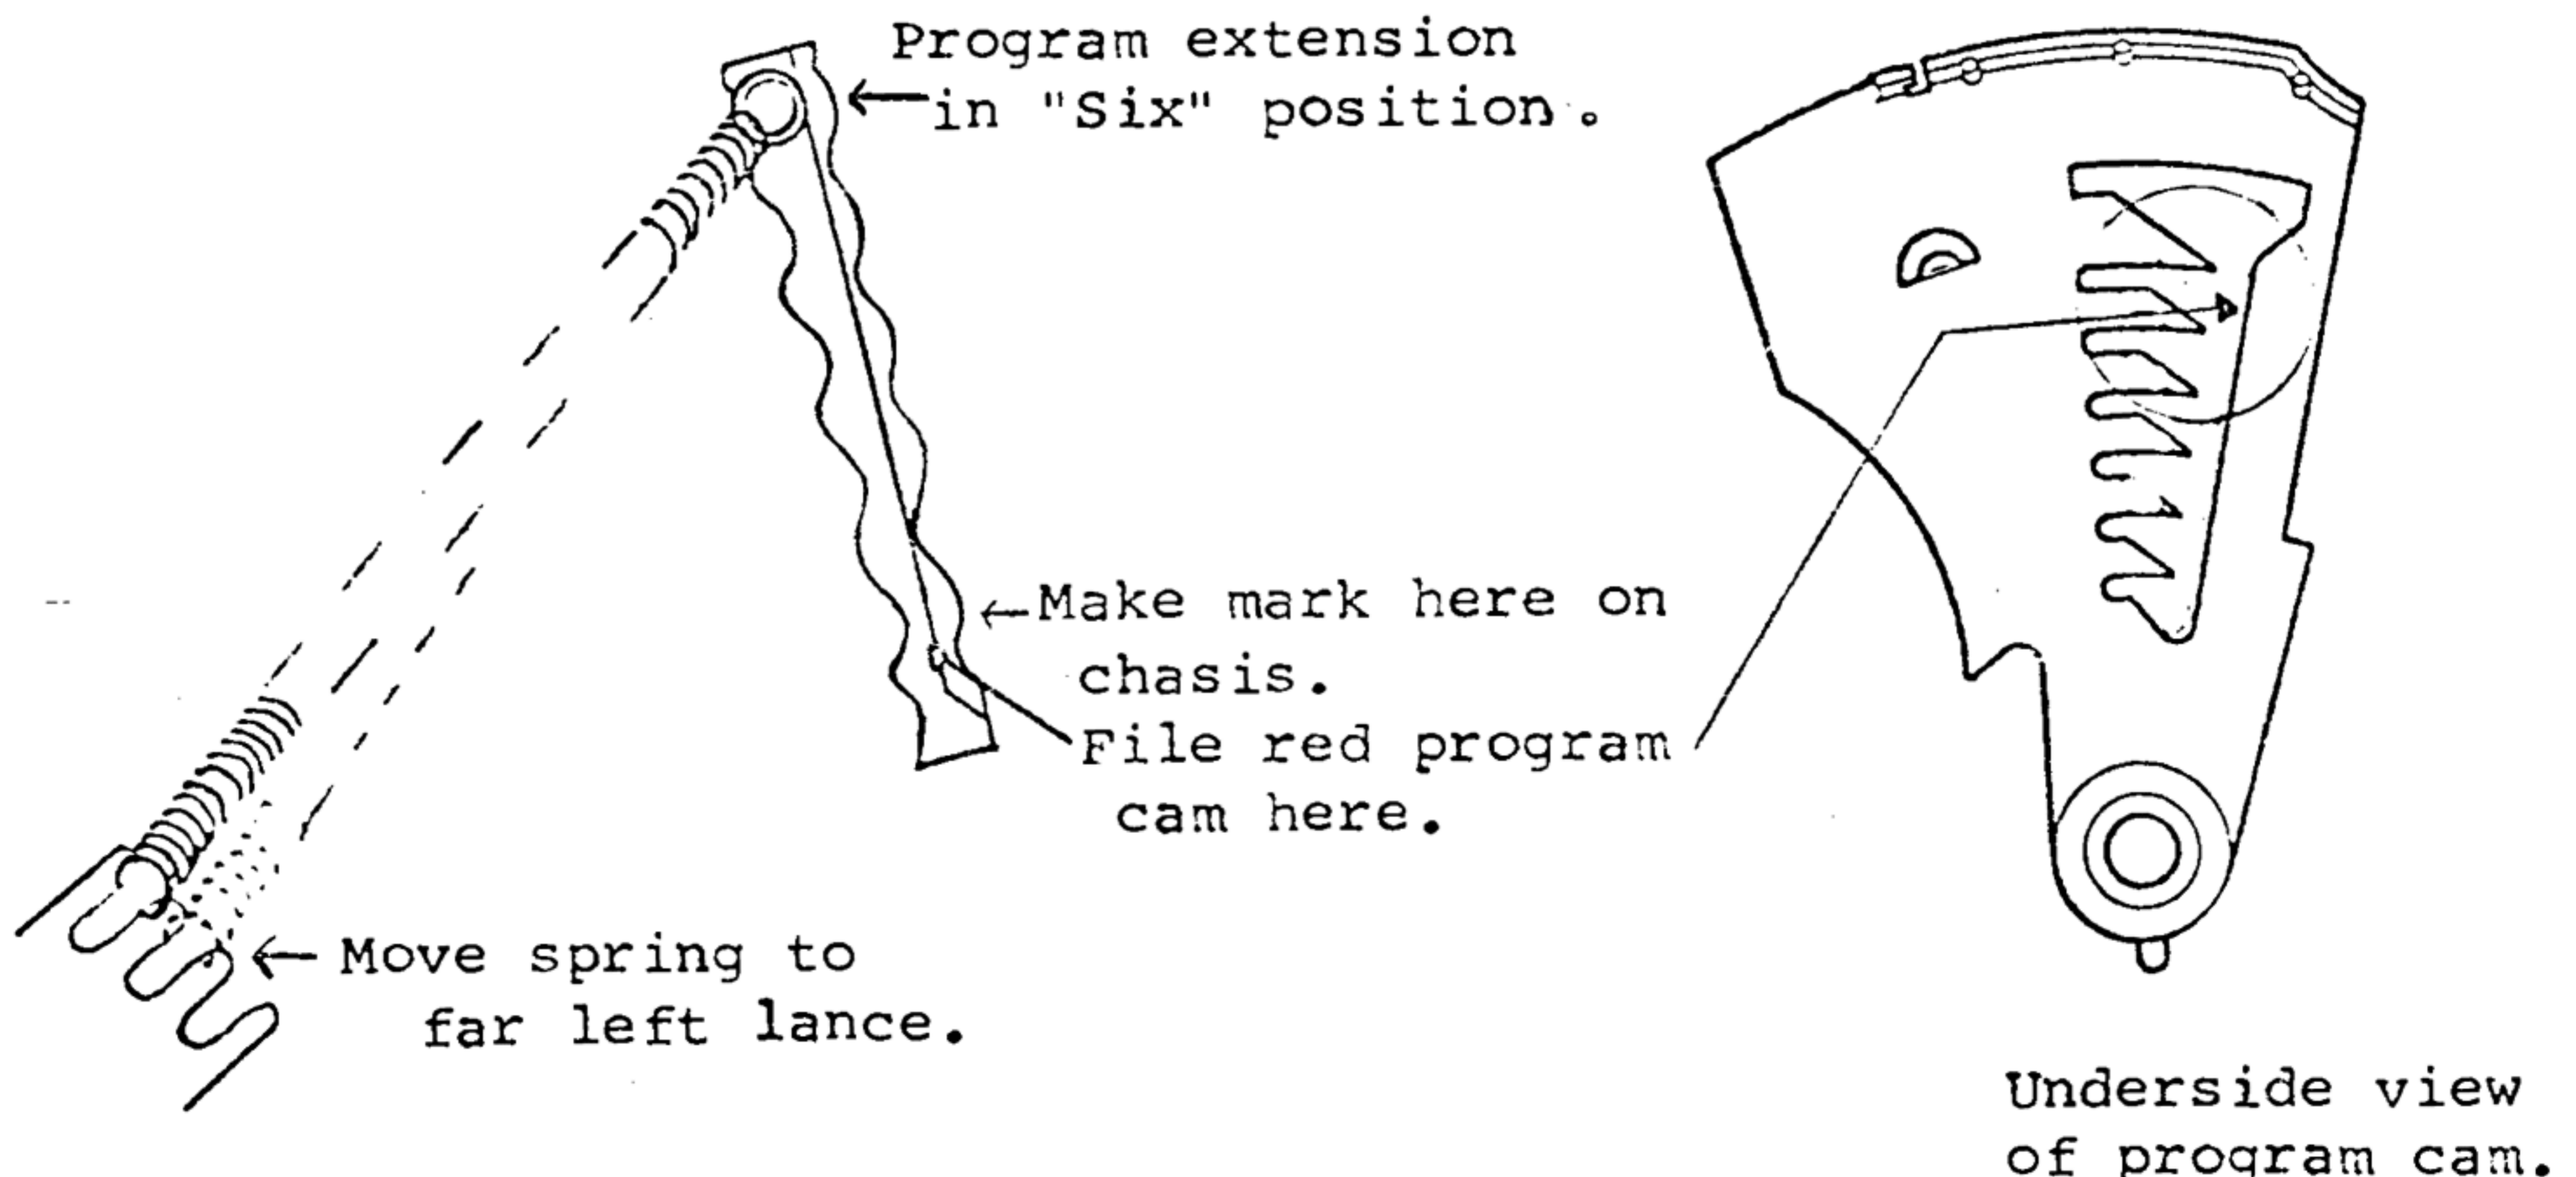
To further improve the reliability and feel of the programmer, the programmer cam plate shown on the attached diagram was changed to a Lexan material commencing on Date Code 7603 (third week of January). It was determined on Date Code 7605 (fifth week of 1976) that the properties of Lexan could contribute to the programmer skipping from One to "Off" position. This is due primarily to the difference in co-efficient of friction between the old part and the Lexan part.

This condition was not picked up on the production line due to the fact that there is an aging process with the new programmer plate and the co-efficient friction did not change until after the units left the Factory.

1. Remove platter.
2. Place program selector in the "One" position.
3. The white program extension extends up through the unit plate. Mark the area where this extension is resting against the red program cam.
4. Move the program selector up to the "Six" position.
5. Using a small file or emery board, rough up the red program cam on the inside edge in the area of the mark. You should be filing straight up and down through the unit plate. See diagram.
6. Move the program spring to the far left tooth notched into the unit plate. See diagram.
7. Replace platter.

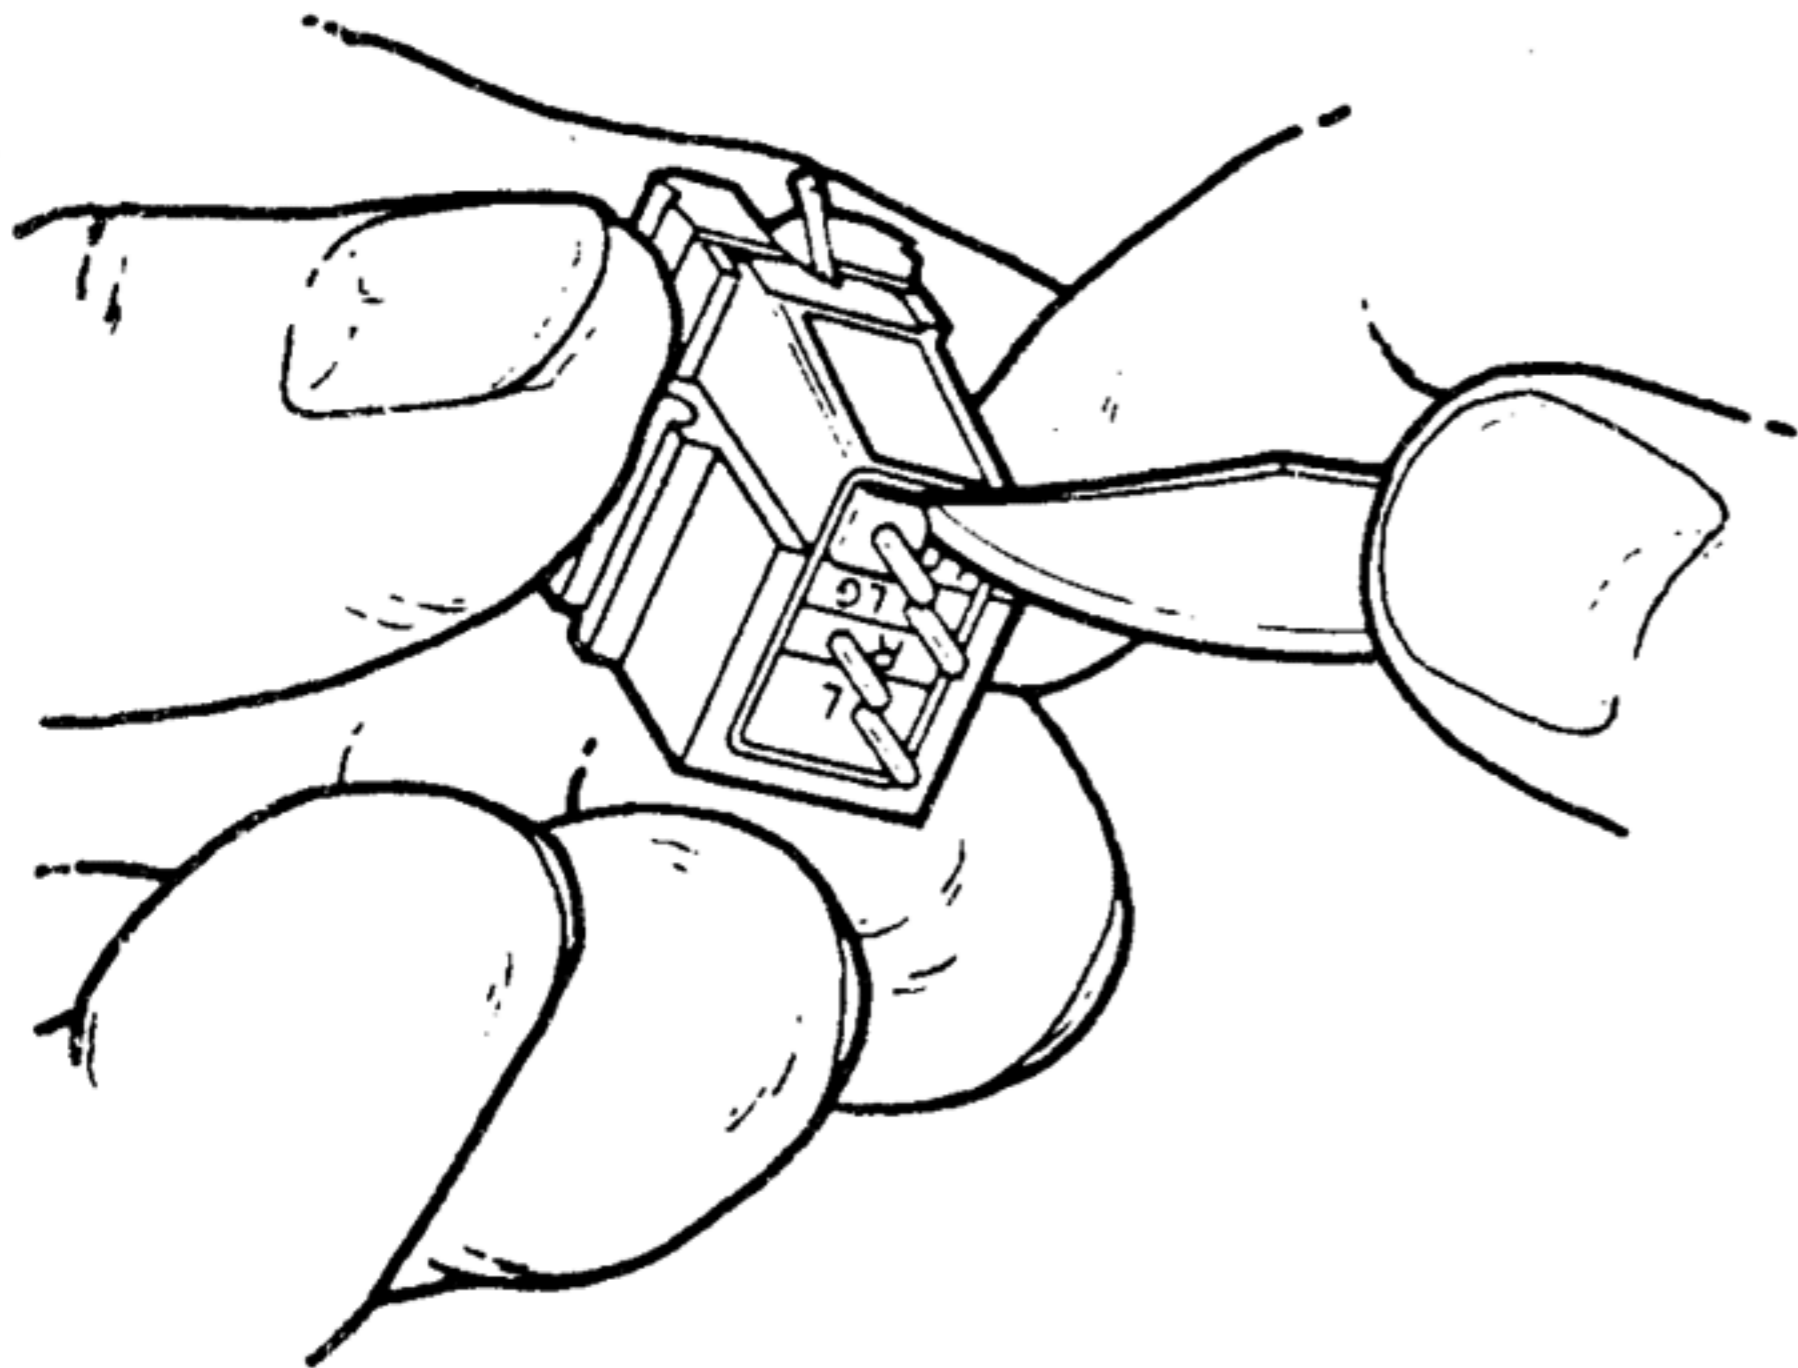
When units with grounded, shielded head shells are used with cartridges that have metal bodies and mounting feet, the small metal "grounding" strap must be removed to eliminate the formation of ground loops which can cause hum through the system.

Remove the ground strap on:

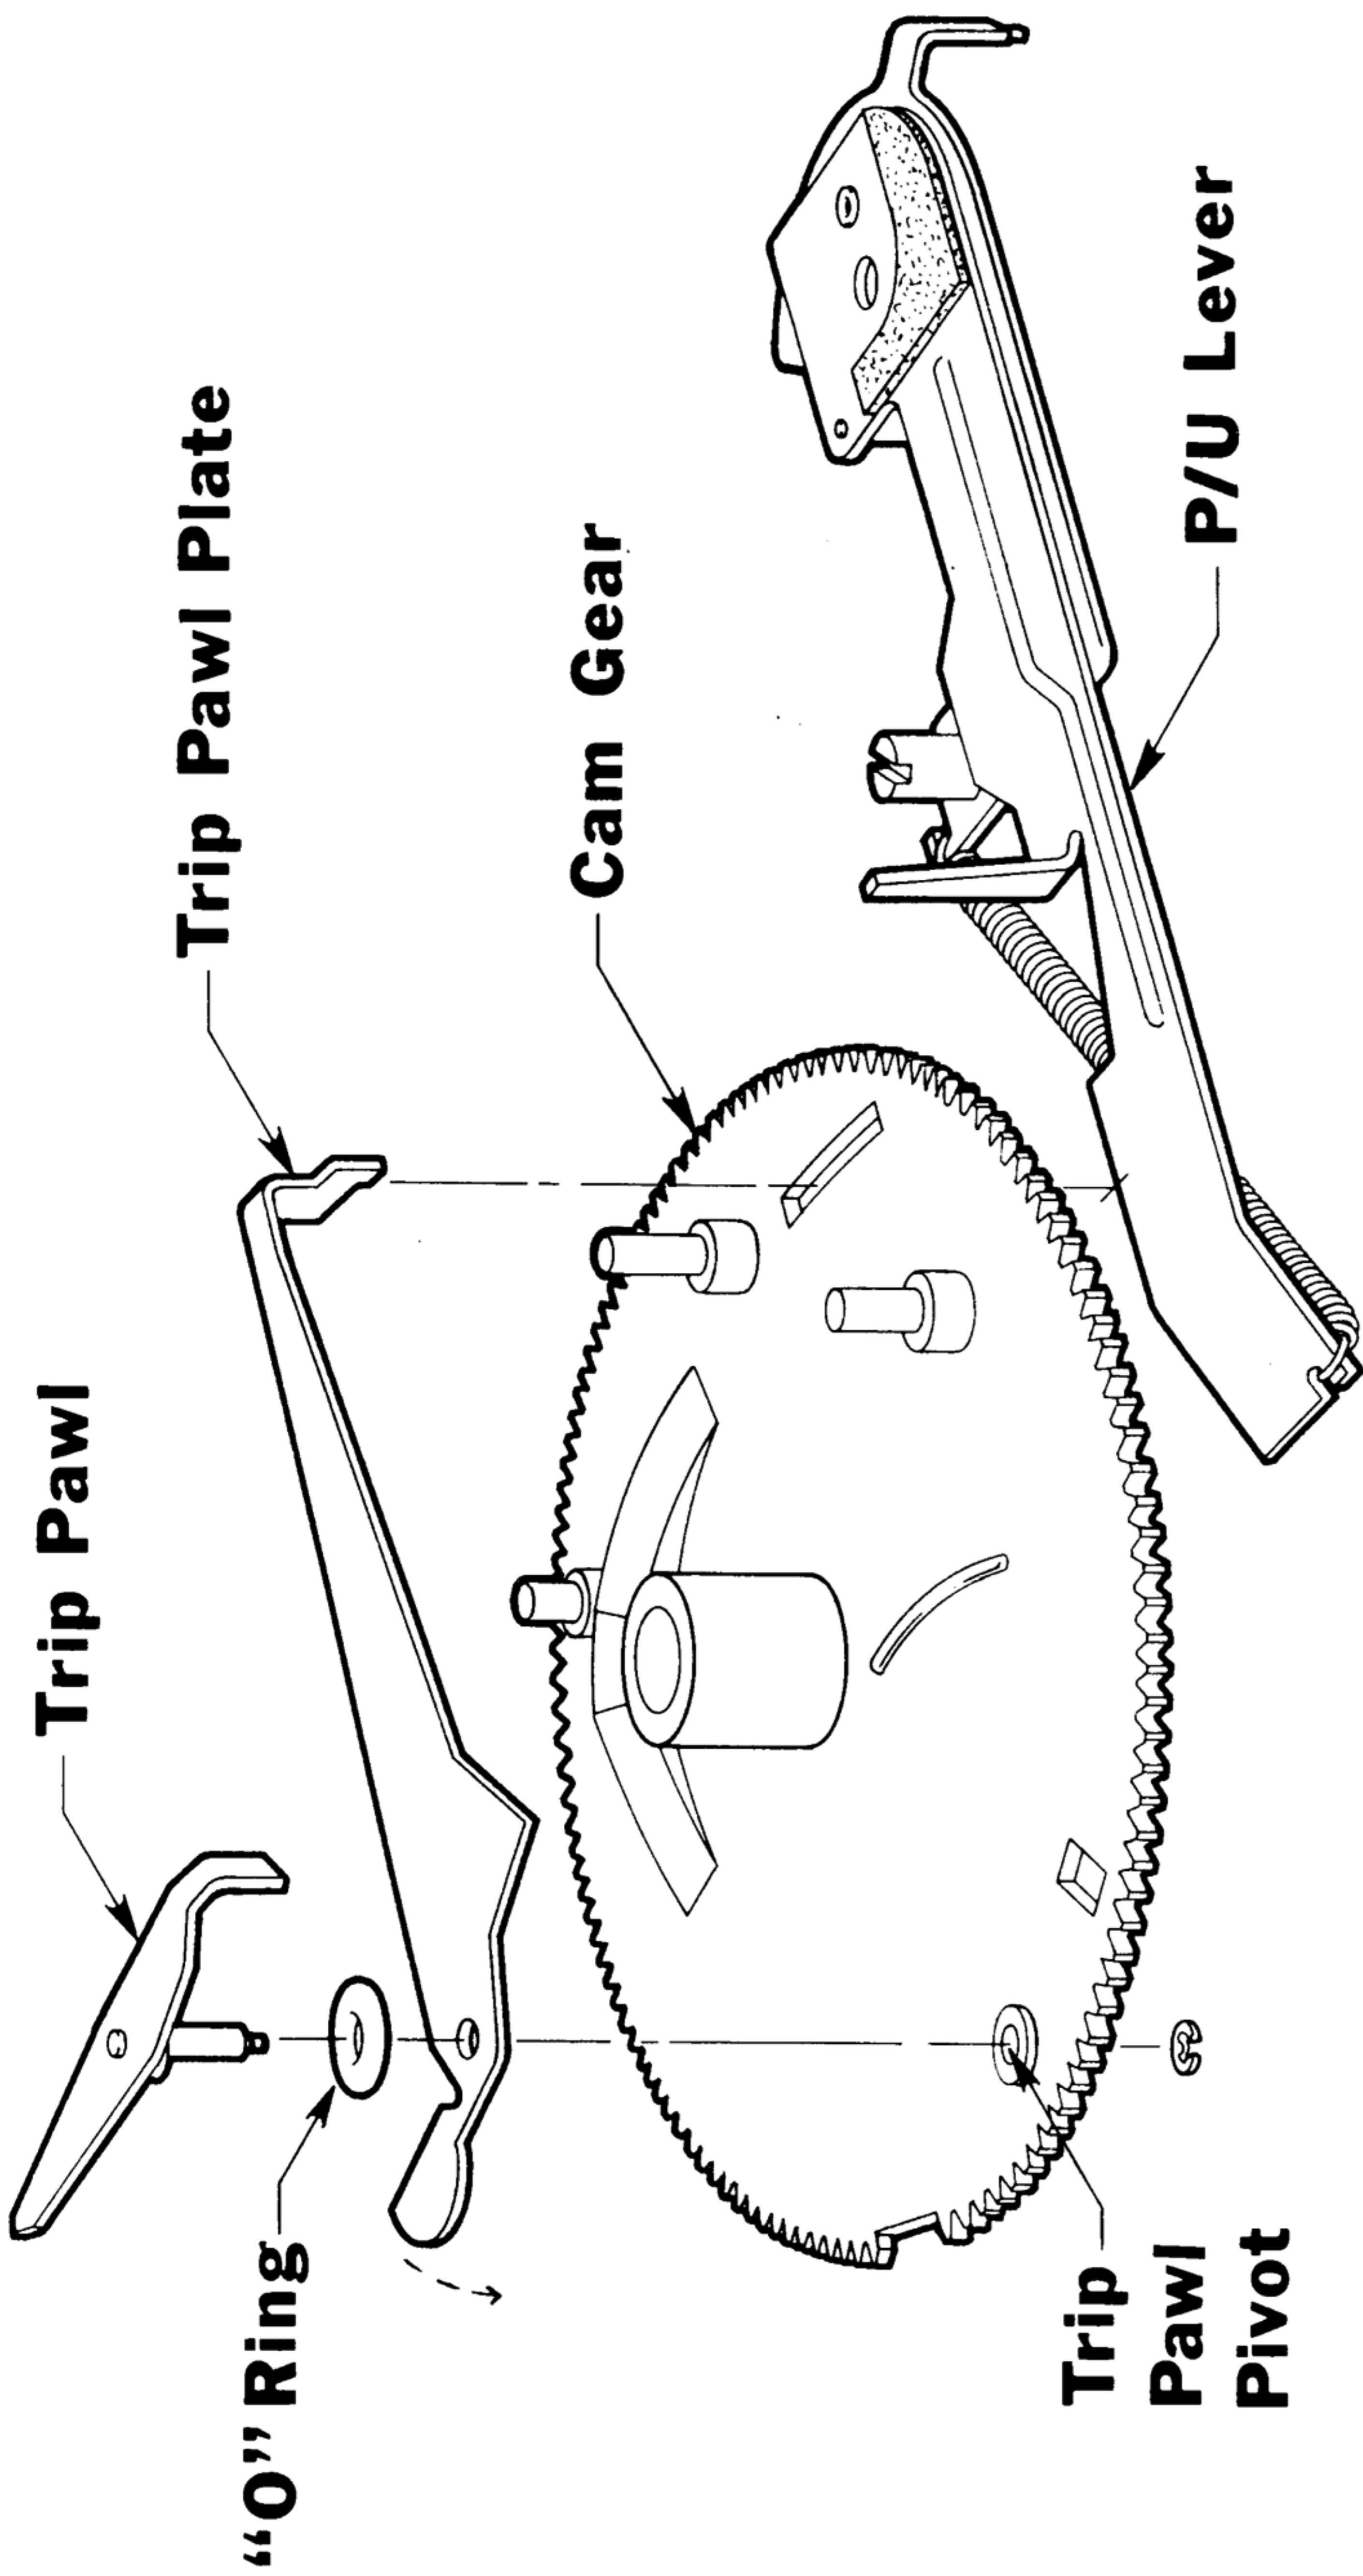
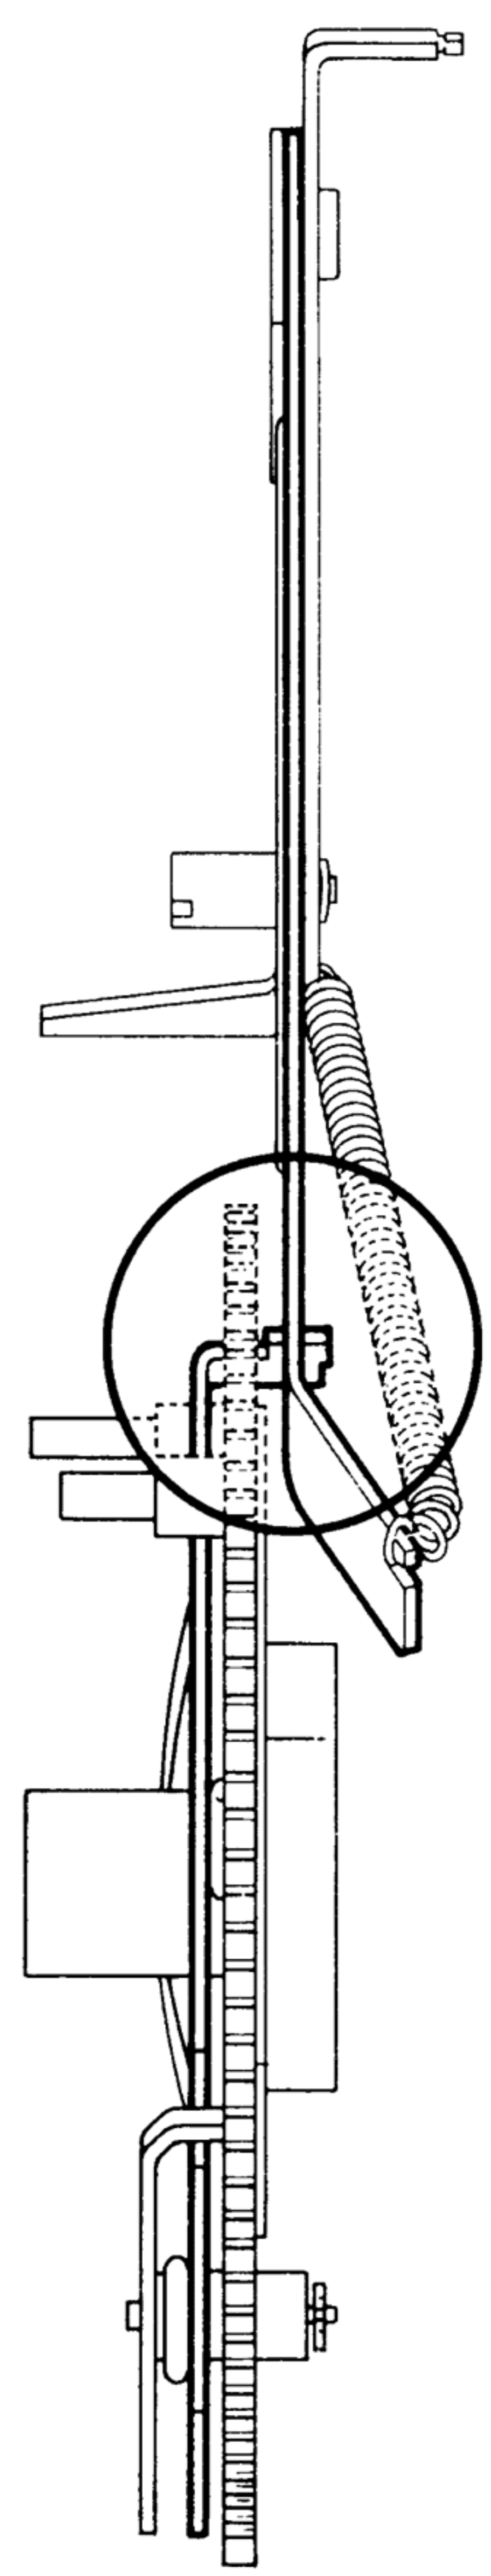
As the tonearm reaches the lead out grooves, the pickup lever begins to impulse the trip pawl plate. The trip pawl "O" ring assembly will move in the same manner. The friction between the trip pawl plate and "O" ring is critical. If the "O" ring is contaminated, a loss of friction between the trip pawl plate and "O" ring may occur.

After a trip is activated, the half moon area on the trip pawl plate (shown near the "O" ring) should extend past the teeth on the main cam gear. Should this not occur, the trip pawl and plate will not reset sufficiently. This will cause a failure to trip condition after the next record has played.

The area of contact between the "O" ring and trip pawl plate should be thoroughly cleaned with alcohol.

The half moon extension can be realigned. Carefully, with a small pair of needle nose pliers, grasp the half moon and pull straight out so that it extends slightly past the cam gear teeth. When examining the trip pawl plate, be certain that it is not pulled too far or bent vertically, as this can cause continuous cycle. Install the platter and cycle the unit. The trip pawl plate will "set" automatically.

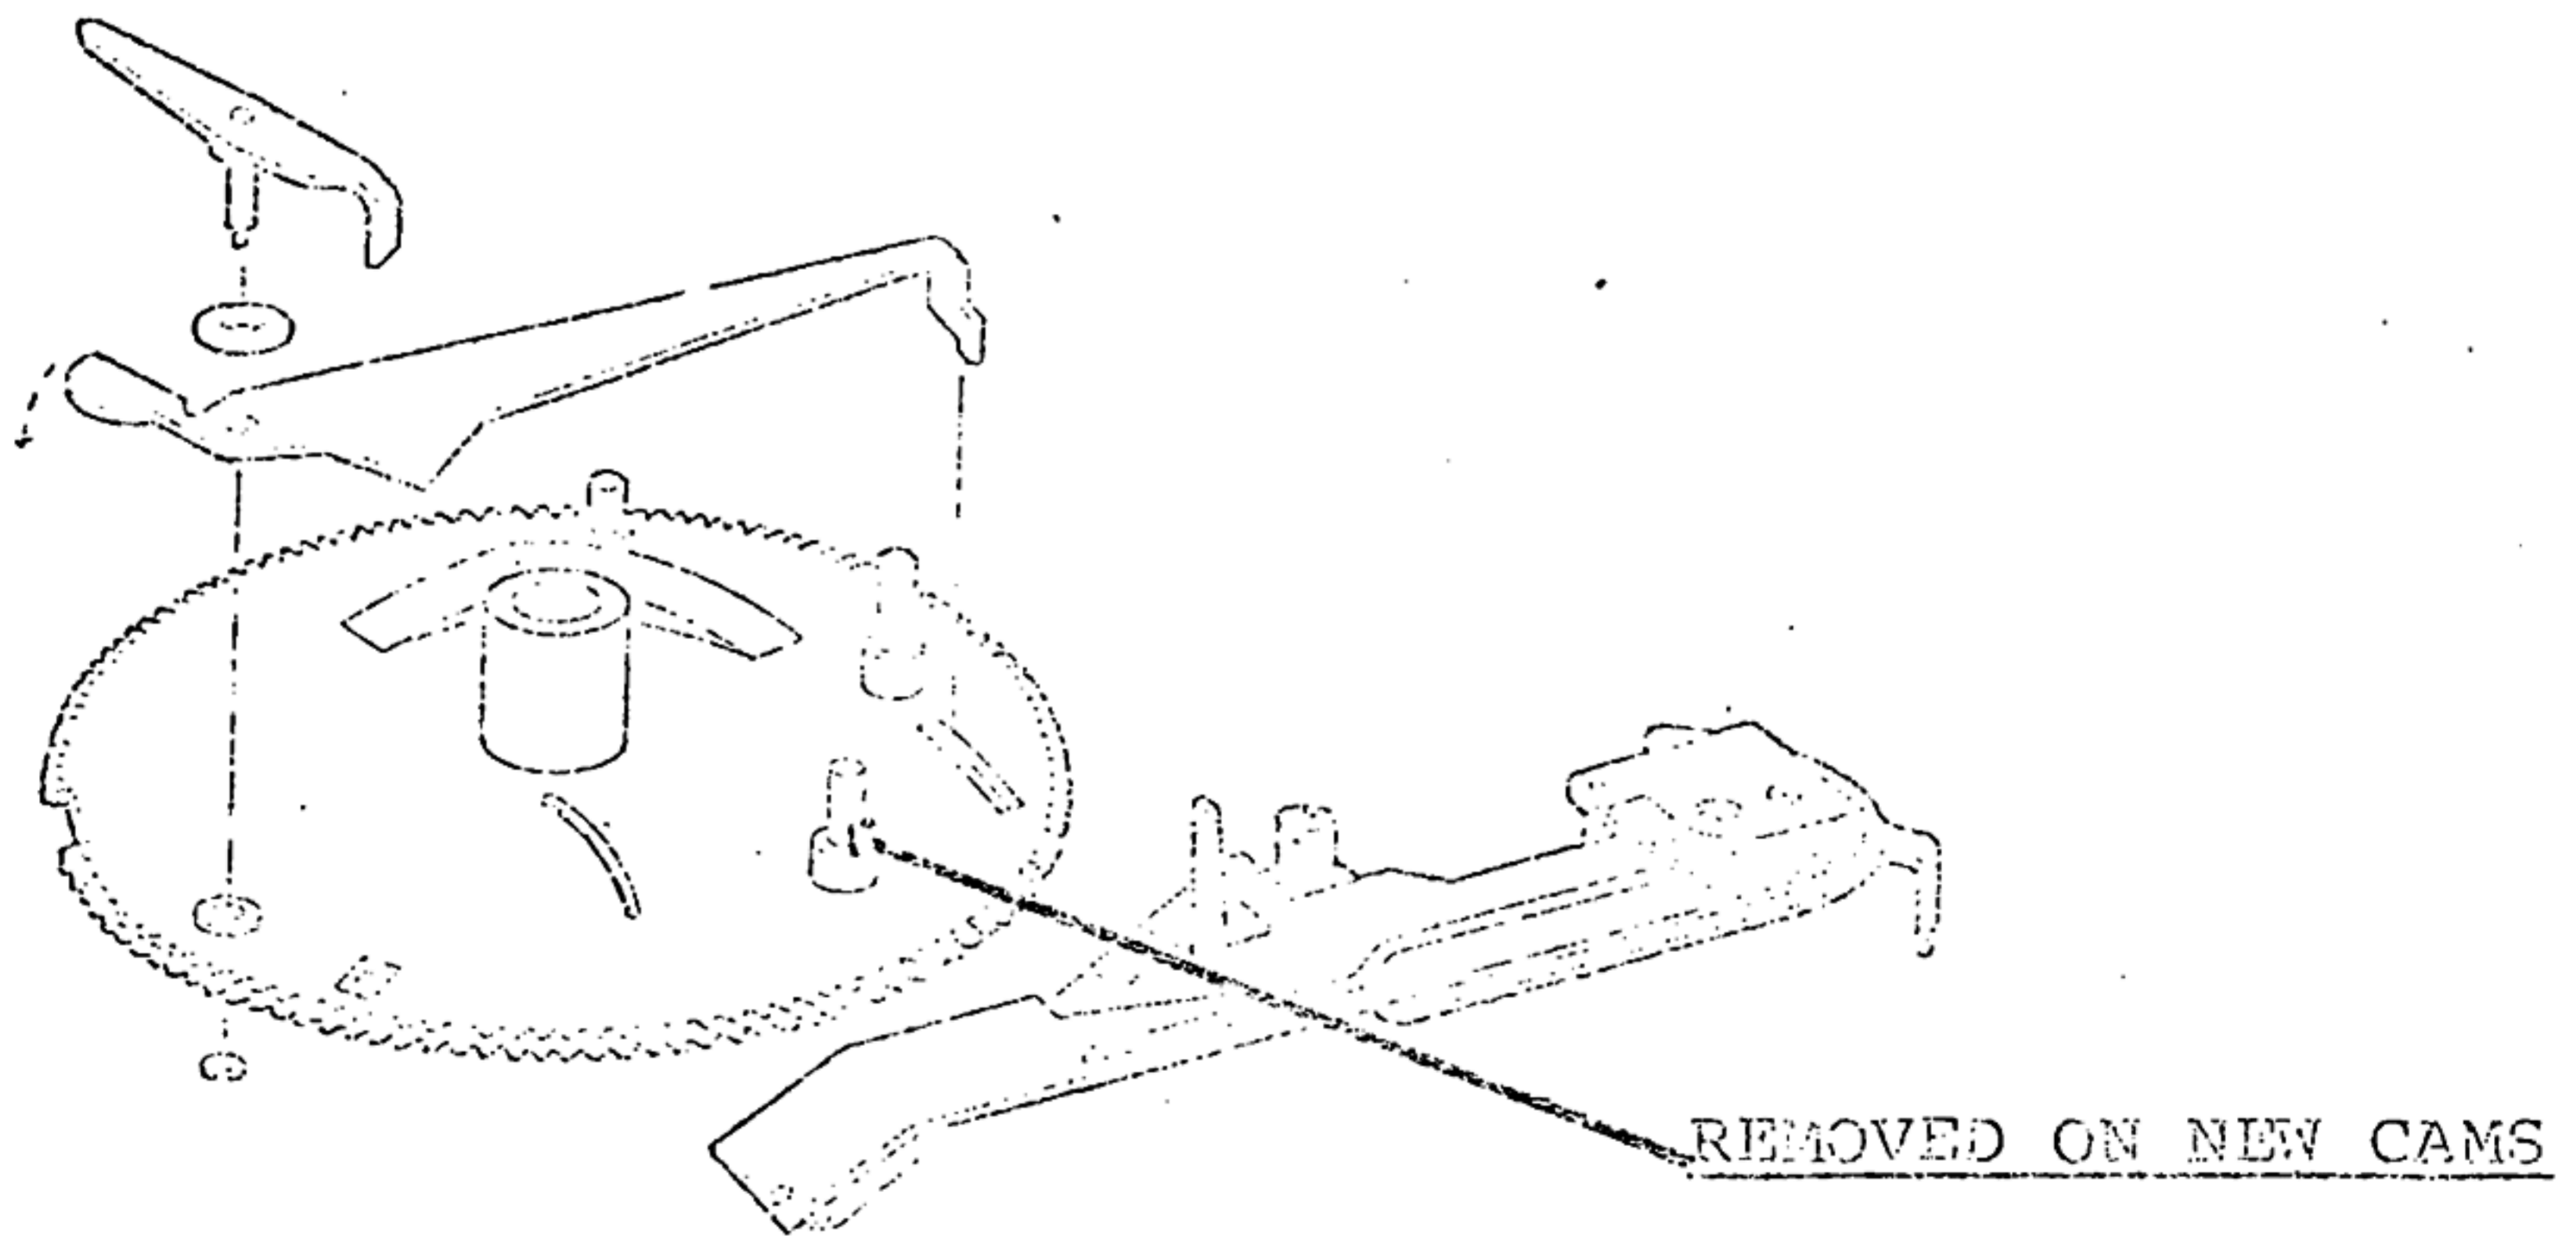
We have determined that the pin nearest the trip pawl plate could contribute to a loss of positive main cam detent. Therefore, we are now supplying main cams with this pin removed (see blowup) below.
