EA-2101

BERNING EA2101 AUDIO-ONE CHANN

BERNING RA-2101 POWER SUPPLY
VERSION 1 OCTOBER 1989

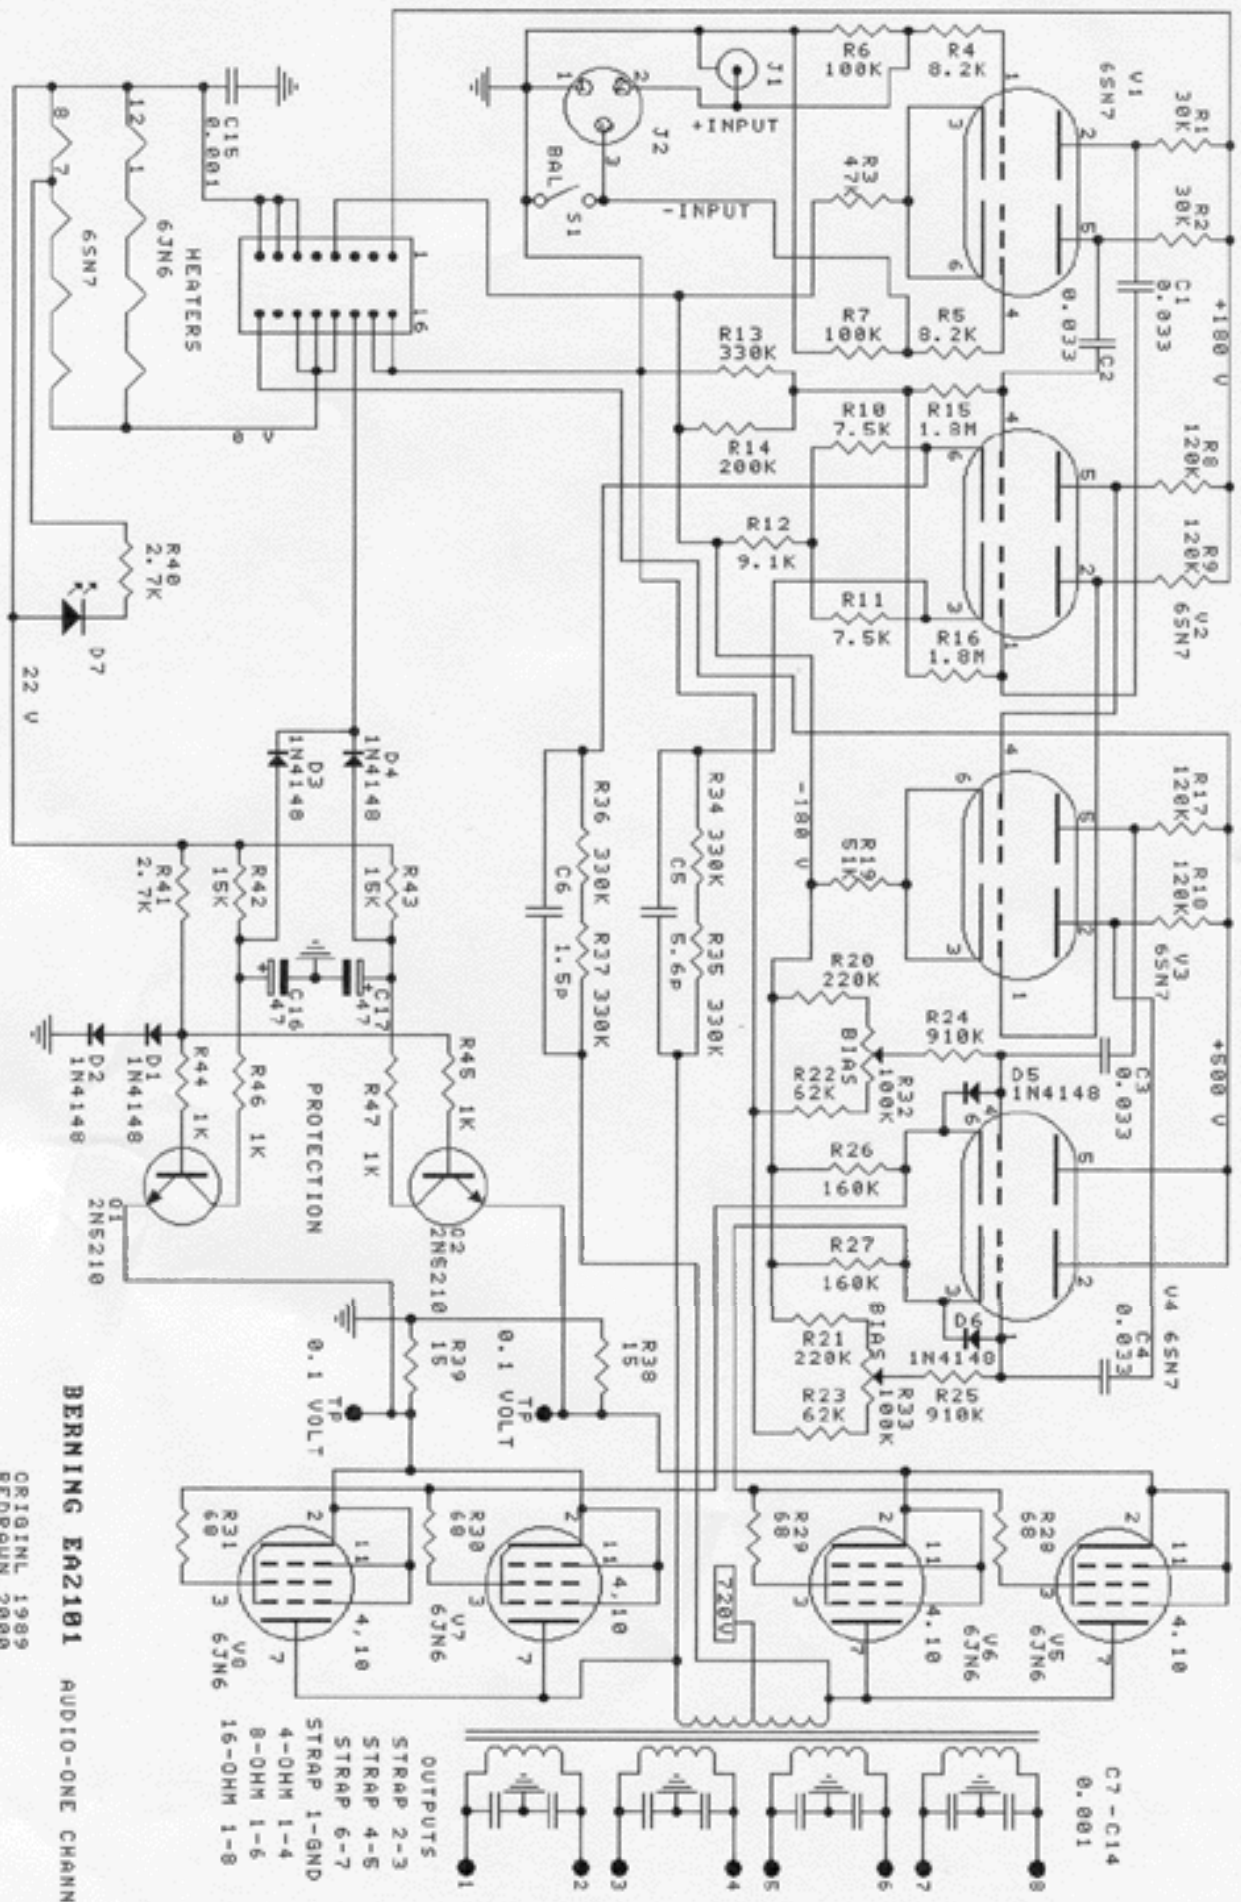
Bias measurements can be made by measuring across the 15 ohm resistors that are mounted along the front edge of the audio boards. These can be accessed via holes in the bottom of the chassis, and the correct voltage is 100mV. This amplifier should be able to deliver at least 100 watts per channel.

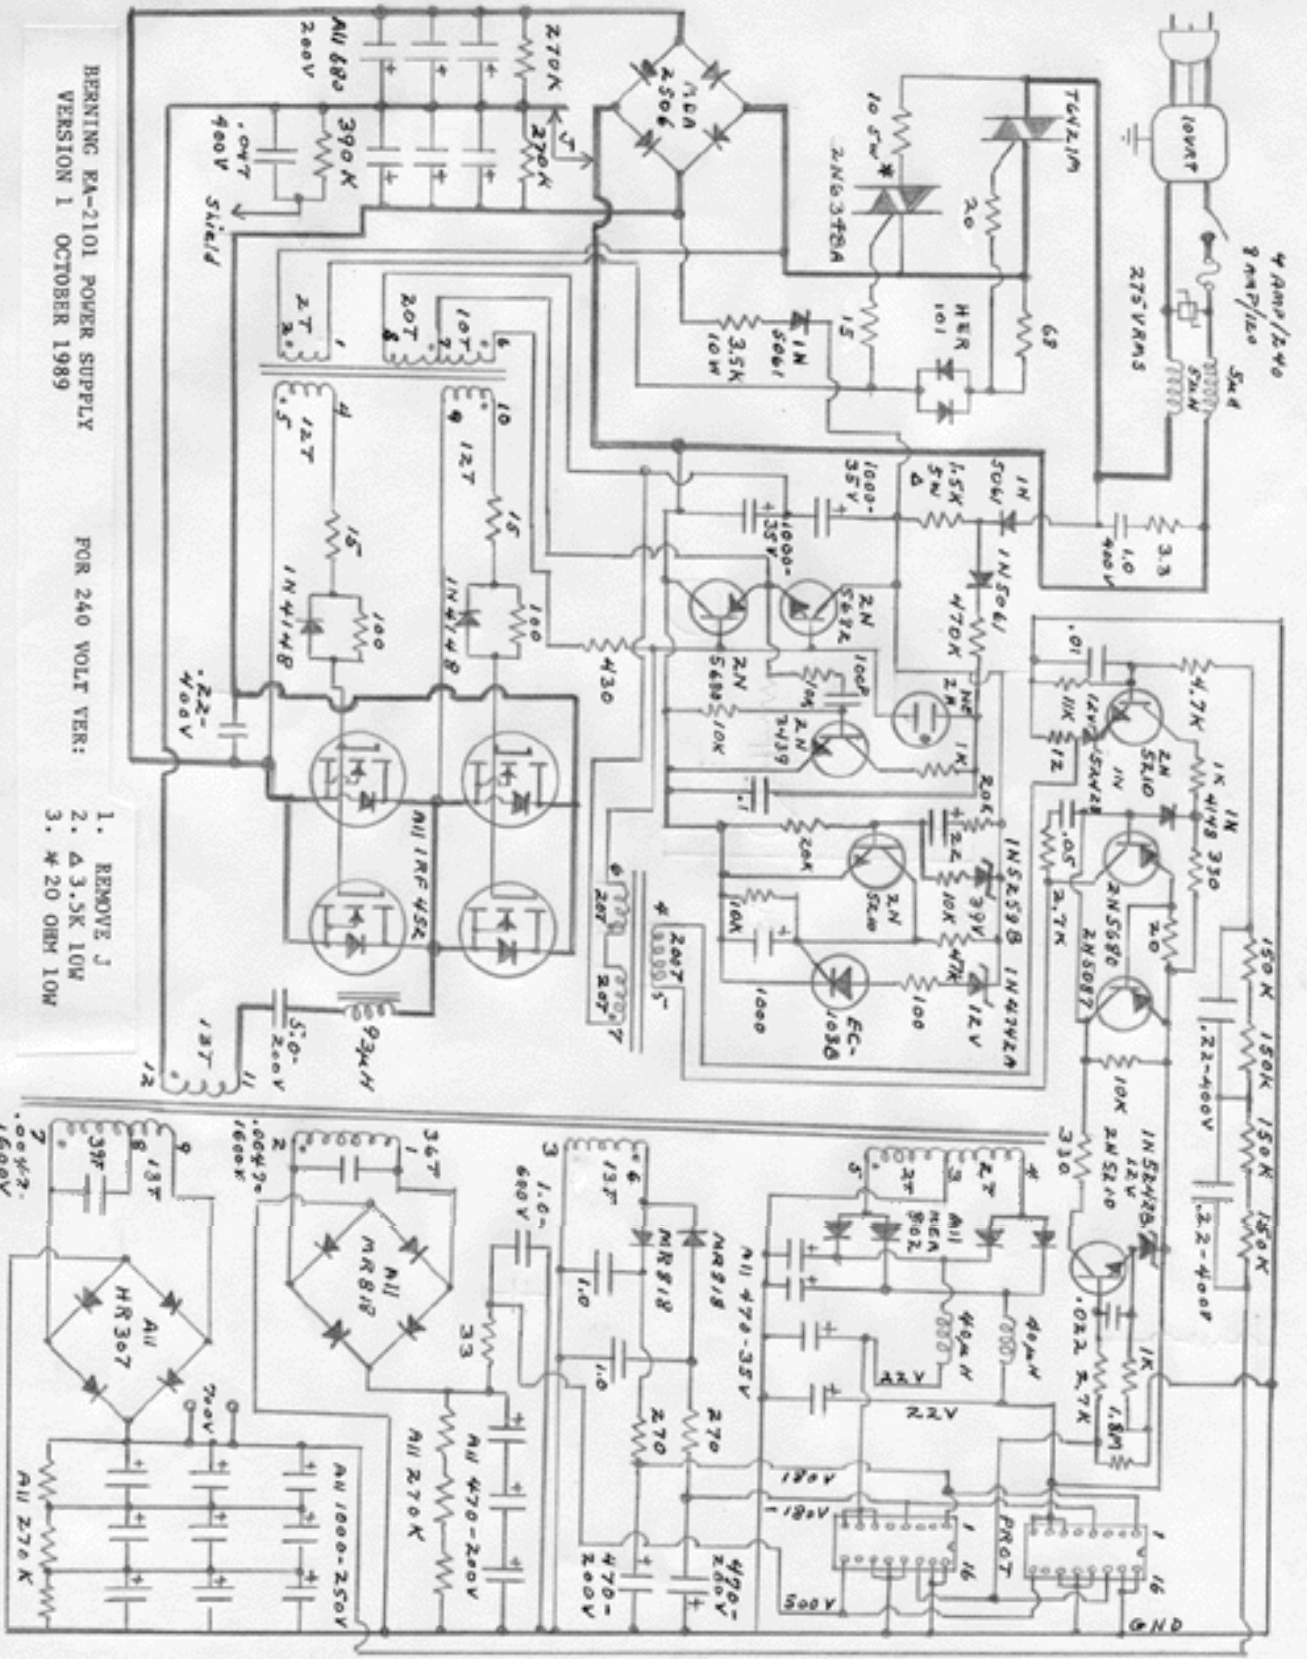
The failure prone parts in the EA-2101 are the four 150K resistors in the feedback sensing. Early versions used carbon film resistors that tended to increase in value, or go open completely, causing the output voltage of the power supply to increase until something else failed. Later versions of the amp used 1 W metal film resistors which have not shown failures. Any amps that have been returned to Berning for any kind of service have had these resistors changed. When this amp is serviced, the 700 volt output of the power supply should be checked. If it is high, more than 720 volts, these resistors should be checked.

Related failures caused by over voltage are the capacitor bank, voltage-equalizing resistors, and the HR307 diodes.
