TF-12

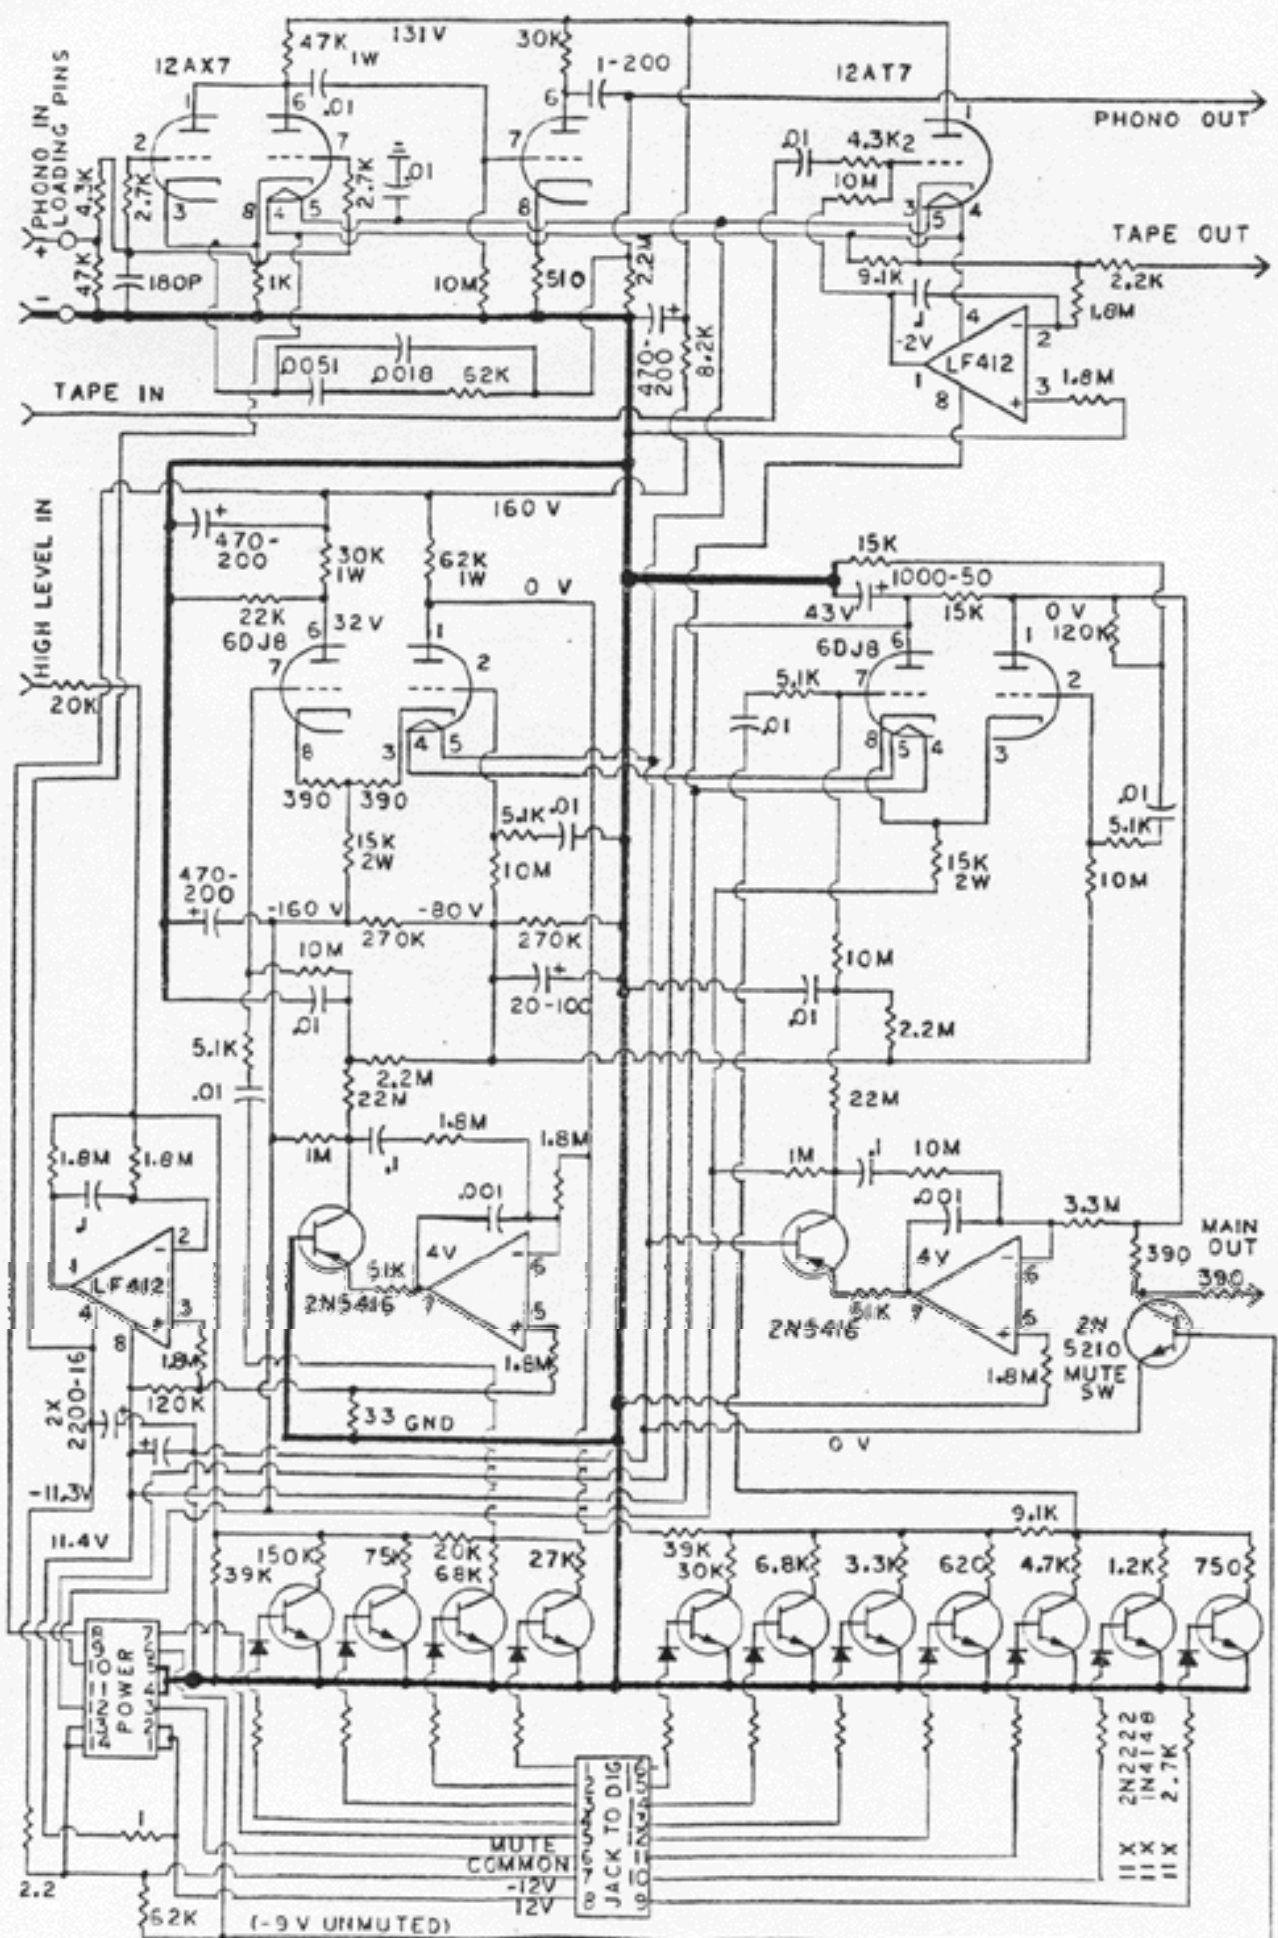
BERNING TF-12 AUDIO (ONE CHANNEL) VER 1 1-19-88

Loud pops, particularly in the phono section when the tubes are moved indicates broken foil on the circuit board. Thin foil traces should be bridged with light-gauge bare wire, even though the breaks can not be seen. Audio noise is sometimes caused by noisy 15K, 2W plate resistors on the 6DJ8/6922 tubes.

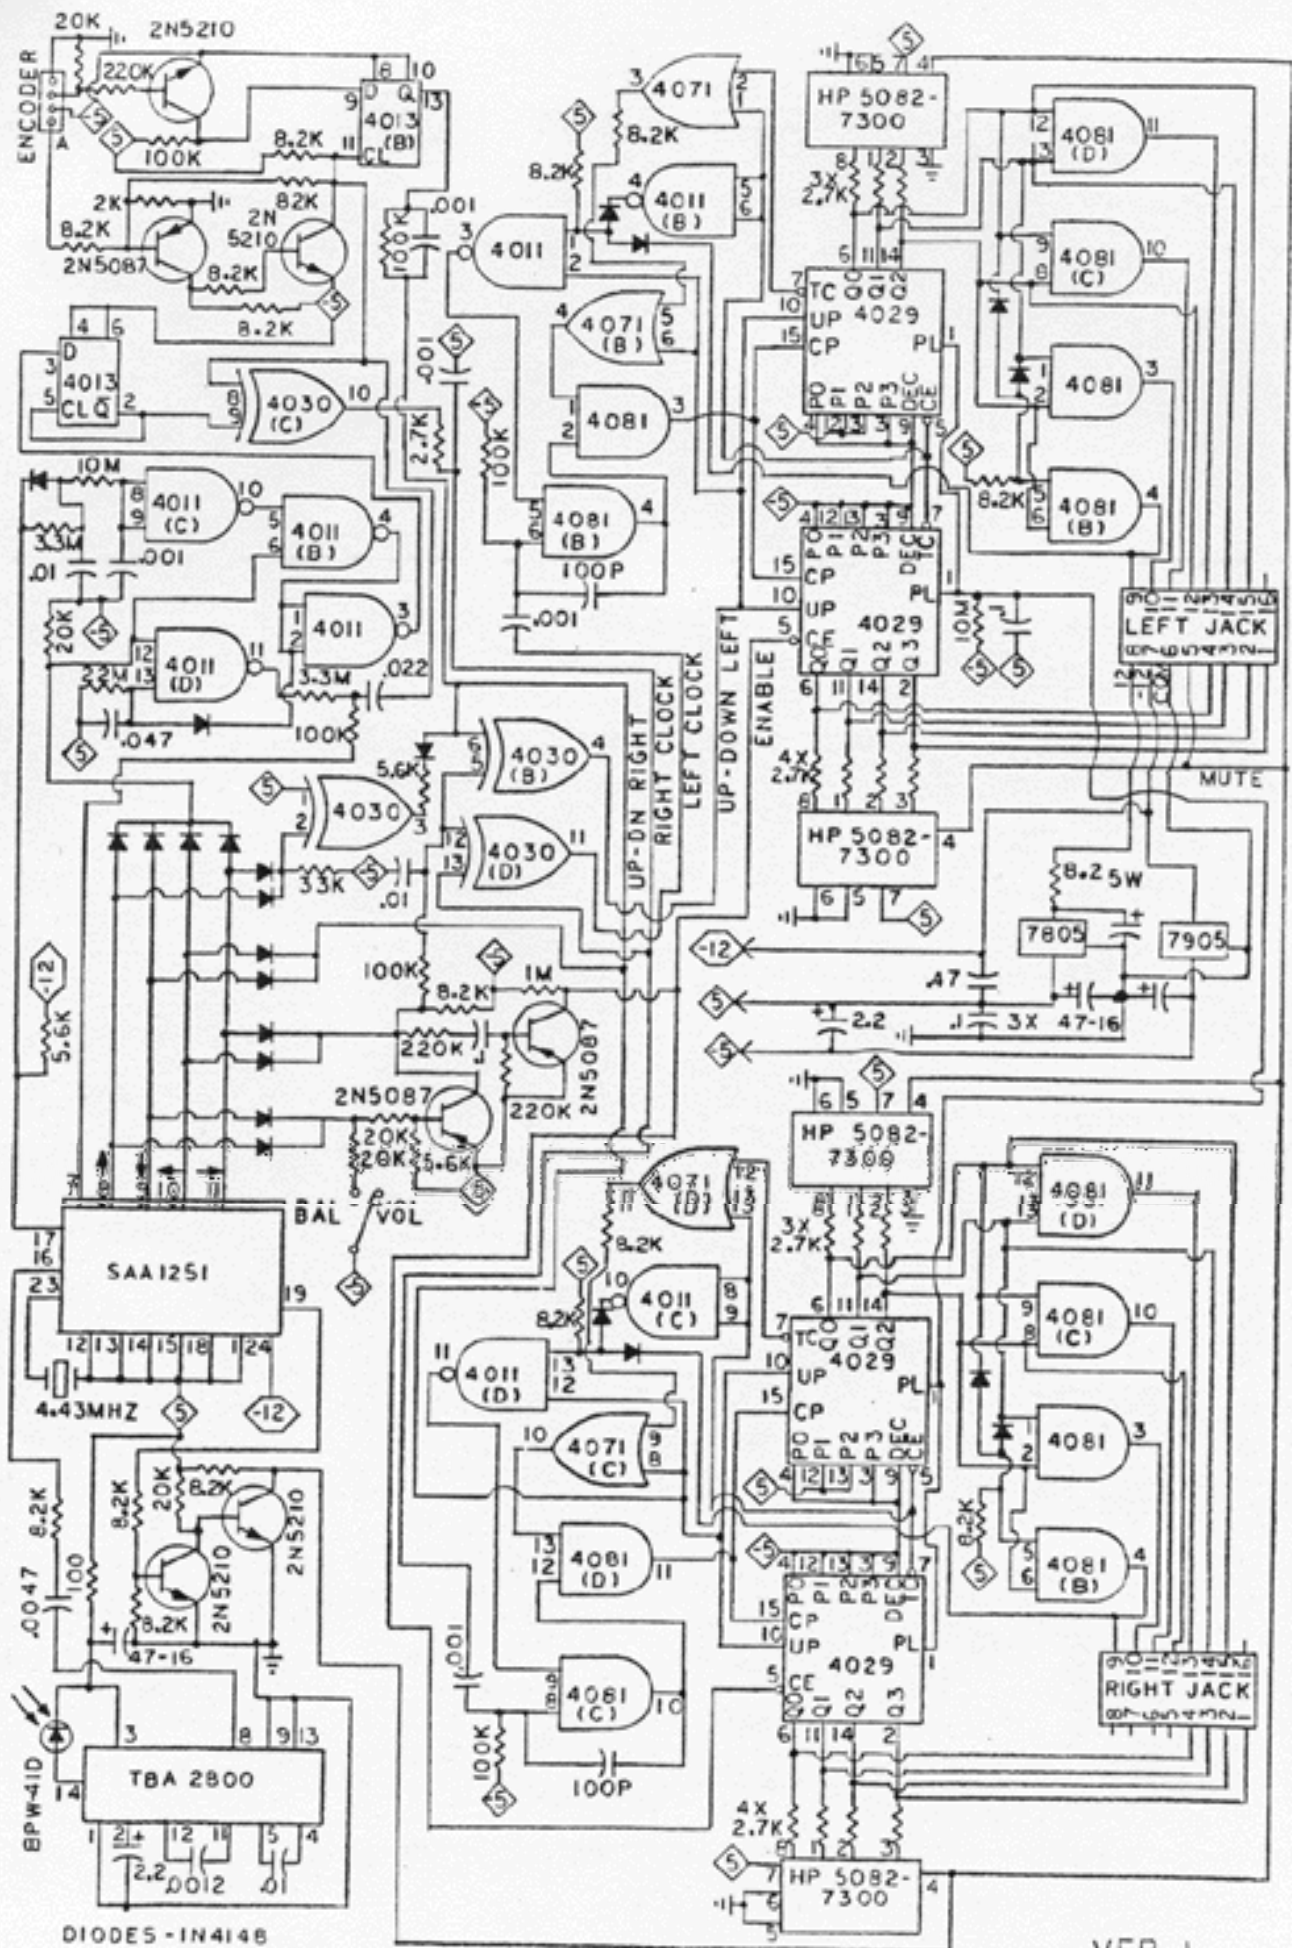
DIODES - 1N4148
 BERNING TF-12 DIGITAL GAIN CONTROLLER VER 1
 1-20-88

The failure prone parts in the TF-12 are the optical encoder volume control, 1Meg resistor in the mute time out (located on the power supply board), the HER602 diodes in the power supply, 470 μ F capacitors associated with these diodes, socket for 7805 voltage regulator IC on digital board (soldered in in later versions), and foil connections under tube sockets on the Teflon circuit board.
