Unbalanced output connection diagrams

Figures affected: Figure 24, 402/802 II Controller Service Manual, P/N 174785. Figure 19, 502 (Panaray) Service Manual, P/N 170310.

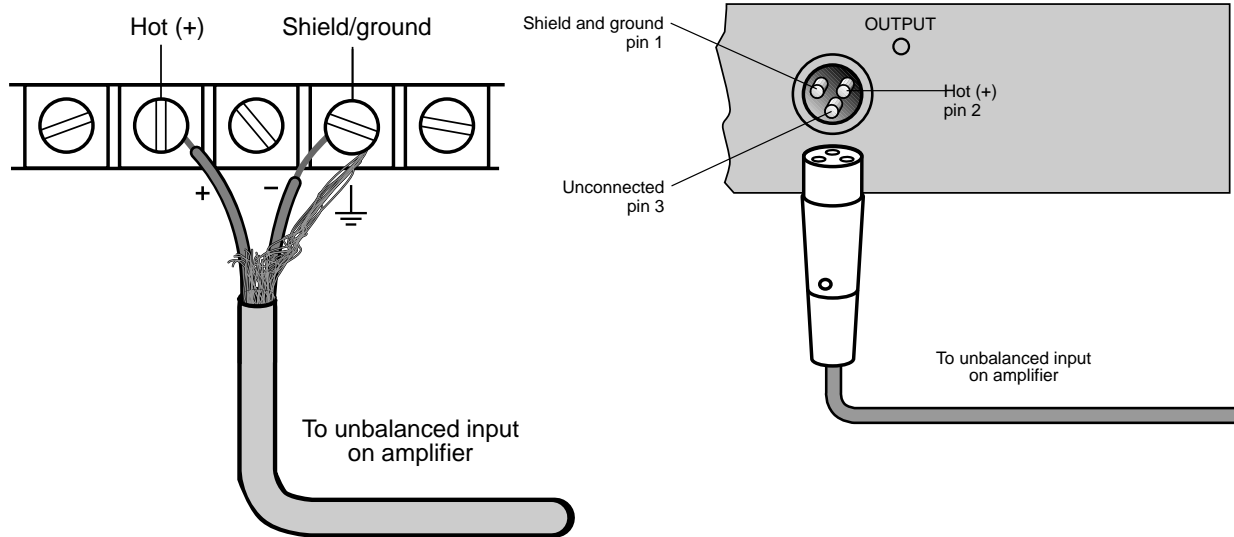
Figure 1. Corrected Unbalanced Output Connection Diagrams

The unbalanced output connection diagrams shown in these manuals are incorrect.

For barrier strip connectors: The shield and ground wires **MUST** connect to the **ground** terminal for the output connections, not the **negative** terminal. See **Figure 1** for reference.

For XLR connectors: The shield and ground wires **MUST** connect to **pin 1** for the output connections, not **pin 3**. **Pin 3** is unconnected, not **Pin 1**. See **Figure 1** for reference.
