Temporary Actions for :

(A) : Cause of failure of C59 & C60

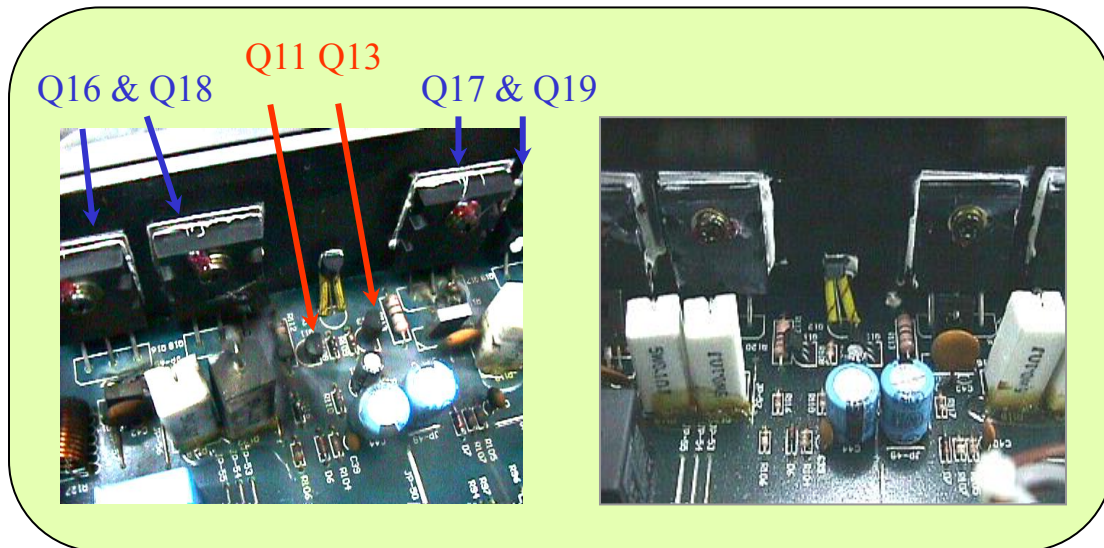
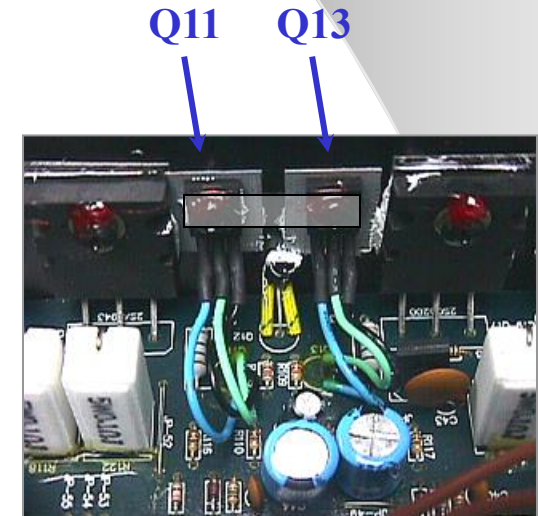
(B) : Cause of failure of Temperature Compensation of Power Transistors

- (1) Temperature rating of C59 & C60 to be changed from 85°C to 105°C as temperature of the capacitor is found to be 89°C during Evaluation. Capacitance will be the same (12000uF , working voltage 63 VDC)

- (2) Q11 is changed from MPSA56 (TO-92) 625mW max to Philips BD140 (TO-220) 1W max and Q13 is changed from MPSA06 (TO-92) 625mW max to Philips BD139 (TO-220) 1W max
- (3) Q11 and Q13 to be mounted onto the heat sink by a metal bracket to have the same temperature as Q16, Q17, Q18 and Q19 so as to restore the temperature compensation function.

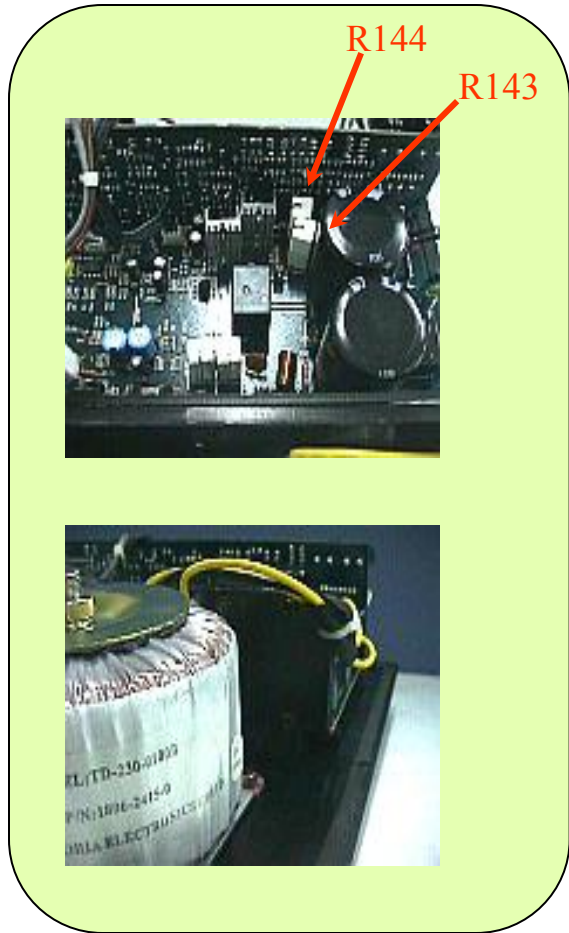
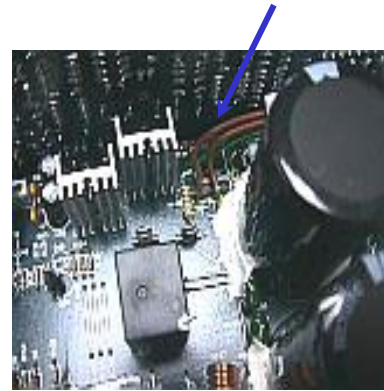
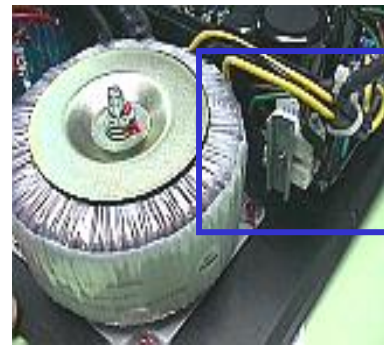
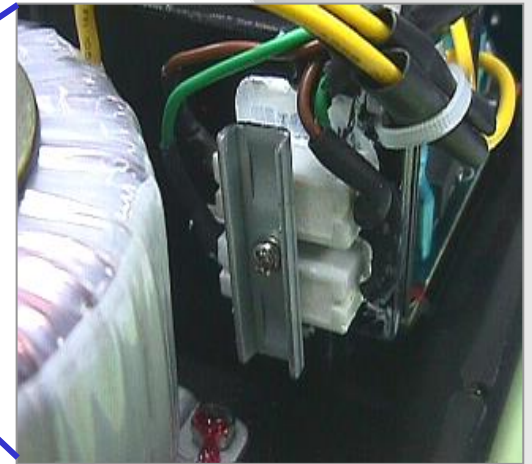
(C) : Cause of failure of Resistors 143 and 144

- (4) R143/R144 have to be relocated onto the heat sink. This avoids directly heating up the nearby capacitors C59/C60 and help further cooling down the body temperature of R143/R144
