LUX Audio of America Ltd.

SUBJECT: ADJUSTMENT FOR UNSTABLE SPEED ON PD-441/PD-444

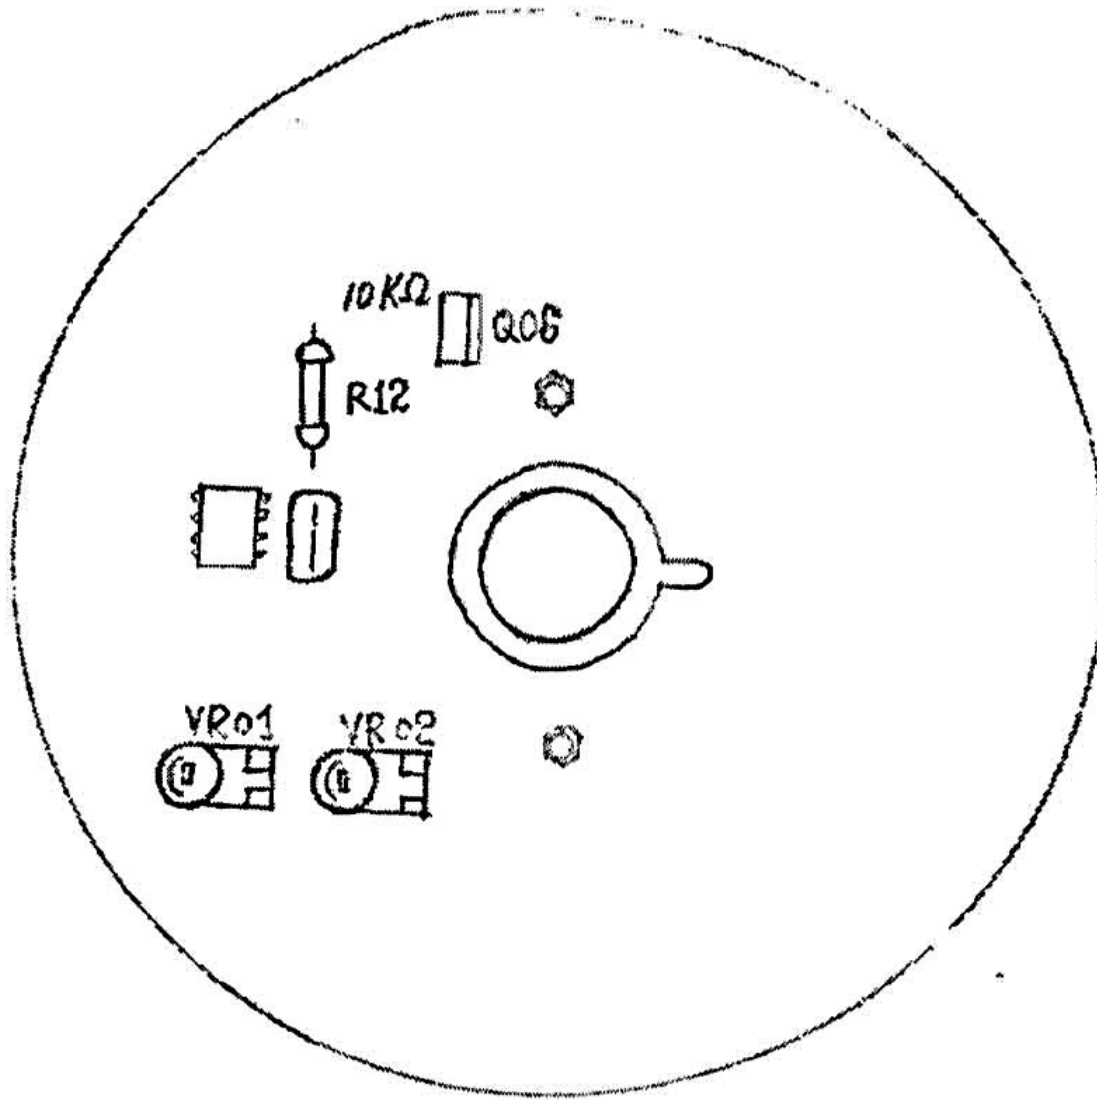
It has been brought to our attention that occasionally, the servo lock system may become intermittent or cut out completely on the PD-441 and PD-444. Should you encounter this situation, the remedial action is as follows:

1. Remove the name plate from the motor cover located on the under-side of the unit.
2. Remove the motor cover (be careful not to damage the rubber bushing).
3. Adjust the D.C. voltage on both sides of R12 on the circular Printed Circuit Board to equal:

<u>Speed</u>	<u>Adjustment</u>	<u>Voltage</u>
45 rpm	VR02	8.5v at 10°C (50°F)
33 1/3 rpm	VR01	7.5 volts at 20°C (68°F) 6.0v at 30°C (86°F)

Note: Variable Resistor (VR) must be turned very slowly. 33 1/3 rpm should be set first and then 45 rpm. Also, the platter of the unit must be in place and turning when making this adjustment. I realize that this is difficult but possibly having the unit right side up and reaching underneath to make the adjustment and measurements.
