## **Service Bulletin**

**No. :** MZ07-090

**Model:** CC4001

**Subject:** The disc tray sometimes will not open.

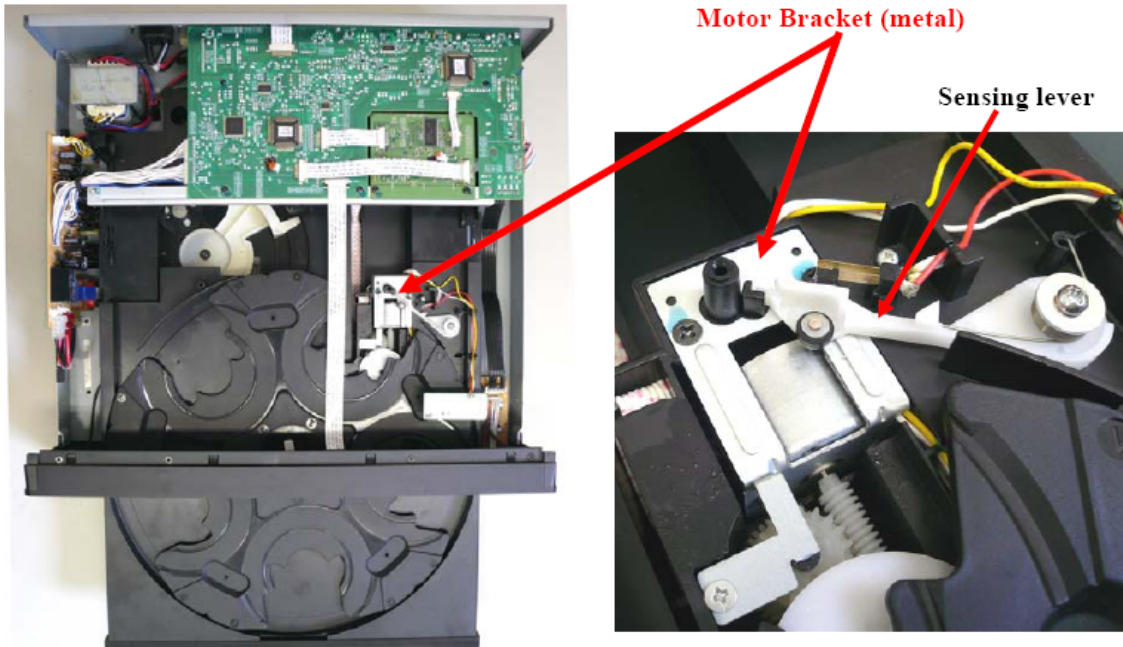
**Symptom:** The roulette (tray) rotation position sensing lever is sometimes caught by a burr that remains on the surface of the motor bracket under the lever.

**Solution:** The burr on the surface of the motor bracket (metal) must be filed off. For the procedure, refer to the following.
