Service Bulletin

No.: MZ06-015

Model: CC4300

Subject: The improvement of ALL Disc Repeat operation.

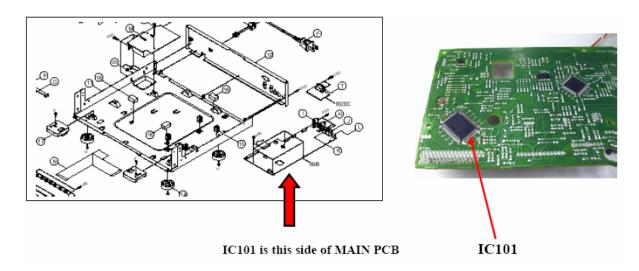
Before updating the CPU, please check the Micro processor version. It can be confirmed from the "SERVICE MODE". Please refer to the CC4300 Service Manual on page 1 for the check procedure.
