**Service Bulletin**

**No.:** MZ07-US03 **Date:** March 8, 2007

Model: CC-4300

Subject: Grinding Noise

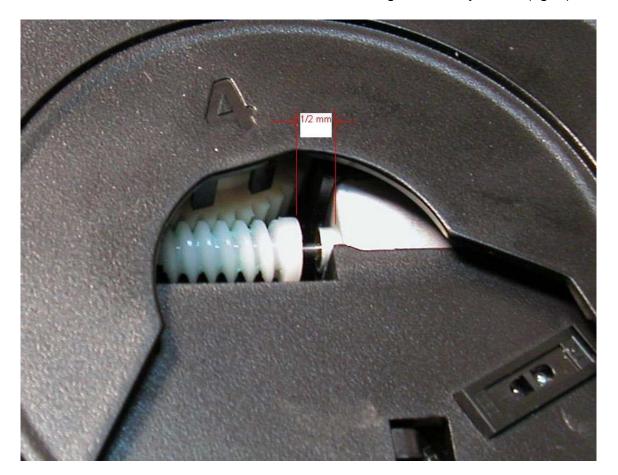
**Symptom:** After replacing the Tray motor and Worm Gear a grinding noise is heard when the tray rotates.

Fig. 2. Confirm a  $\frac{1}{2}$  mm space between the base of worm gear and Tray motor plate.

Using a metric ruler or caliper adjust the worm gear to allow a distance of ½ mm from the base of the Worm Gear to the top plate of the Tray motor (fig. 2) or 3 cm from the base of the Worm Gear to the collar/bearing of the Tray motor (fig. 3).

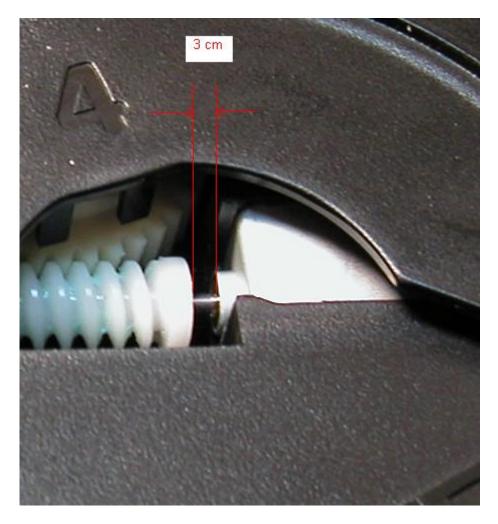
Fig. 3. Confirm a 3cm space exists between the base of the Worm Gear and the collar/bearing of the Tray Motor.
