marantz® SERVICE BULLETIN		Date: 27-Sep-2004	Model: CD5400
		Page: 1 / 1	REF.NBR: MZ04-064
Level		Application:	
★ ★ ★		See below	
		Subject: Capacitors change of the Power Supply.	
		Int.ref:

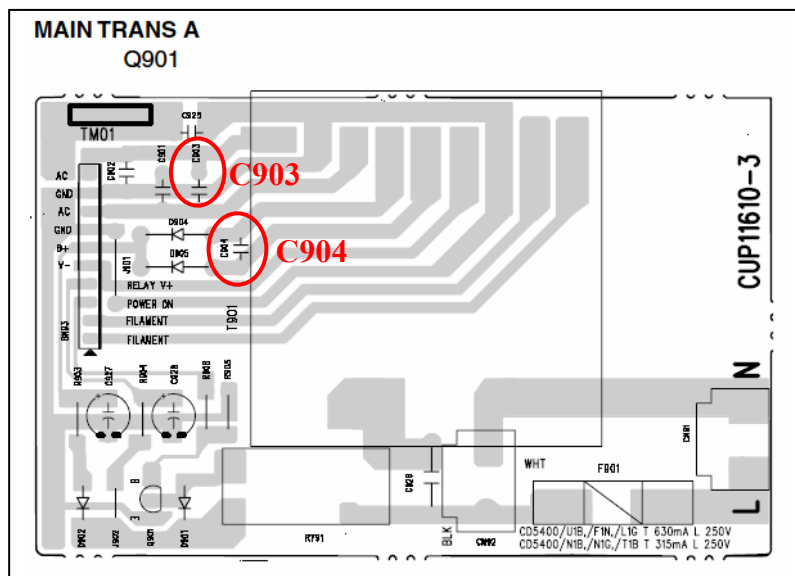
Capacitors C903 and C904 may short-circuit very rarely.

The shortage of voltage-proof of the capacitor.

1. POS.NO **C903** and **C904** CAP,CERAMIC(0.1uF 50V) is changed to part no.**90M-DK100920R**(0.1uF 100V).

POS.NO C903 / C904 **90M-DK100920R** (0.1uF 100V “Factory part no. CR051BX7R104K101F”)
