marantz			Date: 18-Mar-2005 Model: CD5400		
			1 / 2	REF.NBR: MZ05-010	
SERVICE BULLETIN		Subject	Subject:		
Level	Application:	CD DW Disc counct be alread			
**	See below	CD-RW Disc cannot be played.			
		Int.ref:

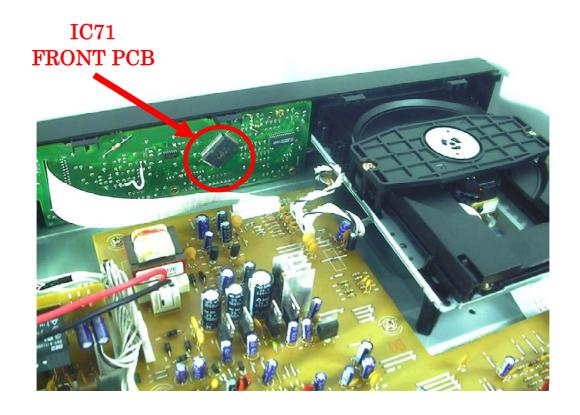
SERVICE MODE

New version 01-19-1

- Insert mains cable plug in the outlet and press POWER button.
- 2. Press the OPEN/CLOSE button to open the tray.
- 3. Press the TIME button for about five seconds.
- 4. The version number of the microprocessor is displayed Ex: 03-27-01.
- Press the EDIT button for about five seconds.
- 6. Light up all the FL segment.
