| marantz® SERVICE BULLETIN | | Date: 10-Dec.-2004 | Model: CD5400 |
| | | Page: 1 / 1 | REF.NBR: MZ04-082 |
| | | Subject: The sound jump sometimes occurs during Playback CD. | |

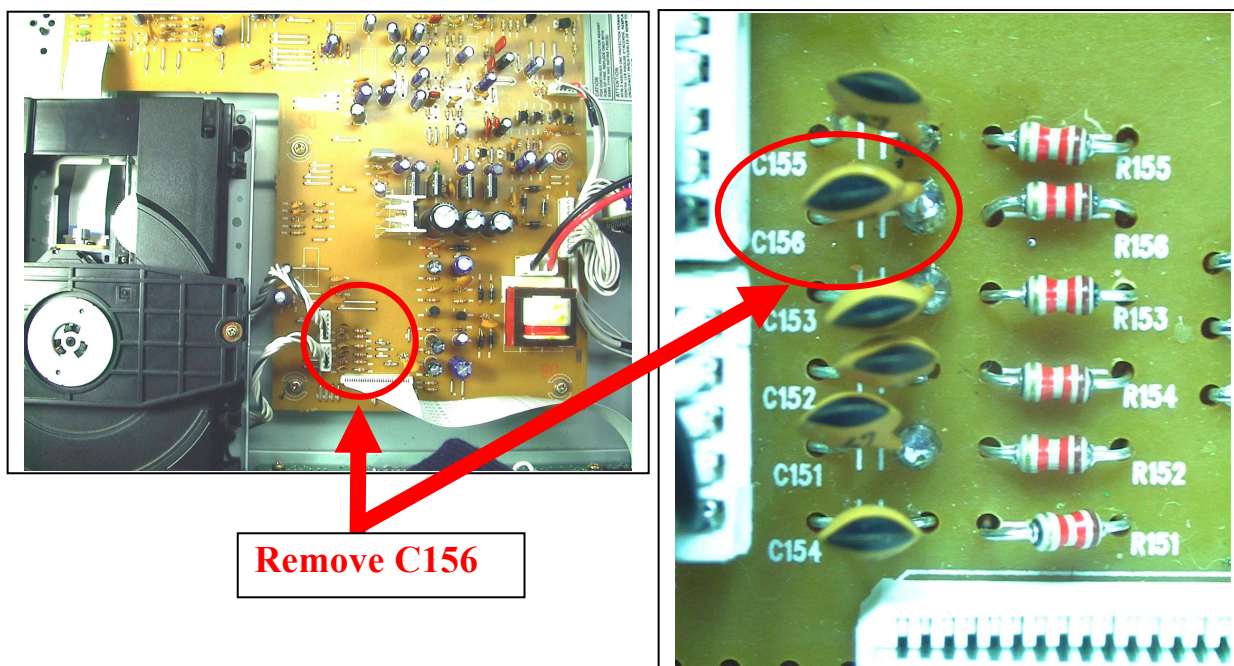
When playback CD, the sound jump sometimes occurs.

C156 Capacitor connected to the CLOCK line of DSP changed the signal, and microprocessor cannot recognize correct data.

POS.NO C156 (Ceramic Capacitor 47pF) is removed.

1. This problem apply to the following week code.
CD5400 apply to MZxx0448xxxxxx
2. This improvement has been done in the production week code MZxx0449xxxxxx and after.
