| marantz. | | Date: | 15-May2003 | Model: DR6000, DR6050, CDR631, CDR500 | |
| SERVICE BULLETIN | | Page: | 1 / 1 | REF.NBR: MZ02-031 | |
| x for information customer complaint in case of service mandatory | G. D.I. | Replace the Chip capacitor on the CDR mode MAR770/MAR775. | | itor on the CDR module of | |

| SERVICE BULLETIN | | Date: | 22-Nov-01 | Model: DR4 | 050/DR6000/DR605 CDR500/CDR631 | |
|---|---|--|---|---|---|--|
| x for information customer complaint in case of service | See below | Improvement for inoperable all buttons | | | | |

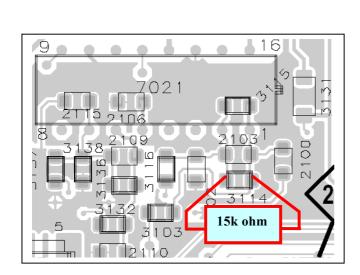
The OPEN/CLOSE movement of disc tray is fast, It may become a CD single [8cm(3in.)] clamp defect.

15k ohm resistor is soldered to the Pos.No.3114 in parallel.

The object of PCB: CD MAIN BOARD of CD Module MAR1250 (Refer to the CDR500 service manual 2-13 page of MAR1250.)
