<b>marantz®</b> <b>SERVICE BULLETIN</b>		Date: 15-May.-2003	Model: DV4300
		Page: 1 / 1	REF.NBR: MZ03-014
Circulation:		Subject:	
Application:		The unit doesn't work pushed ON/ OFF button of the remote controller RC3200.	
x for information customer complaint in case of service mandatory .....		Int.ref:	
See Below

<b>marantz®</b> <b>SERVICE BULLETIN</b>		Date: 25-Feb.-2004	Model: DV4300
		Page: 1 / 2	REF.NBR: MZ04-016
Circulation:		Subject:	
Application:		By crack of Laser Pickup slide shaft, Pickup stops moving and cannot playback the Disc.	
x for information customer complaint in case of service mandatory .....		See below	
		Int.ref:

<b>marantz®</b> <b>SERVICE BULLETIN</b>		Date: 30-June-2003	Model: DV4300
		Page: 1 / 1	REF.NBR: MZ03-027
Circulation:		Subject:	
Application:		FFC and Top Cover short-circuit, and the unit can't be operated.	
x for information customer complaint in case of service mandatory .....	See Below	Int.ref:

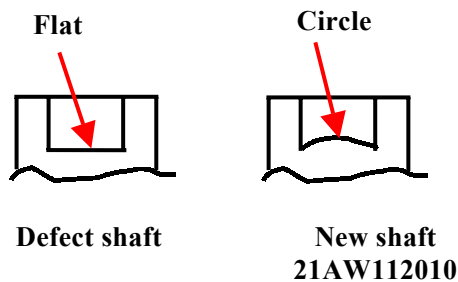
The part defect of the Laser Pickup slide shaft.  
(It occurs only in specific serial number because defective plastic part mixing.)

Difference of a shaft, the bottom form of slot is different.

- 1) **Replace the Laser Pickup slide shaft** of Loader Assy.
- 2) **Old Loader Assy Type no. RL-A700 corresponds.**
- 3) New Loader Assy Type no.DSL-710A does not correspond.

- 1) Part no. **21AW112010** (NEW Laser Pickup slide shaft)
- 2) Part no. **\*G75400000** (FLOIL G754 KANTO KASEI LTD.)

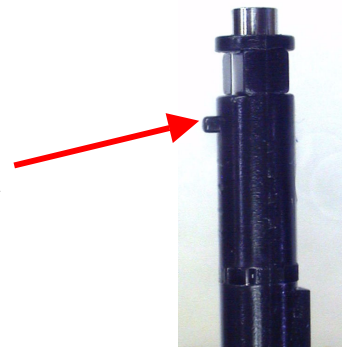
This projection is the DISC outside.

- 7. Attach the New Laser Pickup slide shaft
