marantz® SERVICE BULLETIN		Date: 27-Feb.-2004	Model: DV8400
		Page: 1 / 1	REF.NBR: MZ04-017
Circulation:		Subject:	
Application:		Output signal distortion.	
x for information customer complaint in case of service mandatory			
		See Below

marantz® SERVICE BULLETIN		Date: 15-May-2003	Model DV8400
		Page: 1/1	REF.NBR: MZ03-016
Circulation:		Subject:	
Application:		1. Slow mode problem	
x for information customer complaint in case of service mandatory		2. RC232C command problem in the condition of "No Disc."	
Before MZxxxxxx02xxxx		Int.ref:

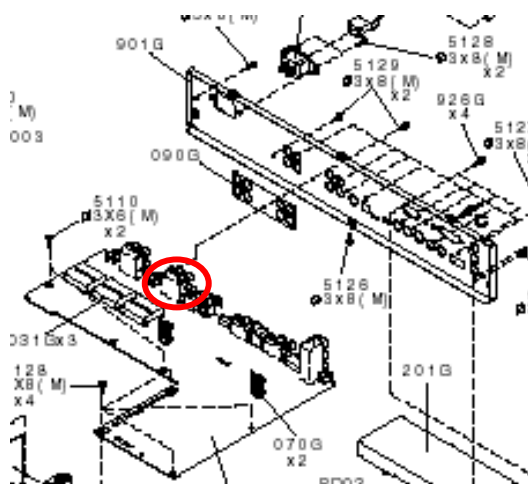
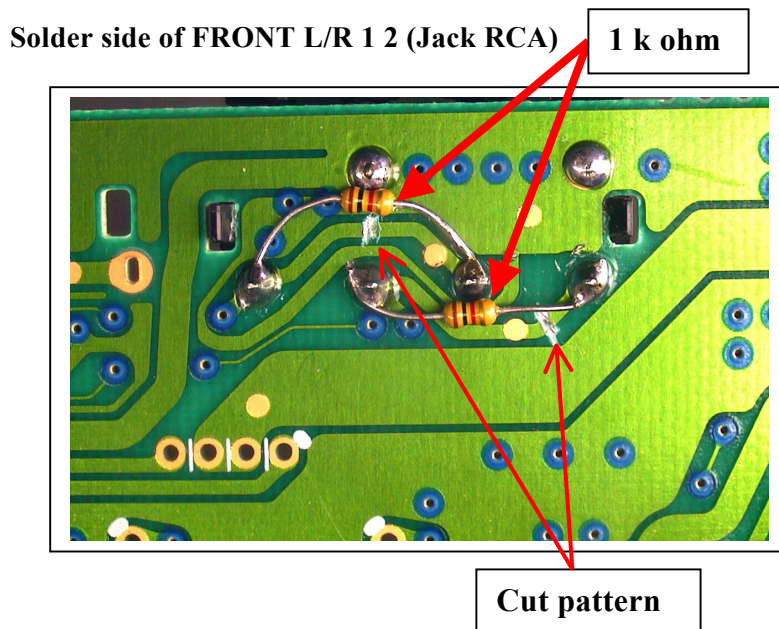
On the PM01-AV CIRCUIT BOAD

- 1) FRONT L/R 1 2 and SURR.L/R, CENTER L/R, SUB W L/R of AUDIO OUTPUT are simultaneously Connected to amplifier.
- 2) If the Amplifier which used the electronic switch is turned off, another sound will be distorted.

FRONT L/R 1 2 are connected parallel, therefore, if the Amplifier input of another side short-circuits, it will influence

1. Resistor 1k ohm is added to 2 of FRONT L/R 1 2.
2. Cut pattern.

Carbon film fixed resistor, 1k ohm +5% 1/6W (part no. **GD05102160**)
