Service Bulletin

No. : MZ08-035

Model: ES7001

Subject: Improvement of FUSE (F802)

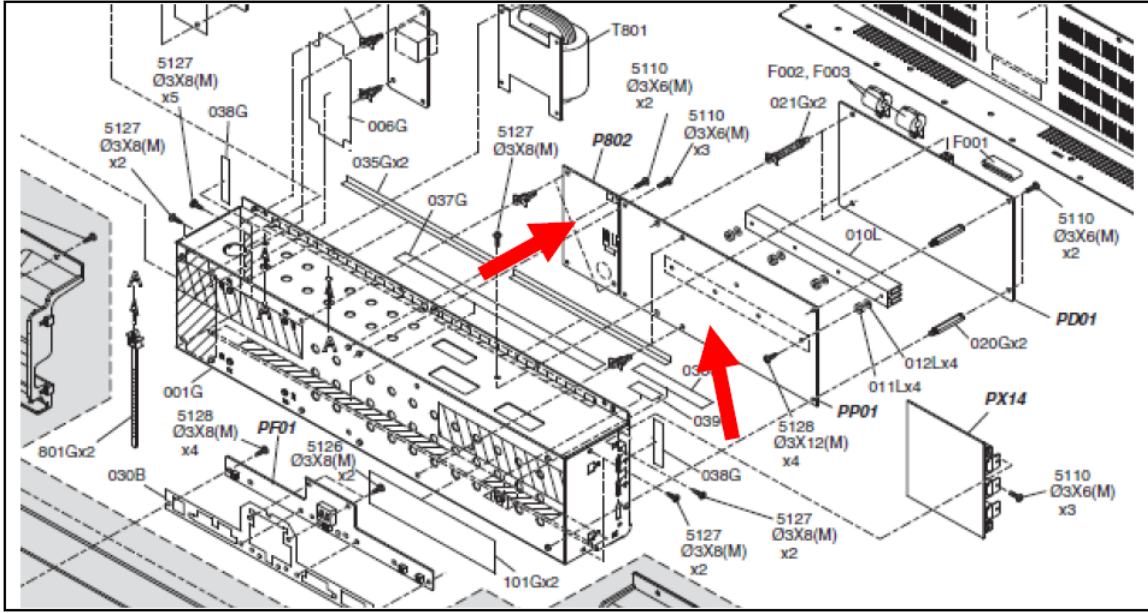
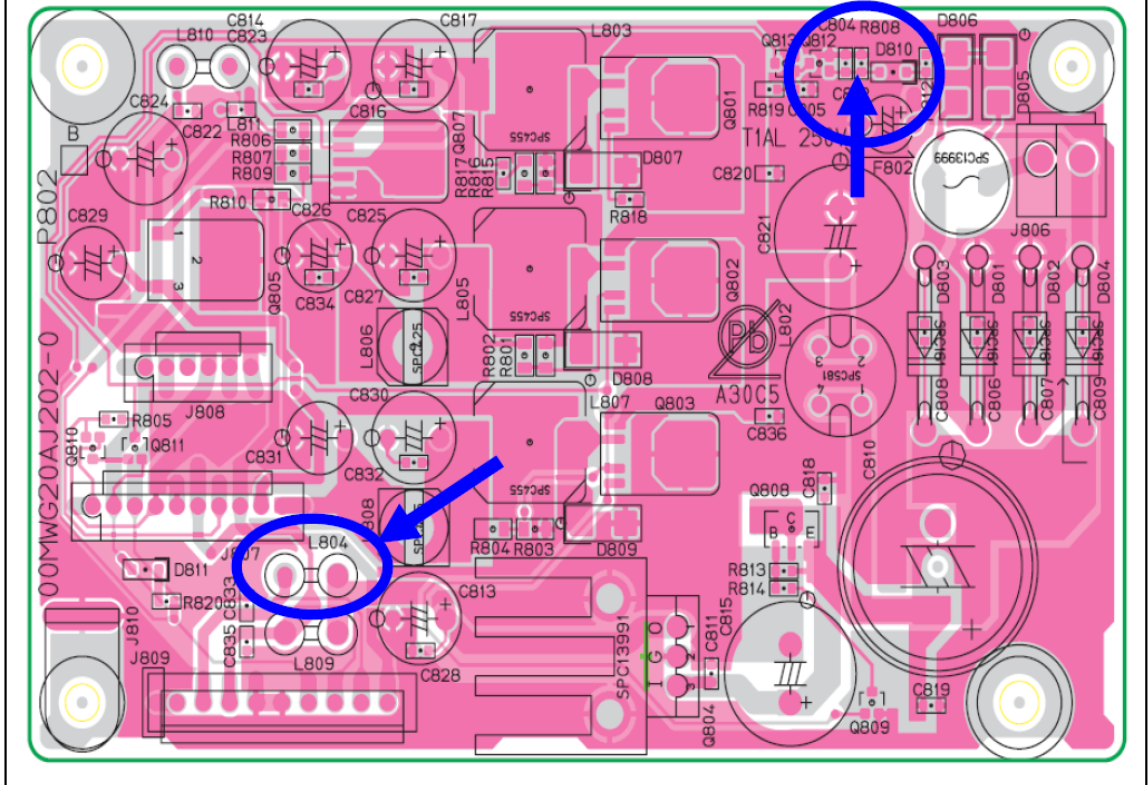
POS NO. R808, L804 (SECONDARY POWER PWB P802)

Symptom: The fuse (F802) may open when the AC rated voltage goes down to -10% or lower while the unit is connected via HDMI.

1. The 18k Ω on **POS NO. R808** (SECONDARY POWER PWB P802) with a **10k Ω** resistor.
2. The FERRITE CORE on **POS NO. L804** (SECONDARY POWER PWB P802) with a **10 Ω** resistor.
3. The 100u/16V on **POS NO. CP40** (DIGITAL AMP PWB PP01) with a **2,200u/16V** capacitor.
