Service Bulletin

No. : MZ08-048

Model: ES7001

Subject: Change of OPT Connector

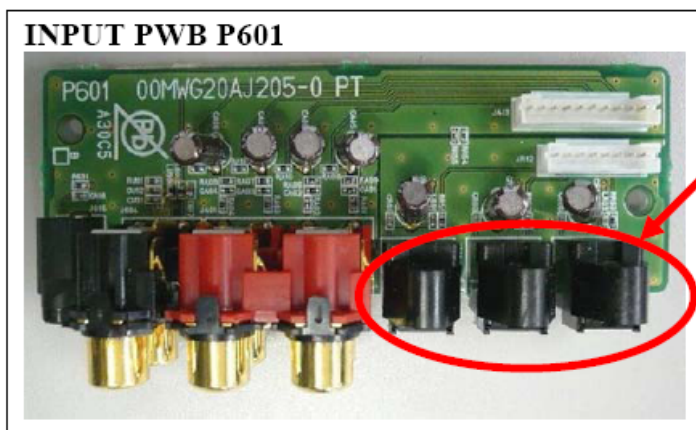
Symptom: The Optical connector shutter has been broken when the OPT cable is unplugged.

All the three to be replaced.

Solution: 1. To prevent the optical connector from being damaged, it has been replaced with one without a shutter. All three POS NO. JR01, JR02, JR03 (INPUT PWB P601) will be all replaced.

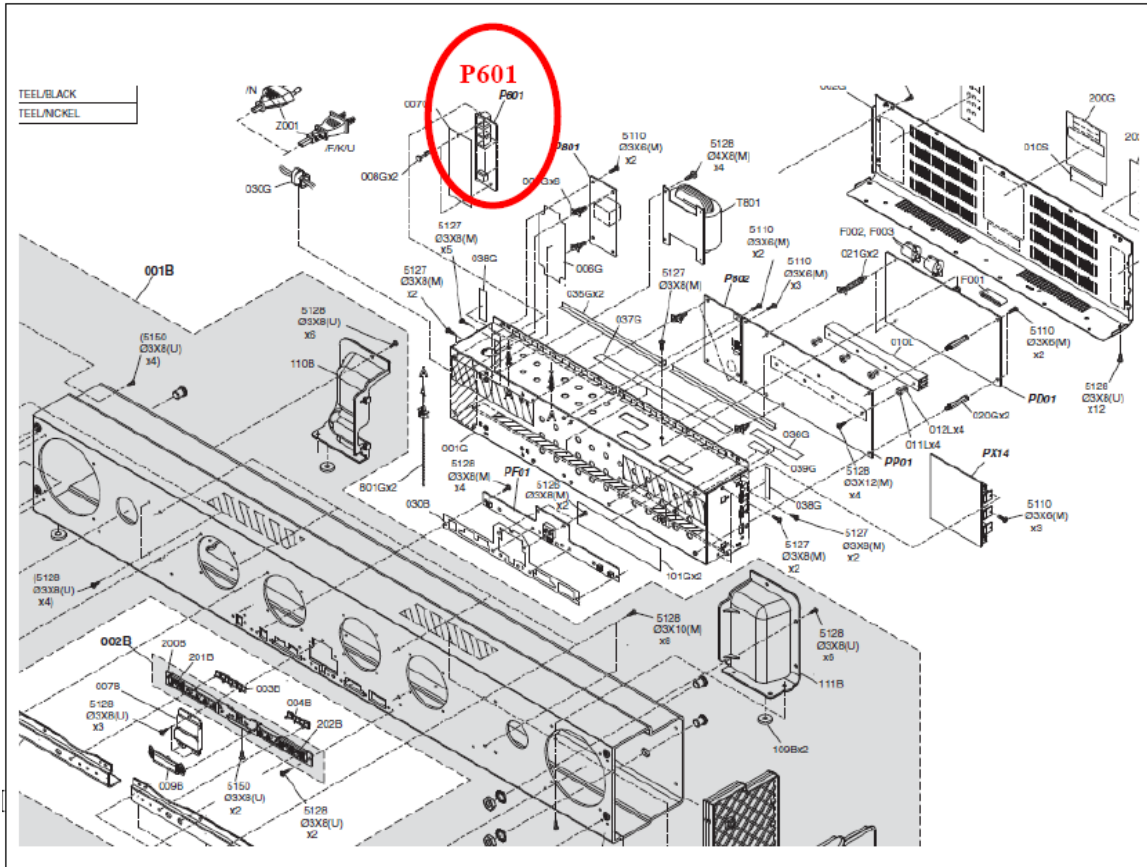
Old PART NO. 00MYJ15000270

New PART NO. 643010054005S

Ref #	FORMER		NEW	
	Description	Part Number	Description	Part Number
JR01, JR02, JR03	OPT. CONN.	00MYJ15000270	OPT. CONN.	643010054005S
