Service Bulletin

No. : MZ05-032

Model: SA8400, SA-11S1, SA-15S1, DV9500

Subject: Improvement of Disc vibration

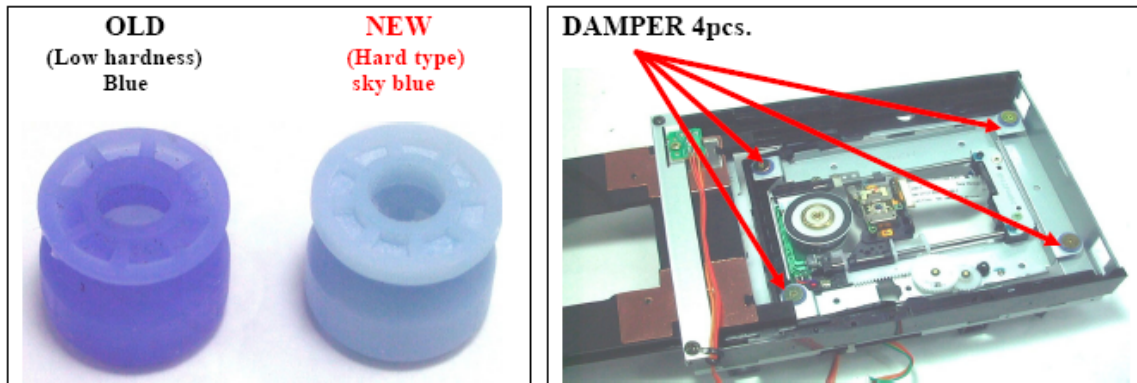
Symptom: During playback, an eccentric or off center Disc will cause the unit to vibrate.

Solution: Replace the 4 traverse Mechanism Dampers to the new hard type.
