Service Bulletin

No. : MZ04-080 Rev. **Date:** December 5, 2006

Model: SA8260, SA17S1

Subject: Can not playback hybrid Super Audio CD's.

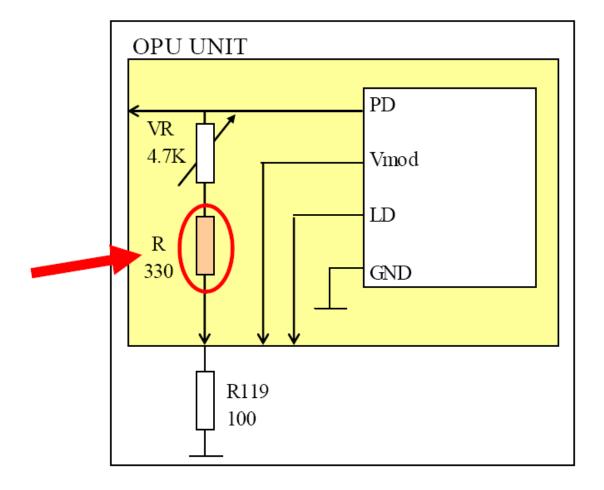
SACD-HF OUTPUT ADJUSTMENT PROCEDURE

- 1. First, HF level of SACD (low reflection DISC) is checked with an OSCILLOSCOPE. The HF level across R383 (1Kohm) of the following figure (see below). The playable range is 330mV or more.
- 2. When HF level is less than 330mV, Change R330 (330 OHM) to 0 OHM.
- 3. Even if R330 changes to 0 OHM, When the HF level falls outside allowable range, the trimming potentiometer needs to be adjusted. (<u>Caution</u>: A problem may occur with a high reflection DISC if the HF level is raised too much.)
- 4. Playback SACD (low reflection DISC) and the voltage of the both ends of R112 or R113 is measured. Check the measurement voltage it should be 544mV or less. When the measured voltage is over 544mV, replacment of the PICK UP UNIT is required.

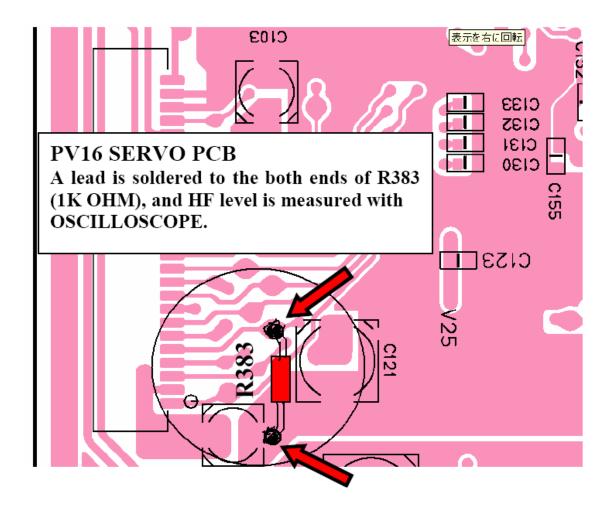
1. First, Check the HF level of SACD (low reflection DISC) with OSCILLOSCOPE.

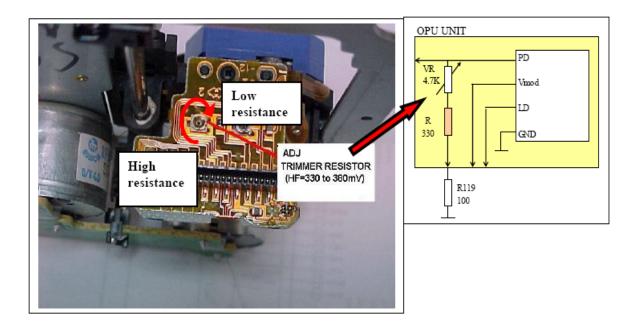
Be careful! The trimming potentiometer adjustment is very critical.

- 3. Even if R330 is changed to 0 OHM, When the HF level falls outside allowable range, the trimming potentiometer needs to be adjusted.
- 3-1) First, turn OFF the Unit, adjust the variable resistor by rotating it by eye measurement
- 3-2) First, the resistance of the both ends of trimming potentiometer is measured.
- 3-3) Then, resistance is made to increase from measured value by about 10% to 20%.
- 3-4) Set the HF level to 330mV to 380mV.

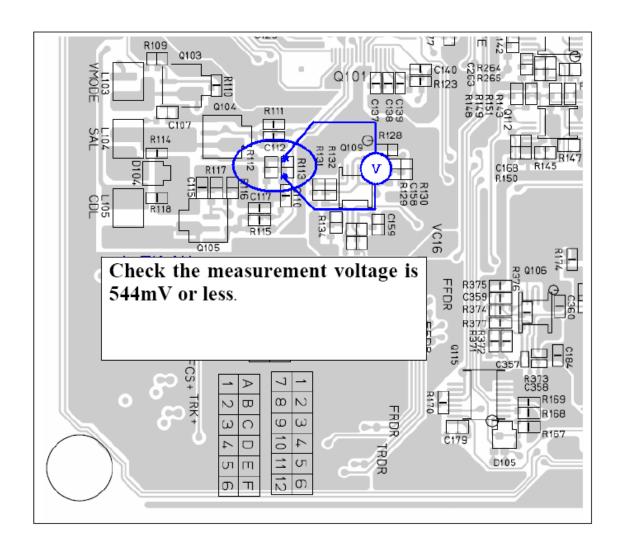
4. Playback SACD (low reflection DISC) and the voltage of the both ends of R112 or R113 is measured. Check the measurement voltage should be 544mV or less. (see picture below)

When measurement voltage is over 544mV, replacing of PICK UP UNIT is required for safety.
