Service Bulletin

No.: MZ07-060 **Date:** May 21, 2007

Model: SR4001, SR5001 SR7001, SR8001

Subject: A component configuration change: TUNER MODULE and FM ANTENNA only for the US version.

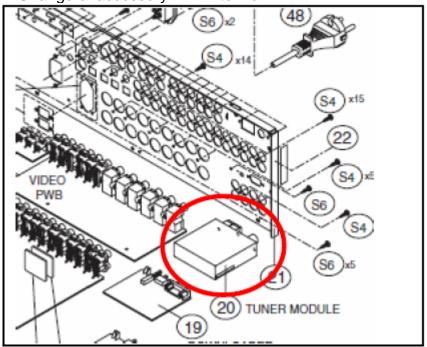
Symptom: The configuration of the FM Antenna Terminal was changed from the APL/F common connector to the F Connector.

Solution: 1. Change of TUNER MODULE

POS.NO. 20 SR4001, SR5001 POS.NO. 60 SR7001, SR8001
