Service Bulletin

No. : MZ07-073

Model: SR4001, SR5001

Subject: Software Update Information.

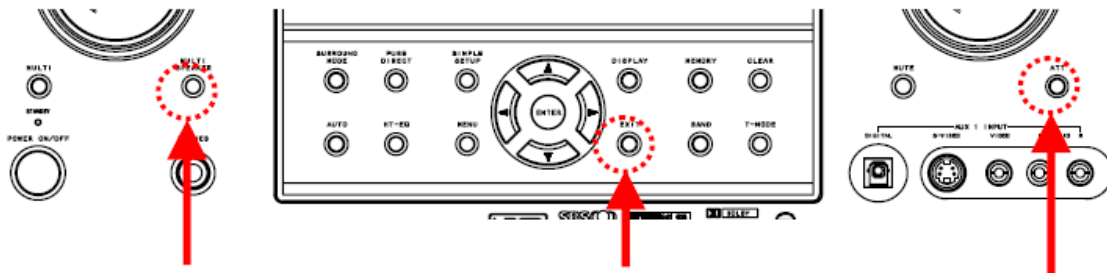
*1 If the set can not be powered on again by plugging into the AC power source (while the STANDBY LED keeps flickering every 125m sec.), the POWER AMP has been damaged. The power supply can be restored by the following means:

“FACTORY” KEY = SR5001: [MULTI SPEAKER] + [EXIT] + [ATT] SR4001: [S.SPEAKER B] + [EXIT] + [ATT] **However, this can further damage the POWER AMP. Never let end users do this.**
