<b>marantz®</b> <b>SERVICE BULLETIN</b>		Date: 31-Oct.-2003	Model: SR4300/SR4400
		Page: 1 / 3	REF.NBR: MZ03-047
Circulation:		Subject:	
Application:		The problem of the Speaker protection circuit.	
x for information customer complaint in case of service mandatory .....			
Service code XE00 XE00xxxxxxxxxx

<b>marantz®</b> <b>SERVICE BULLETIN</b>		Date: 30-June-2003	Model: SR4300,SR4400
		Page: 1 / 1	REF.NBR: MZ03-025
Circulation:		Application:	
x for information customer complaint in case of service mandatory .....		See Below	
		Subject: FM(with RDS) signal is received, Frequency Indication becomes the setup of default by the remote control operation . (only N and A version occurs)	
		Int.ref:

<b>marantz®</b> <b>SERVICE BULLETIN</b>		Date: 30-June-2003	Model: SR4300,SR4400
		Page: 1 / 1	REF.NBR: MZ03-023
Circulation:		Subject:	
Application:		The sound is interrupted, when the playback DIGITAL of CD-R/RW of the SCMS signal.	
x for information customer complaint in case of service mandatory .....	See Below	Int.ref:

<b>marantz®</b> <b>SERVICE BULLETIN</b>		Date: 30-June-2003	Model: SR4300
		Page: 1 / 3	REF.NBR: MZ03-026
Circulation:		Application:	
x for information customer complain

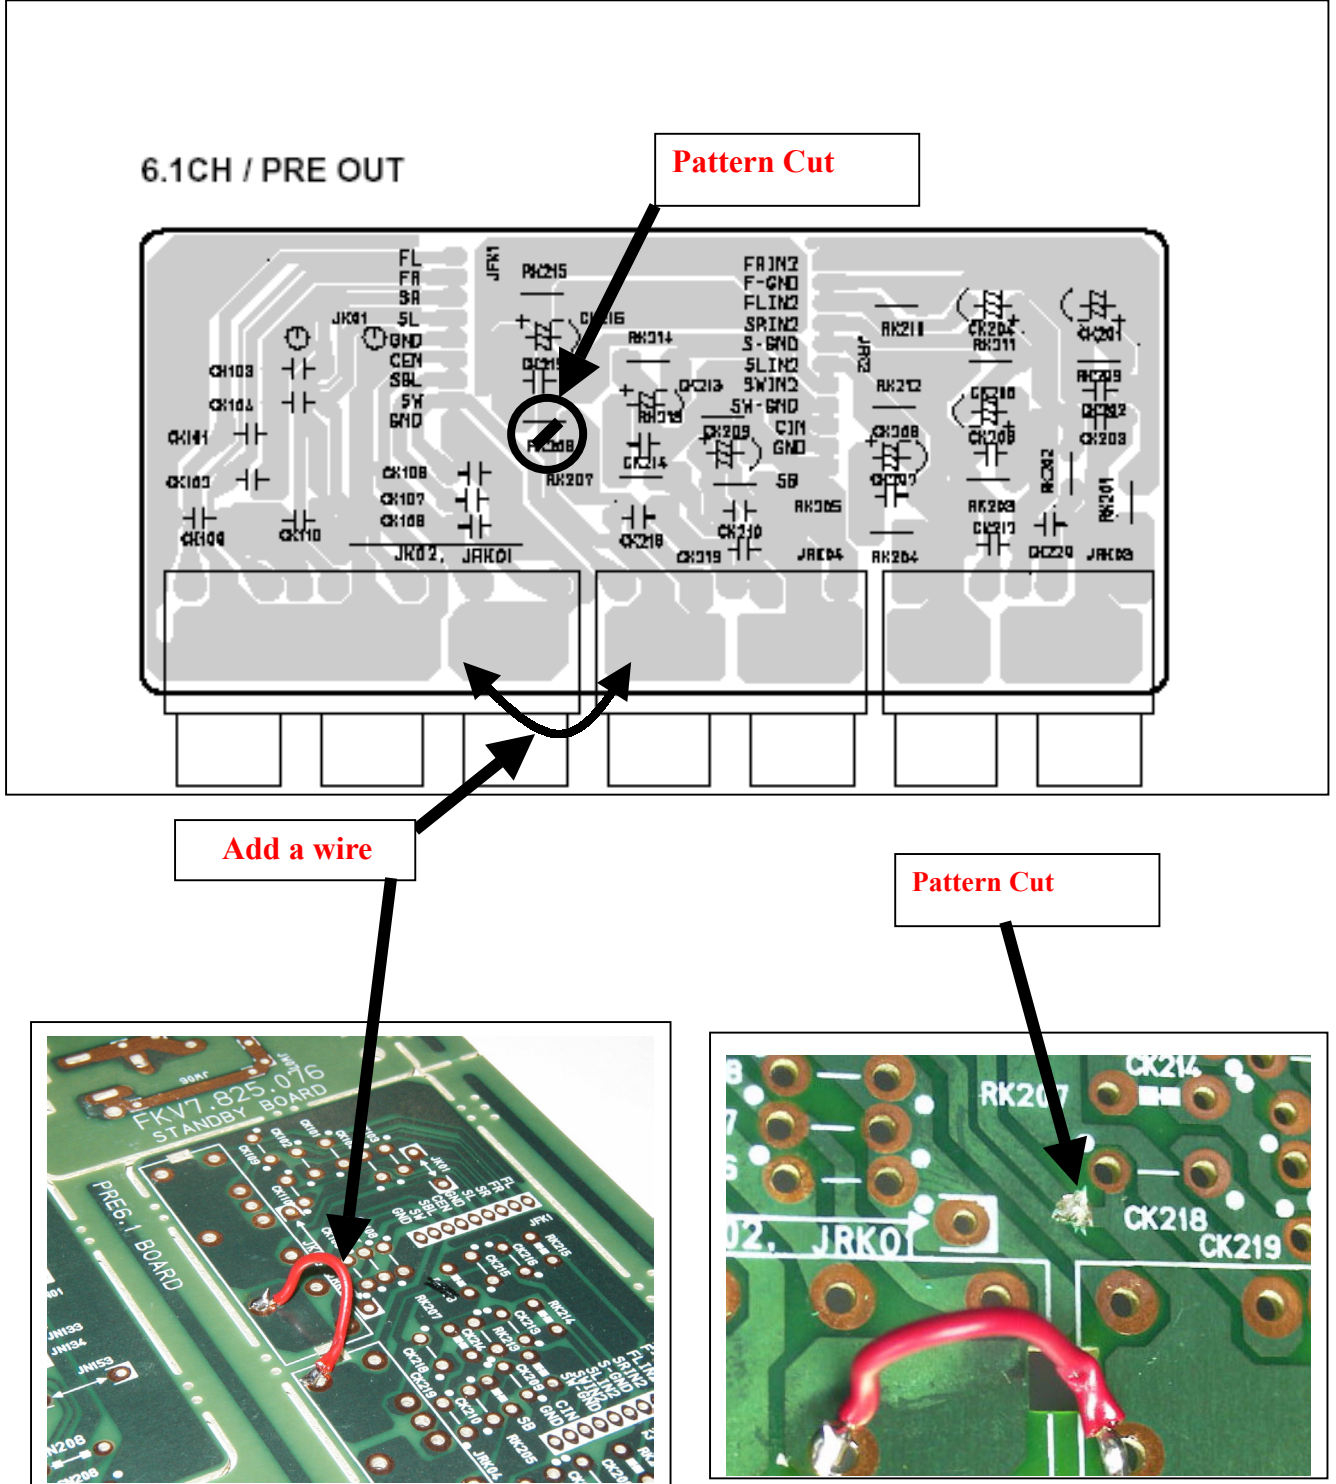
Fig.1

Noise is conspicuous PREAMP OUTPUTS and SPEAKER OUTPUTS by the conditions.

3. Cut a pattern. (please see Fig.1)
  4. Add a wire. (please see Fig.1)
  5. Twist the wire 5 times. (please see Fig.2)
- The 9pin wires are connected to JFS05(DIGITAL/AUDIO PCB) from JFK1(6.1CH/PRE OUT PCB)
