marantz® SERVICE BULLETIN		Date: 30-June-2003	Model: SR4300,SR4400
		Page: 1 / 1	REF.NBR: MZ03-023
Circulation:		Subject:	
Application:		The sound is interrupted, when the playback DIGITAL of CD-R/RW of the SCMS signal.	
x for information customer complaint in case of service mandatory	See Below	Int.ref:

marantz® SERVICE BULLETIN		Date: 31-Oct.-2003	Model: SR4300/SR4400
		Page: 1 / 3	REF.NBR: MZ03-047
Circulation:		Subject:	
Application:		The problem of the Speaker protection circuit.	
x for information customer complaint in case of service mandatory			
		Service code XE00 XE00xxxxxxxxxx

marantz® SERVICE BULLETIN		Date: 30-June-2003	Model: SR4300,SR4400
		Page: 1 / 1	REF.NBR: MZ03-025
Circulation:		Application:	
x for information customer complaint in case of service mandatory		See Below	
		Subject: FM(with RDS) signal is received, Frequency Indication becomes the setup of default by the remote control operation . (only N and A version occurs)	
		Int.ref:

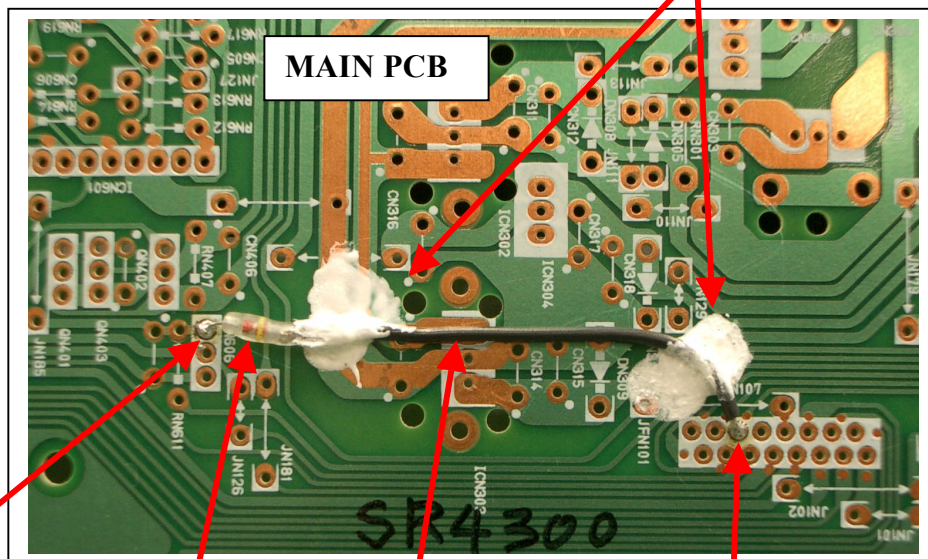
BASE of QN606

DN601
Part no. HD20002000

No.5 pin of JFN101

Insulation tube is used

- 2) Chip Resistor **DN601(Part no.HD20002000---Silicon Diode 1SS254 ROHM)** is added between BASE of QN606 SEMICOM.COMP and No.5 pin of JFN101 Connector

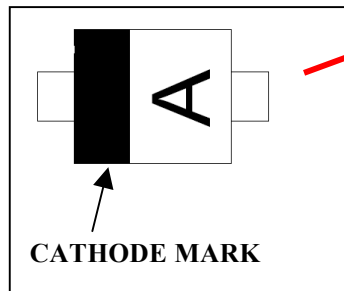
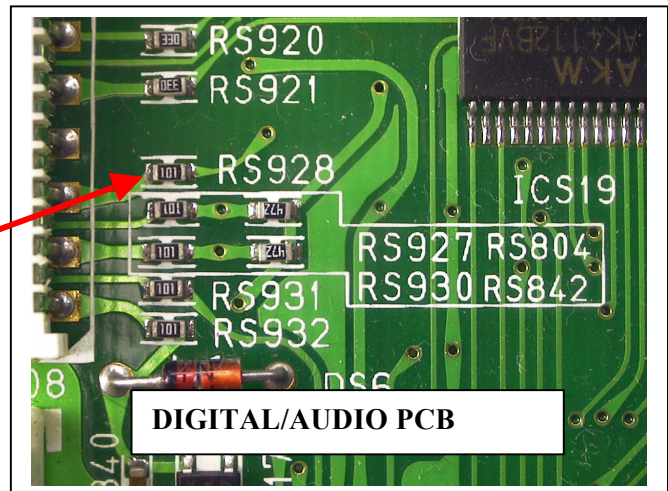
SR4400

RS928 is changed to
Part no. *HD201810R

Caution
JFS08 (FPC CONNECTOR) side is
CATHODE

- 1) Chip Resistor **RS928** (100 ohm 1/16W part no. NN05101610) is changed to **Silicon Diode (Part no. *HD201810R--- 1SS400 POHM: EMD2, EIAJ: SC-79, JEDEC: SOD-523)**.

Adhesives:
SC608LVZ (Sony Chemical Corp. – Self-extinguishing adhesive) or the equivalent
