Service Bulletin

No. : MZ07-097

Model: SR4320

Subject: Correction of the Service Manual, part no. of Sub Transformer.

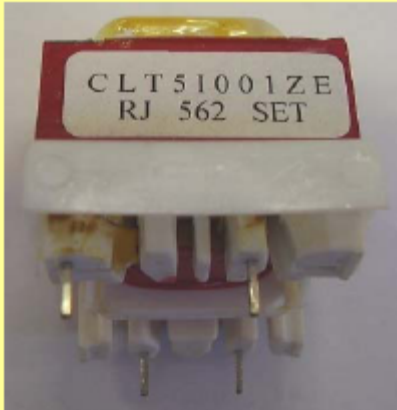
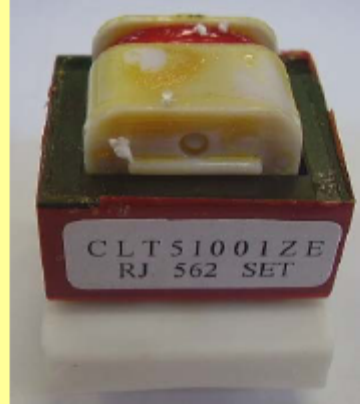
Symptom: The Sub Transformer 120V/12V part number (POS. NO.T701) mentioned on the SR4320's Service Manual is incorrect. (Service Manual page 39)

OLD *TS001870R 230V/12V (Factory code no. CLT5I001ZE)

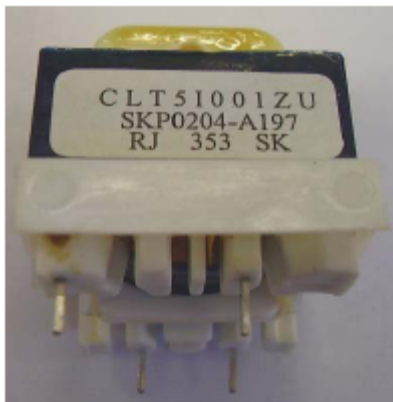
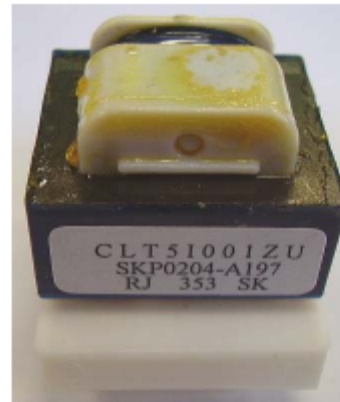
NEW 90M-TS001860R 120V/12V (Factory code no. CLT5I001ZU)

Solution: Use the new part number listed when ordering a replacement sub transformer.
