| marantz® SERVICE BULLETIN | | Date: 31-Oct.-2003 | Model: SR4300/SR4400 |
| Application: | | The problem of the Speaker protection circuit. | |

| marantz® SERVICE BULLETIN | | Date: 30-June-2003 | Model: SR4300,SR4400 |

| marantz® SERVICE BULLETIN | | Date: 15-May-2003 | Model SR4300 |

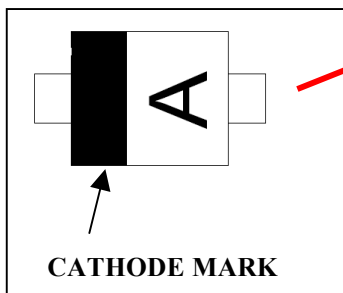
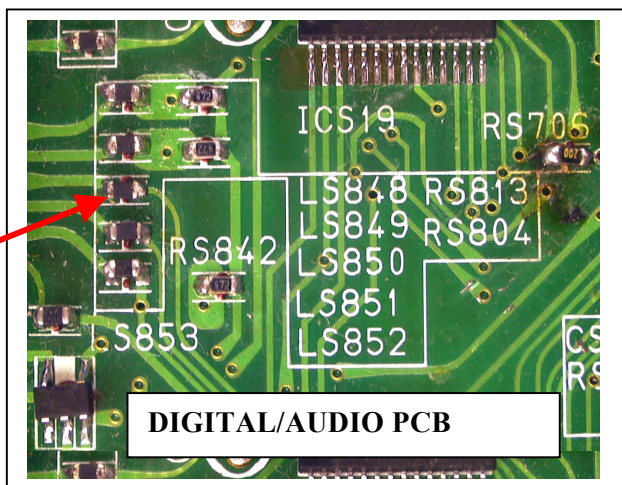
SR4300

LS850 is changed to
Part no. *HD201810R

Caution
JFS08 (FPC CONNECTOR) side is
CATHODE

- 1) Chip Resistor **LS850** (100 ohm 1/16W part no. NN05101610) is changed to **Silicon Diode (Part no. *HD201810R--- 1SS400 POHM: EMD2, EIAJ: SC-79, JEDEC: SOD-523)**.

Adhesives:
SC608LVZ (Sony Chemical Corp. – Self-extinguishing adhesive) or the equivalent

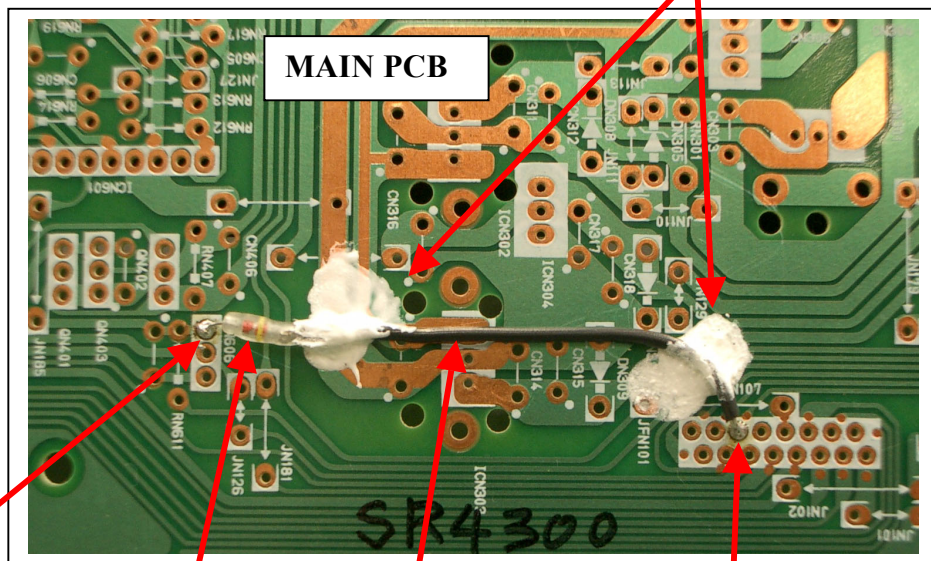
BASE of QN606

No.5 pin of JFN101

DN601
Part no. HD20002000

Insulation tube is used

- 2) Chip Resistor **DN601(Part no.HD20002000---Silicon Diode 1SS254 ROHM)** is added between BASE of QN606 SEMICOM.COMP and No.5 pin of JFN101 Connector

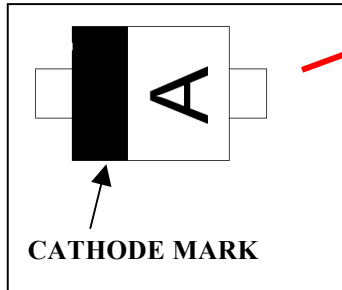
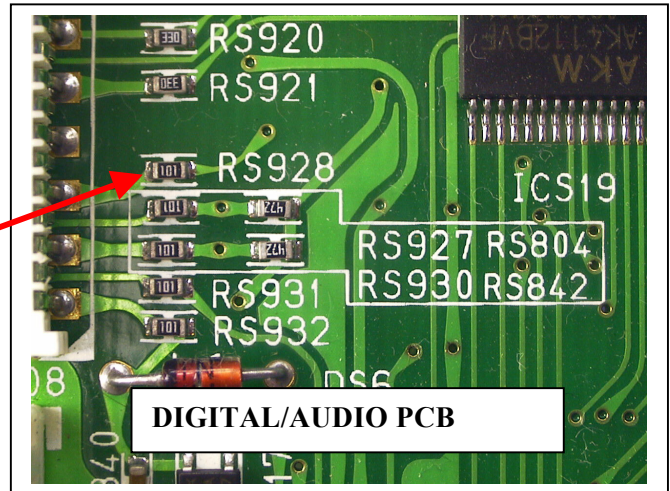
SR4400

RS928 is changed to
Part no. *HD201810R

Caution
JFS08 (FPC CONNECTOR) side is
CATHODE

BASE of QN606

No.5 pin of JFN101

Insulation tube is used

DN601
Part no. HD20002000

- 1) Chip Resistor **RS928** (100 ohm 1/16W part no. NN05101610) is changed to **Silicon Diode (Part no. *HD201810R--- 1SS400 POHM: EMD2, EIAJ: SC-79, JEDEC: SOD-523)**.

- 2) Chip Resistor **DN601(Part no.HD20002000---Silicon Diode 1SS254 ROHM)** is added between BASE of QN606 SEMICOM.COMP and No.5 pin of JFN101 Connector

Adhesives:
SC608LVZ (Sony Chemical Corp. – Self-extinguishing adhesive) or the equivalent

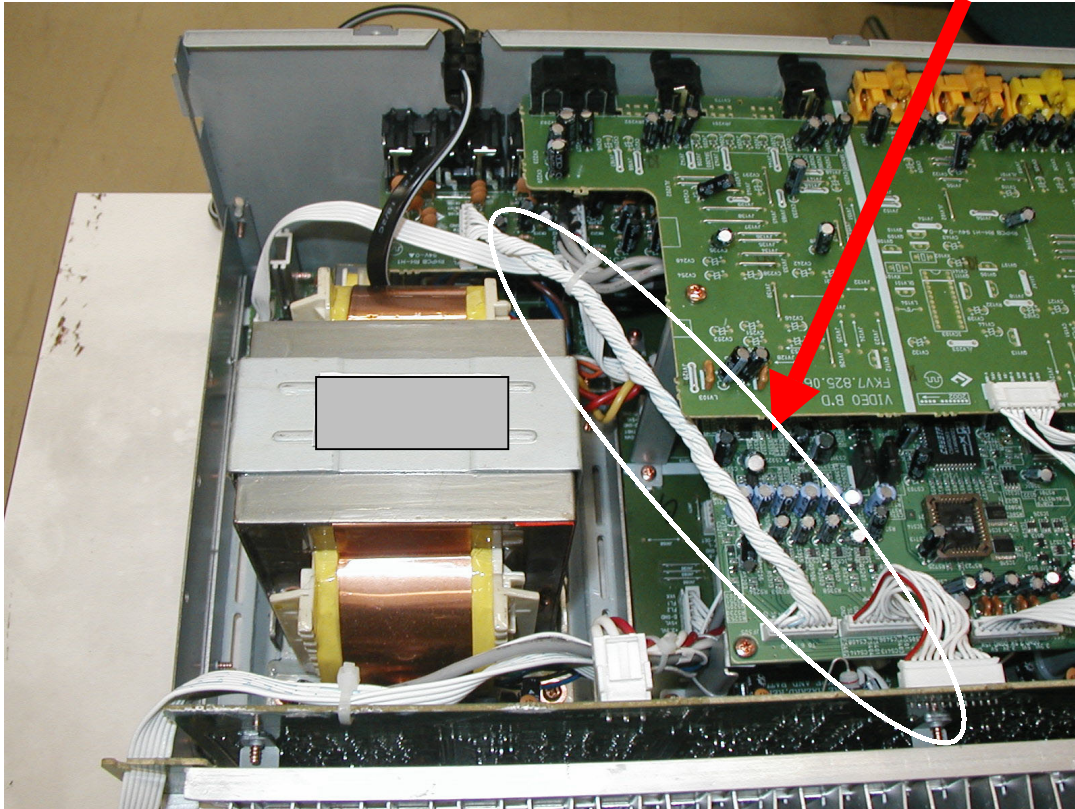
Fig.2

Twist the wire 5 times

↓ FRONT SIDE

3. Cut a pattern. (please see Fig.1)
 4. Add a wire. (please see Fig.1)
 5. Twist the wire 5 times. (please see Fig.2)
- The 9pin wires are connected to JFS05(DIGITAL/AUDIO PCB) from JFK1(6.1CH/PRE OUT PCB)

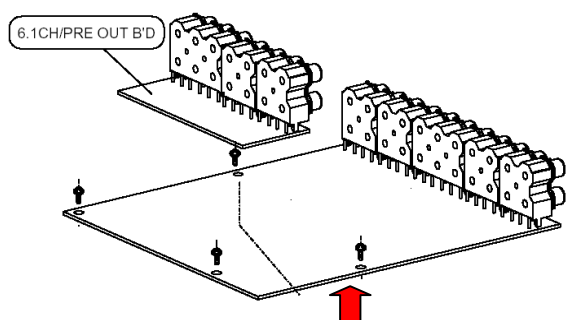
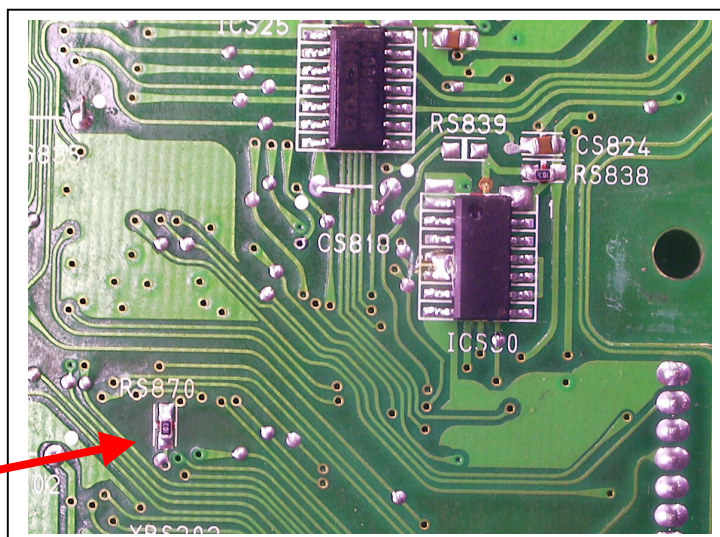
When the unit warms up, CPU clock stops, and the unit becomes a perfect stop.
The capacitor (0.1uF) was mounted instead of resistor RS870(10 k ohm) .
(When the PCB is repaired, it has the possibility that a capacitor (0.1uF) was used.)

RS870 is this side of DIDITAL/AUDIO PCB

RS870 (10 k ohm)

1. Confirm whether **RS870** on DIGITAL/AUDIO PCB is **10 k ohm Chip resistor**.
2. The part which isn't right, changed to **10 k ohm Chip resistor (Part no. NN05103610)**.

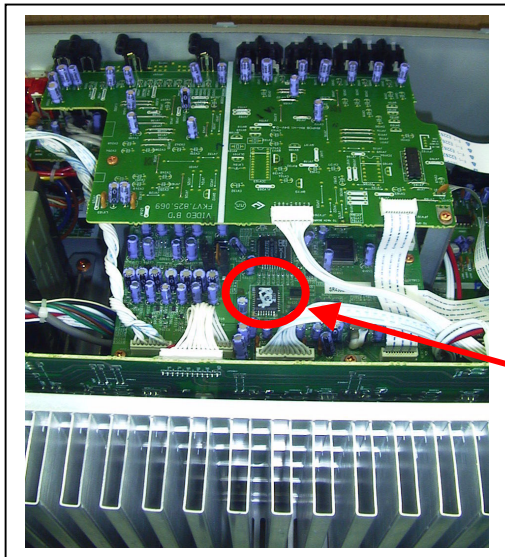
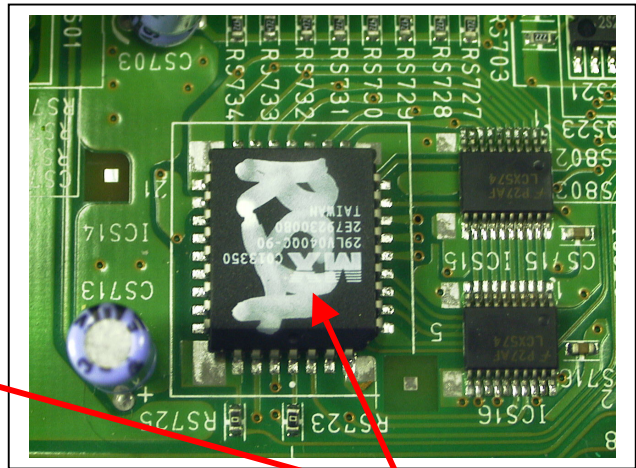
Treble is slightly distorted when the level of TruBass is increased in CSII mode. (only in case of Rch)

Replace IC (ICS14) on the **DIGITAL/AUDIO CIRCUIT BOARD**.

POS.NO ICS14 Part no. *HS09AWX2R MX29LV040QC-90 **Factory part no. OICMX29LV040QC90**
 [OLD part no. *HS09AWX0R Factory part no. OICMX29LV040QC90]
