<b>marantz®</b> <b>SERVICE BULLETIN</b>		Date: 30-June-2003	Model: SR4300,SR4400
		Page: 1 / 1	REF.NBR: MZ03-023
Circulation:		Subject:	
Application:		The sound is interrupted, when the playback DIGITAL of CD-R/RW of the SCMS signal.	
x for information customer complaint in case of service mandatory .....		Int.ref:	
See Below

<b>marantz®</b> <b>SERVICE BULLETIN</b>		Date: 31-Oct.-2003	Model: SR4300/SR4400
		Page: 1 / 3	REF.NBR: MZ03-047
Circulation:		Subject:	
Application:		The problem of the Speaker protection circuit.	
x for information customer complaint in case of service mandatory .....			
		Service code XE00 XE00xxxxxxxxxx

<b>marantz®</b> <b>SERVICE BULLETIN</b>		Date: 30-June-2003	Model: SR4300,SR4400
		Page: 1 / 1	REF.NBR: MZ03-025
Circulation:		Application:	
x for information customer complaint in case of service mandatory .....		See Below	
		Int.ref:

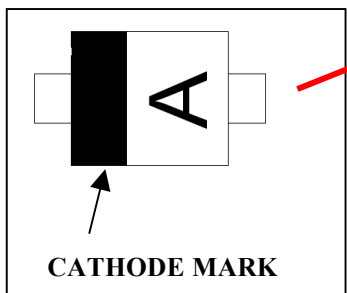
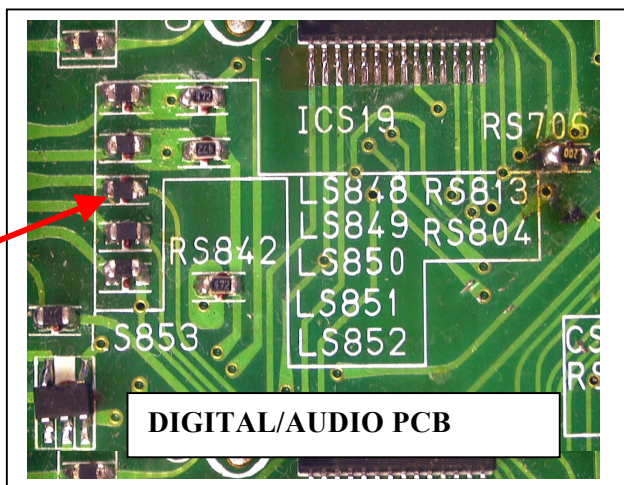
**SR4300**

LS850 is changed to  
Part no. \*HD201810R

**Caution**  
JFS08 (FPC CONNECTOR) side is  
CATHODE

- 1) Chip Resistor **LS850** (100 ohm 1/16W part no. NN05101610 ) is changed to **Silicon Diode (Part no. \*HD201810R--- 1SS400 POHM: EMD2, EIAJ: SC-79, JEDEC: SOD-523 )**.

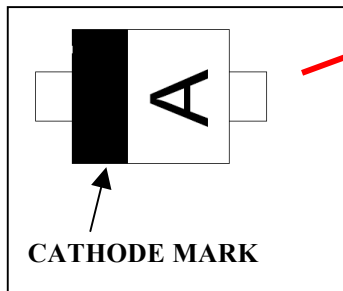
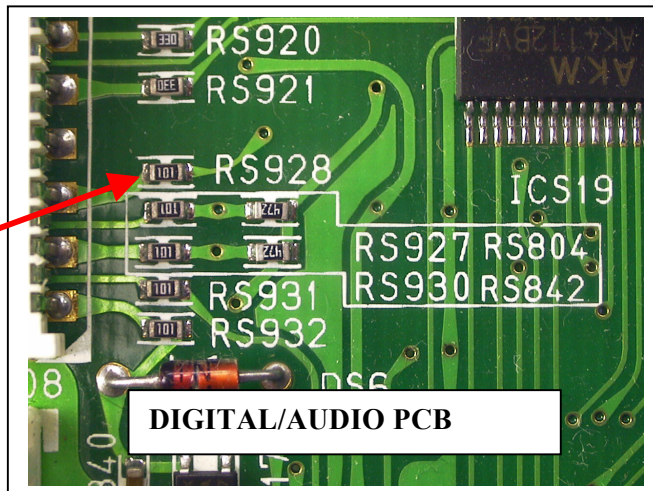
SR4400

RS928 is changed to  
Part no. \*HD201810R

**Caution**  
JFS08 (FPC CONNECTOR) side is  
CATHODE

- 1) Chip Resistor **RS928** (100 ohm 1/16W part no. NN05101610 ) is changed to **Silicon Diode (Part no. \*HD201810R--- 1SS400 POHM: EMD2, EIAJ: SC-79, JEDEC: SOD-523 )**.

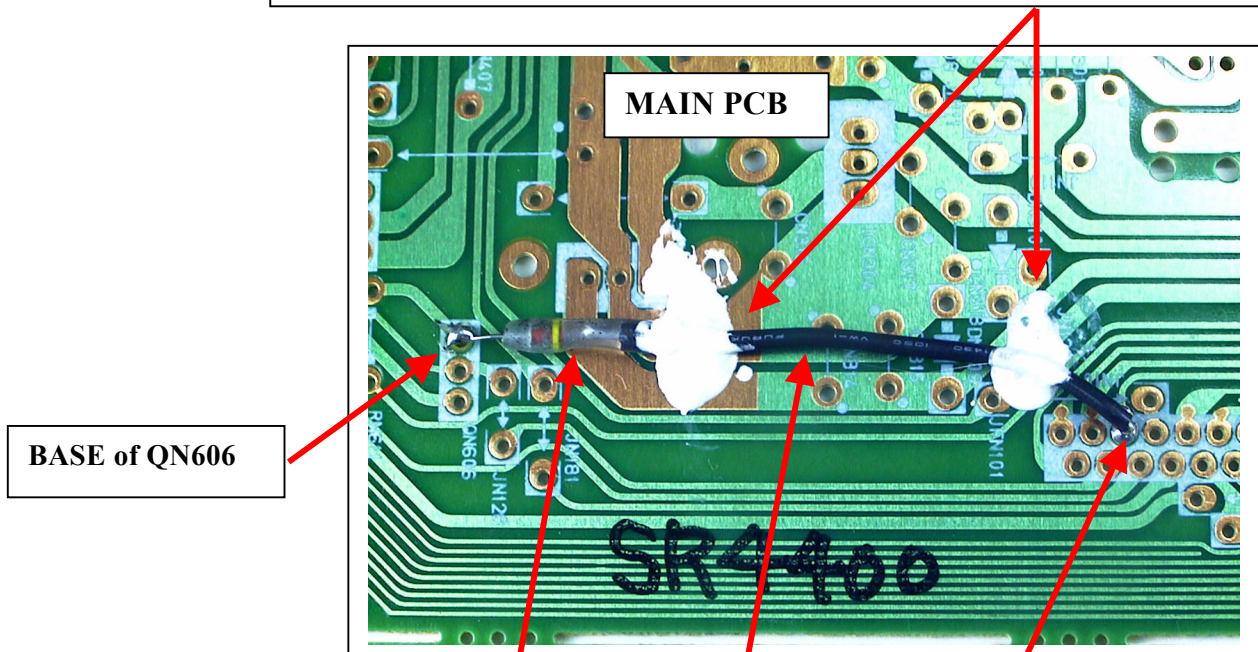
DN601  
Part no. HD20002000

No.5 pin of JFN101

Insulation tube is used

- 2) Chip Resistor **DN601(Part no.HD20002000---Silicon Diode 1SS254 ROHM)** is added between BASE of QN606 SEMICOM.COMP and No.5 pin of JFN101 Connector
