SR5001

Service Bulletin

No. : MZ06-046 **Date:** April 12, 2007

Subject: Corrections made to DC trigger circuit.

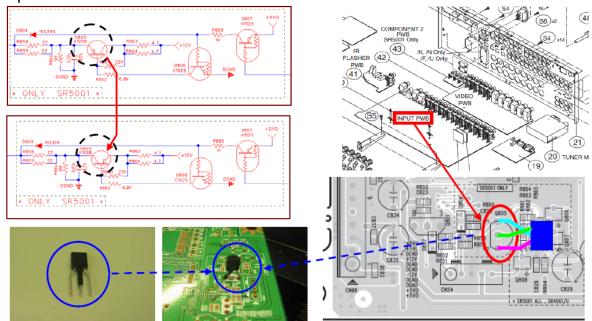
Symptom: Since the electrical current capacity to the DC trigger output is low, the DC trigger output voltage may drop with some units, and as a result, such units may not operate properly even when they are connected to the output.

Solution: 1. Reverse the emitter and collector connections of Q805 on the input PWB.

2. In units where problems have occurred in the trigger operation, the transistor may have been damaged. For this reason, replace Q805, and reverse the connections of its emitter and collector as above.
