Service Bulletin

No. : MZ07-021

Model: SR4001, SR5001

Subject: Correction of the Service Manual, System Error Information.

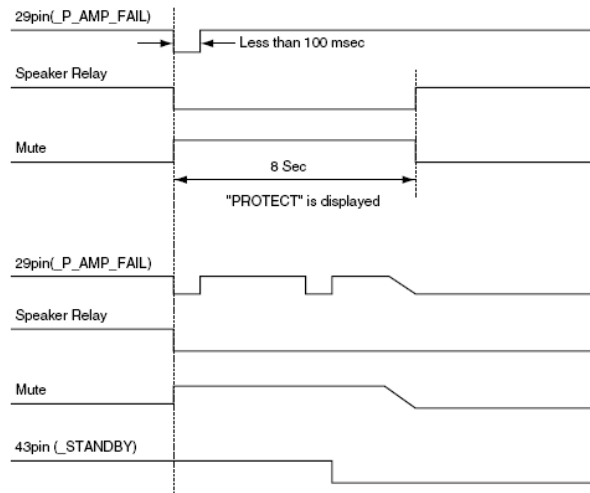
2. When "L" of less than 100msec is detected by 29pin (Power Amp Fail) of IC17, Speaker Relay becomes OFF and MUTE becomes ON state, and the state is held for 8 seconds. At this time, "PROTECT" is displayed. When similar abnormal detection was considered to be it for these 8 seconds, the unit will be in standby mode and STANDBY LED will blink. When it was not detected abnormally for 8 seconds, the unit returns to normal use state.

- ②. マイコンの29pin (Power Amp Fail)に100msec未満の"L"検出がされた場合はSpeaker RelayをOFF, MUTEをON状態にして8秒間その状態を保持する。この間、FL Displayに "PROTECT"の表示を行う。この8秒間に同様の異常検出がされた場合はSETをSTANDBY状態にしてFront Panel上のSTANDBY LEDを点滅状態にします。8秒間、異常検出されなかった時はSETを通常使用状態に戻します。

1. Check AMP PWB.
2. When AMP does not have a problem, it is confirmed whether there is not abnormality by disconnection of pattern of 29pin (Power Amp Fail) and the detect circuit.

- ①. Power Ampに不具合が生じている場合は修理を行う。
- ②. Power Ampに不具合が無い場合は、29pin (Power Amp Fail)のパターンの断線及び検出回路に異常が無いが確認する。
