Service Bulletin

No.: MZ09-100

Model: SR6004, SR5004

Subject: A Hum Noise occurs at shorting of FRONT AUX Audio input.

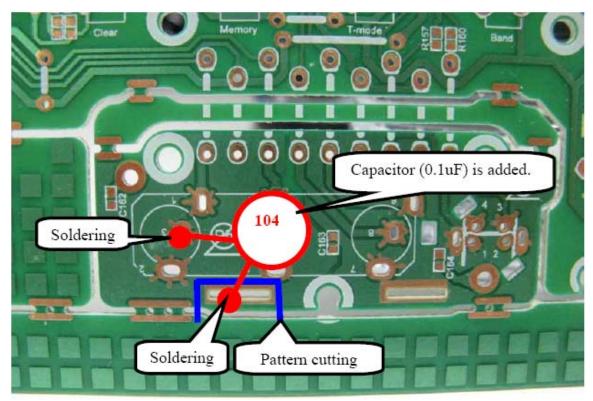
Bottom SIDE of CUP12205Z/Y AUX P.W.B. (FRONT P.W.B. ASSY)

Symptom: The AUX Audio input (Front) terminal is shorted at MAIN Volume MAX. The Hum noise is louder than REAR AUX input terminal in the rear panel. The earth side of the AUX input terminal is connected directly with the chassis, the earth circuit is looped.

Please add the following capacitor on AUX P.W.B. (FRONT P.W.B. ASSY: CUP12205Z/Y) and cut the pattern as shown below.
