marantz.		Date:	15-May-2003	Model: SR5200/SR6200/SR7200	
		Page:	1/2	REF.NBR: MZ02-033	
SERVICE BU	JLLETIN	Subject:			
Circulation:	Application:	Hymnesiae and he heard from Headah are out			
x for information customer complaint in case of service mandatory	See below	Hum noise can be heard from Headphone out			
1		Int.r	ef:

Hum noise can be heard from Headphone out

SERVICE BULLETIN		Date: 15-May-2003 Model: SR5200/SR6200/SR72			
		Page:	1/6	REF.NBR	: MZ02-032
		Subje	ct:		
Circulation:	Application:			Pop noise	
x for information customer complaint in case of service mandatory	See below				
-		Int.r	ef:

marantz		Date: 27-Sep-01		Model: SR5200/6200/7200	
		Page:	1/2	REF.NB	MZ01-016
SERVICE BULLETIN		Subject:			
Circulation:	Application:				
x for information customer complaint in case of service	Refer to following.	The noise (stripes) occur on the picture.			
mandatory		Int.ref

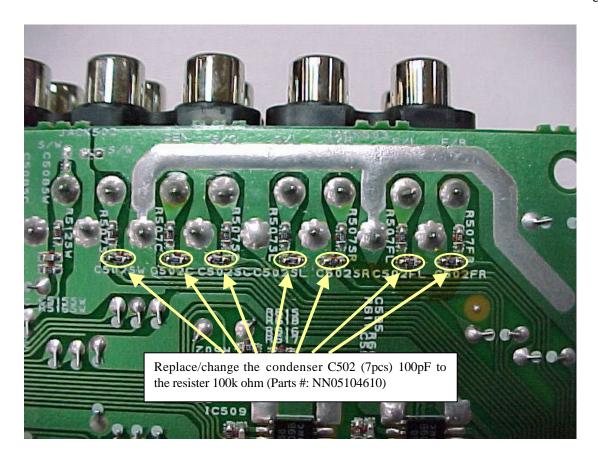
* Version 1 P.C.Board (7020 06076 001-0): Please apply the modification mentioned below (Page2 to 4).

Pop noise appears when stop playing or track skip on CD playback with Digital connection. Pop noise appears in the condition of the Main volume is changed 74dB to 75dB(Mute).

^{*} Version 1 P.C.Board (7020 06076 001-0): Please apply the modification mentioned on Page2 to 4.
