## **Service Bulletin**

**No. :** MZ07-067

**Model:** SR5500

**Subject:** Software Update Information.

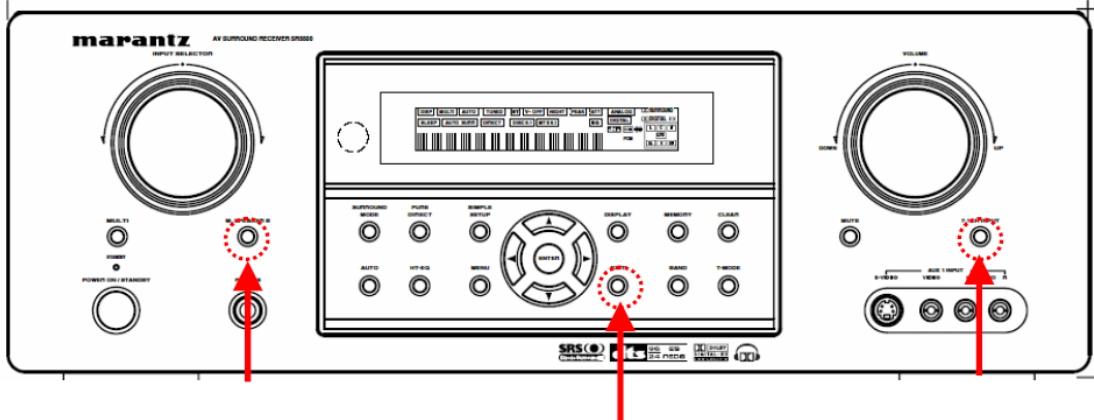
**\*1: If the unit cannot be powered on after being plugged in again (with the STANDBY LED flickering every 125m seconds), the power amp has been damaged. The unit still can be powered on again through the following method,**

but it can cause further damage the power amplifier. Please never let end-users perform this procedure.

Can be powered on by “FACTORY” KEY = [7.1CH INPUT] + [EXIT] + [M. SPEAKER B]”
