## **Service Bulletin**

**No. :** MZ07-068

**Model:** SR5600

**Subject:** Software Update Information.

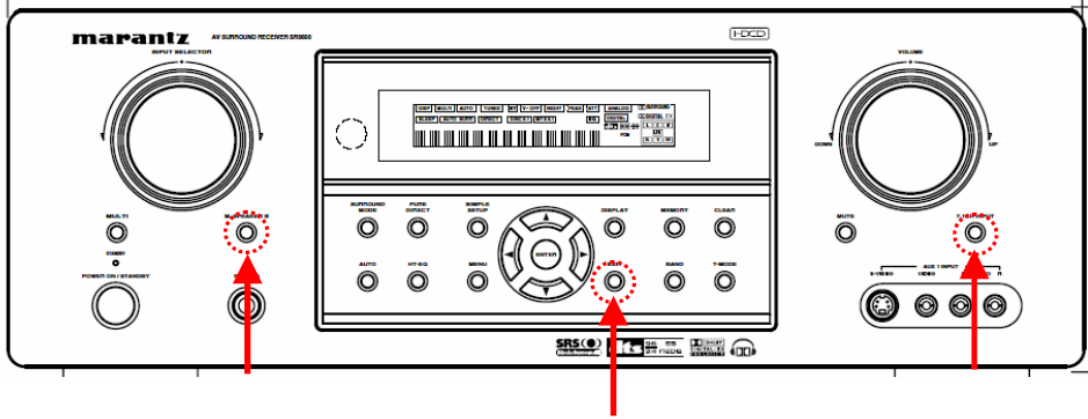
**\*1: If the unit cannot be powered on after being plugged in again (with the STANDBY LED flickering every 125m seconds), the power amp has been damaged. The unit still can be powered on again through the following method,**

but it can cause further damage the power amplifier. Please never let end-users perform this procedure.

Can be powered on by “FACTORY” KEY= [7.1CH INPUT] + [EXIT] + [M. SPEAKER B]”.
