marantz® SERVICE BULLETIN		Date: 15-May-2003	Model: SR5200/SR6200/SR7200
		Page: 1/2	REF.NBR: MZ02-033
Circulation:		Subject:	
Application:		Hum noise can be heard from Headphone out.	
x for information customer complaint in case of service mandatory			
See below

marantz® SERVICE BULLETIN		Date: 15-May-2003	Model: SR5200/SR6200/SR7200
		Page: 1/6	REF.NBR: MZ02-032
Circulation:		Application:	
x for information customer complaint in case of service mandatory		See below	
		Subject: Pop noise	
		Int.ref:

marantz® SERVICE BULLETIN		Date: 15-May.-2003	Model: SR5200,SR6200,SR7200
		Page: 1 / 1	REF.NBR: MZ02-027
Circulation:		Application:	
x for information customer complaint in case of service mandatory		See Below	
		Subject: Video synchronization problem.	
		Int.ref:

marantz® SERVICE BULLETIN		Date: 15-May.-2003	Model: SR5200,SR6200,SR7200
		Page: 1 / 1	REF.NBR: MZ02-039
Circulation:		Application:	
x for information customer complaint in case of service mandatory		See Below	
		Subject: The damage of the power transistor	
		Int.ref:

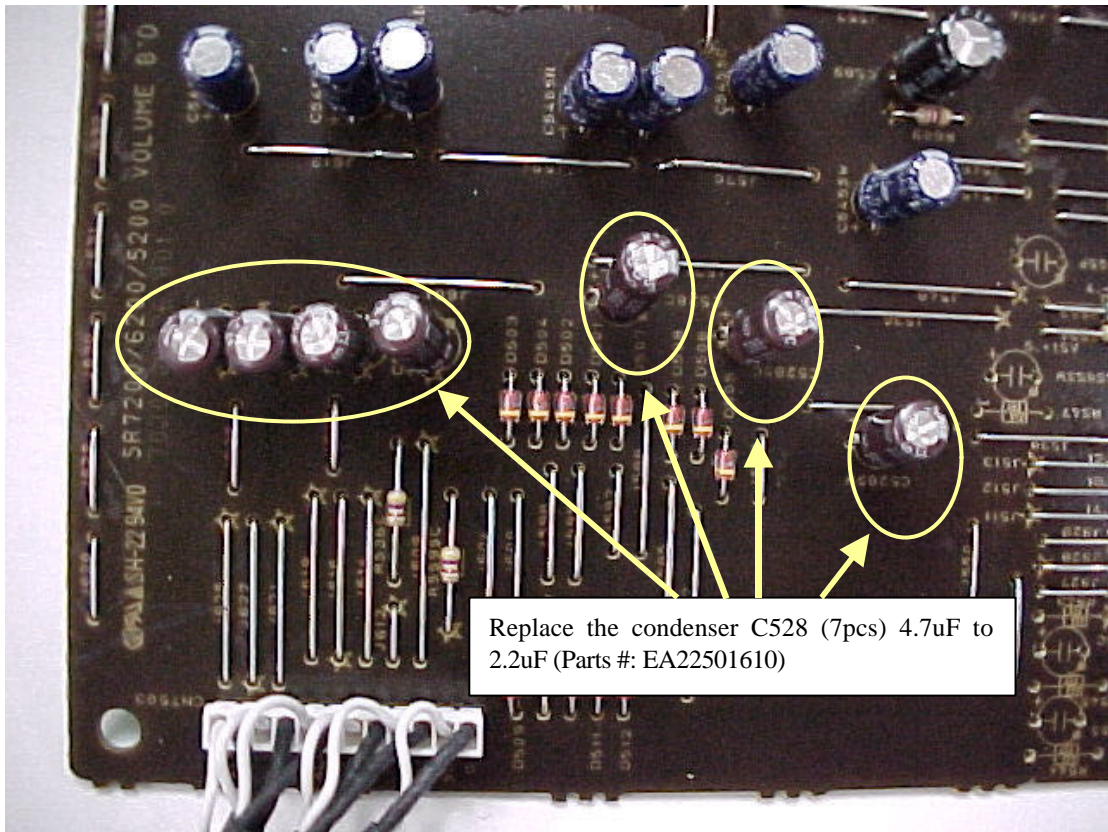
* Version 1 P.C.Board (7020 06076 001-0) : Please apply the modification mentioned below (Page2 to 4).

Pop noise appears when stop playing or track skip on CD playback with Digital connection.
Pop noise appears in the condition of the Main volume is changed 74dB to 75dB(Mute) .

* Version 1 P.C.Board (7020 06076 001-0) : Please apply the modification mentioned on Page2 to 4.

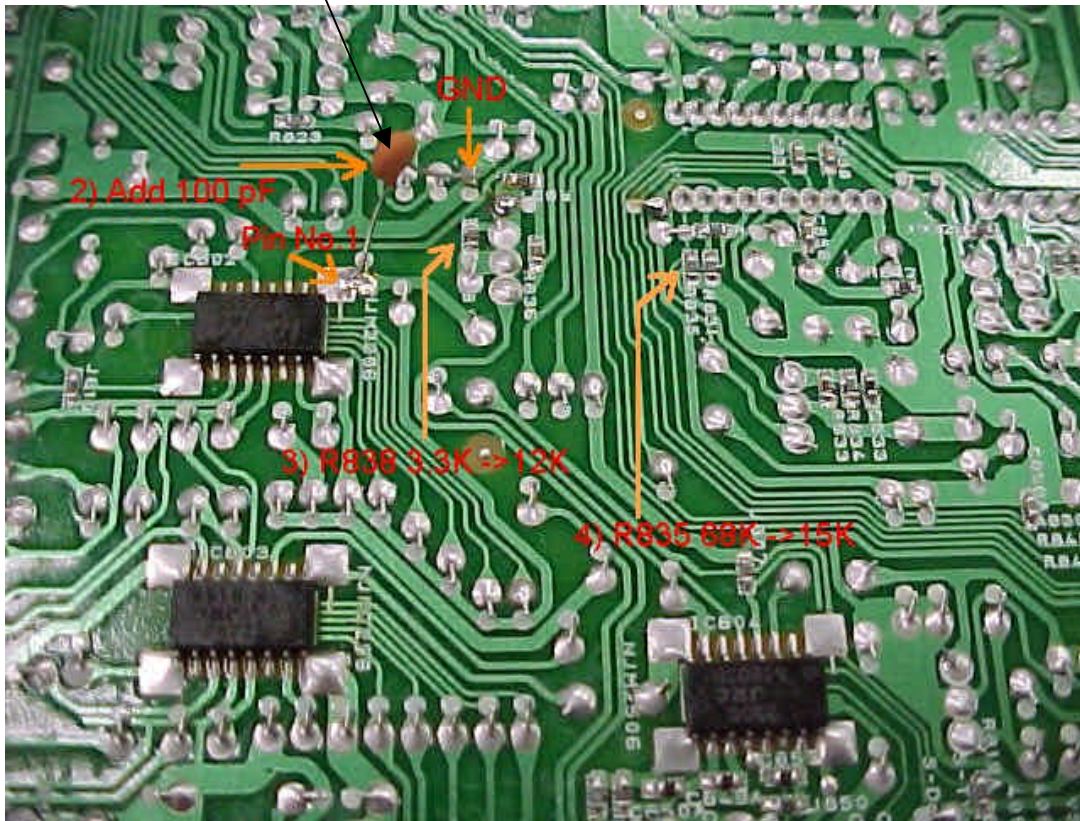
PIC.01

When a output connect with the monitor via the S-VIDEO terminal, noise(stripes) occur at the picture.

The clock from the OSD circuit, it caused interference to VIDEO-AMP circuit.

- 1) The capacitor(C810A 100pF: DK16101300 4822 122 33195) is added between 1P of IC802 and GND(refer to PIC.01).
- 2) The jumper wire(J841) is deleted and a capacitor(C840A 47uF/16V: EA47601620 9965 000 06289) is added to same position (refer to PIC.02).
- 3) The chip resistor(R838) is changed into 12kohm one(NN05123610 4822 051 30123) from the present 3.3kohm one.
- 4) The chip resistor(R835) is changed into 15kohm one(NN05153610 4822 051 30153) from the present 68kohm one.

C810A (100pF: DK16101300

4822 122 33195)
