Service Bulletin

No. : MZ07-040

Model: SR7001, SR8001

Subject: Software Update Information.

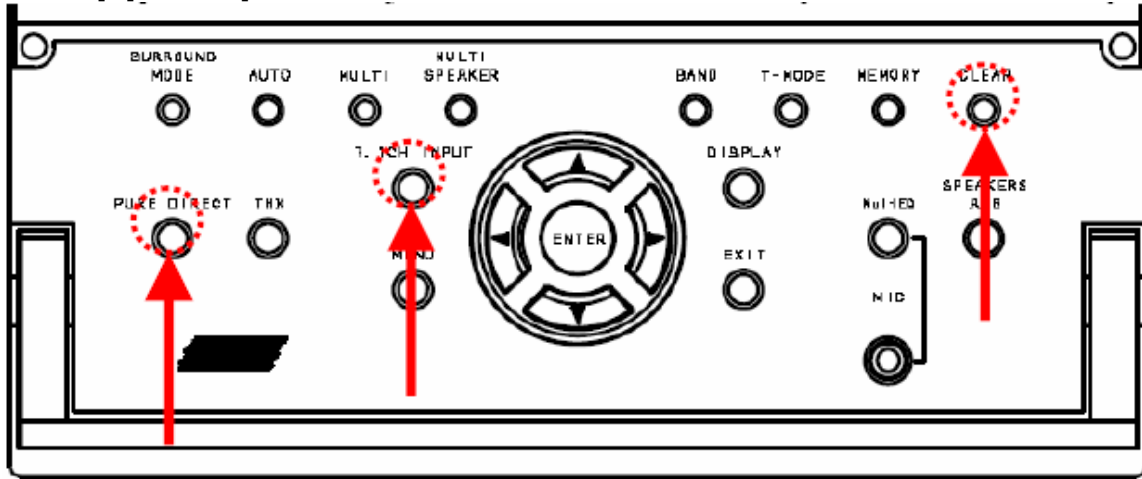
Can be powered on by “FACTORY KEY” = [PURE DIRECT]+[7.1 CH INPUT]+[CLEAR]

***1: If the unit cannot be powered on after being plugged in again (with the STANDBY LED flickering every 125m seconds), the power amp has failed. The unit still can be powered on again through the following method, but it can further damage the power amplifier. Please never let end-users perform this procedure.**
