marantz.		Date:	15-May-2003	Model: SR5200/SR6200/SR7200	
		Page:	1/2	REF.NBR: MZ02-033	
SERVICE BU	JLLETIN	Subject:			
Circulation:	Application:	Hymnesiae and he heard from Headelbare out			
x for information customer complaint in case of service mandatory	See below	Hum noise can be heard from Headphone out			
		Int.r	ef:

Hum noise can be heard from Headphone out

SERVICE BULLETIN		Date: 15-May-2003 Model: SR5200/SR6200/SR72			
		Page:	1/6	REF.NBR	: MZ02-032
		Subje	ct:		
Circulation:	Application:			Pop noise	
x for information customer complaint in case of service mandatory	See below				
-		Int.r	ef:

marantz.		Date:	15-May2003	Model: SR5200,SR6200,SR7200
		Page:	1 / 1	REF.NBR: MZ02-027
SERVICE BU	SERVICE BULLETIN		•	
Circulation:	Application:	Video synchronization problem.		
x for information customer complaint in case of service mandatory	See Below	Int.ref:

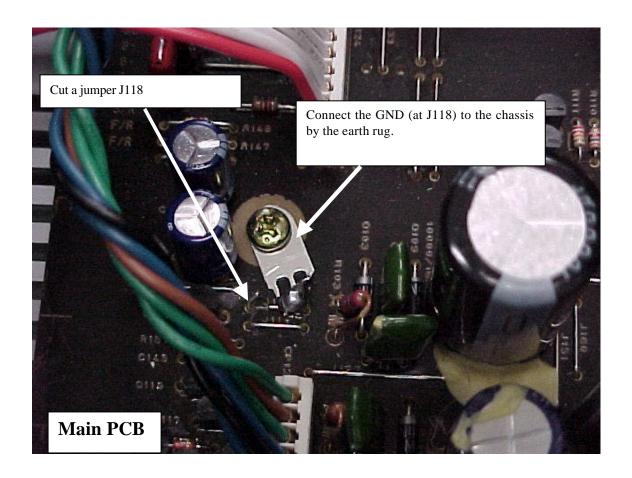
Caused by ground loop of the headphone out.

Please apply the following solution.

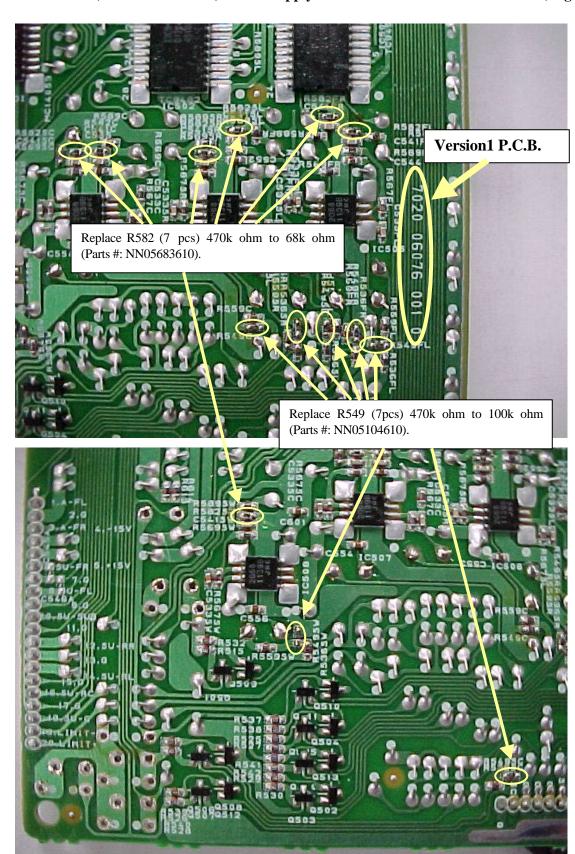
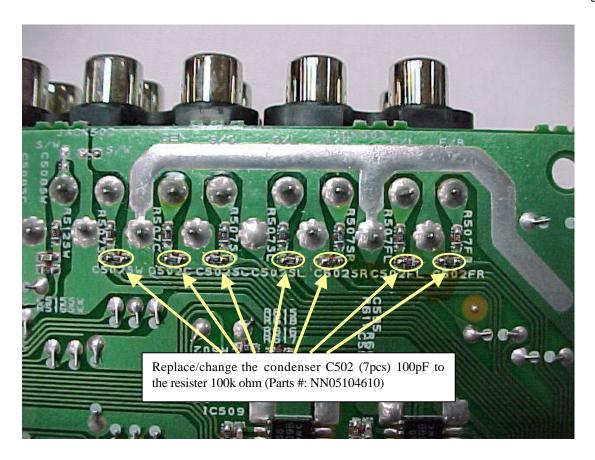
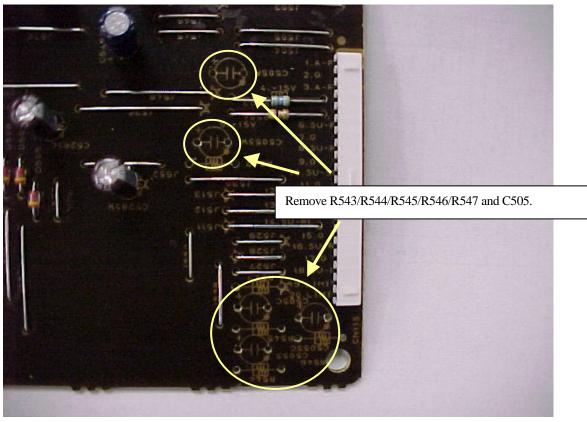
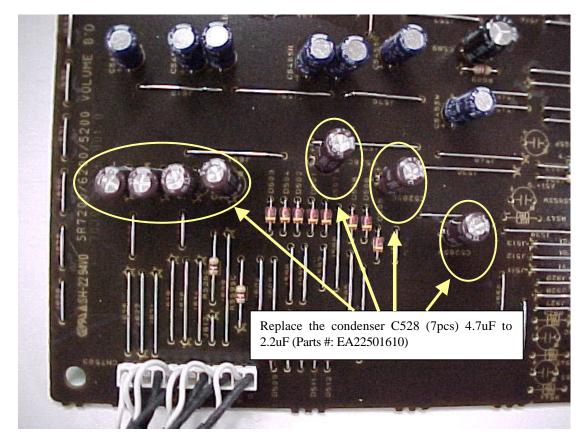
* Version 1 P.C.Board (7020 06076 001-0): Please apply the modification mentioned below (Page2 to 4).

Pop noise appears when stop playing or track skip on CD playback with Digital connection. Pop noise appears in the condition of the Main volume is changed 74dB to 75dB(Mute).

^{*} Version 1 P.C.Board (7020 06076 001-0): Please apply the modification mentioned on Page2 to 4.

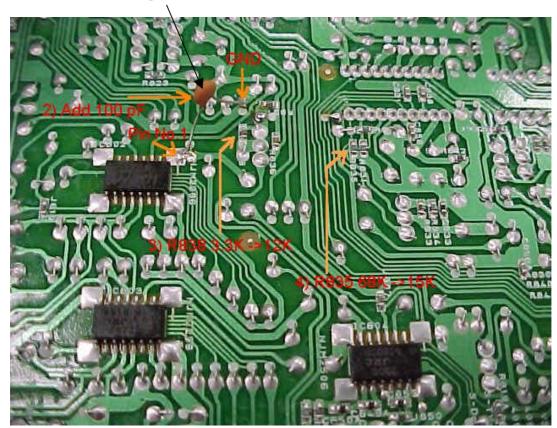
PIC.01

When a output connect with the monitor via the S-VIDEO terminal, noise(stripes) occur at the picture.

The clock from the OSD circuit, it caused interference to VIDEO-AMP circuit.

- 1) The capacitor(C810A 100pF: DK16101300 4822 122 33195) is added between 1P of IC802 and GND(refer to PIC.01).
- 2) The jumper wire(J841) is deleted and a capacitor(C840A 47uF/16V: EA47601620 9965 000 06289) is added to same position (refer to PIC.02).
- 3) The chip resistor(R838) is changed into 12kohm one(NN05123610 4822 051 30123) from the present 3.3kohm one.
- 4) The chip resistor(R835) is changed into 15kohm one(NN05153610 4822 051 30153) from the present 68kohm one.
