Service Bulletin

No. : MZ03-003 **Date:** December 5, 2006

Model: SR7300

Subject: Broken Knob

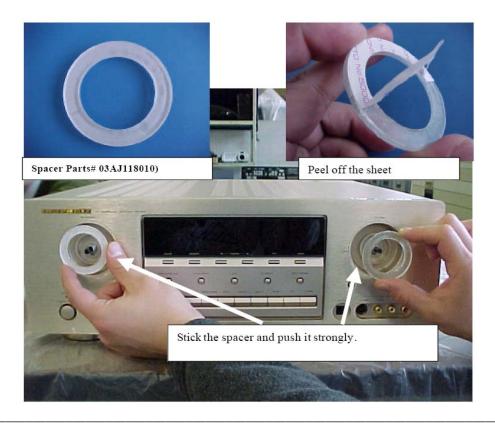
Symptom: Broken Volume or Selector knob by transportation. The clearance between the front panel and knob is a little large and this can stress to the volume or selector shaft.

Solution: Add the spacer (see parts) to the front panel as follows:

Ref#	Description	Part Number
NA	SPACER	03AJ118010
